TECHNICAL MEMORANDUM

To: Bob Jaques, Seaside Watermaster Program Manager
From: Georgina King and Derrik Williams
Date: February 21, 2017
Subject: Seaside Groundwater Basin Analysis of Wells Sampled in December 2016

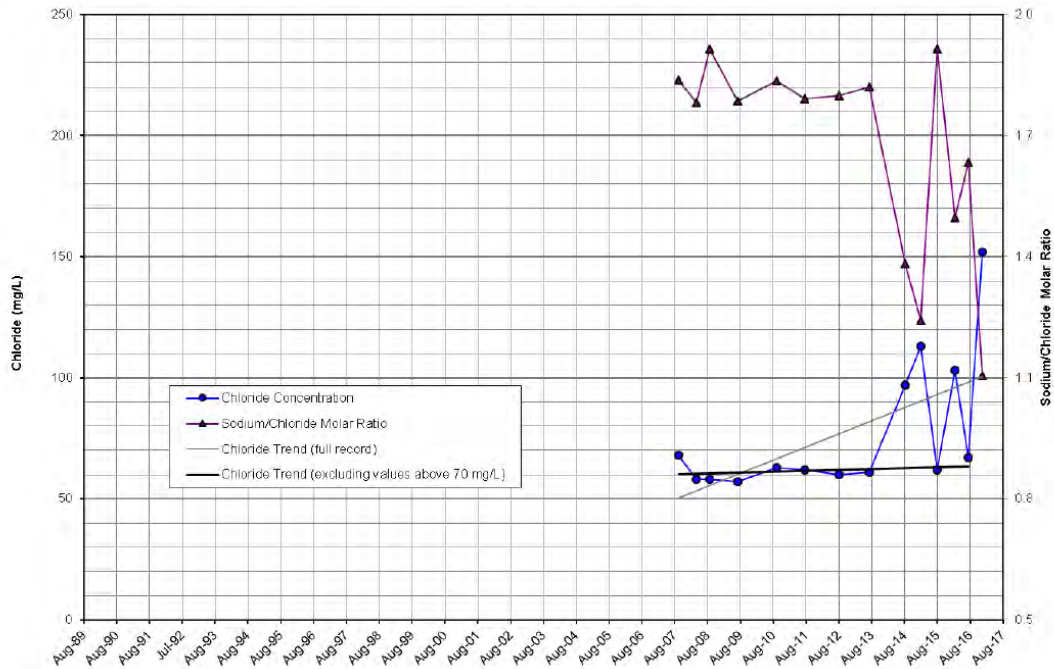
Figure 1: SBWM-1 (1,390 ft) Chloride Concentrations and Sodium/Chloride Ratios

- Well SBWM-1 (1,390 ft) had a 85 mg/L chloride increase since July 2016 and its overall chloride concentrations are increasing. The increasing chloride trend (grey trend line) observed in this well is more pronounced because of seasonal fluctuations where the winter concentrations tend to be higher than summer concentrations. There is a slight, but inconsequential, increasing trend if the high winter concentrations are excluded (> 70 mg/L, black trend line). The sodium/chloride ratio is well above the ratio of 0.86, below which other investigators have proposed as an indicator of seawater intrusion.
- Well SBWM-2 (1,470 ft) chloride concentrations declined in December to less than 70 mg/L, back to within the range of historical concentrations. The overall chloride trend is virtually flat if the July 2016 sample is excluded. The

sodium/chloride ratio is well above the ratio of 0.86, below which other investigators have proposed as an indicator of seawater intrusion.

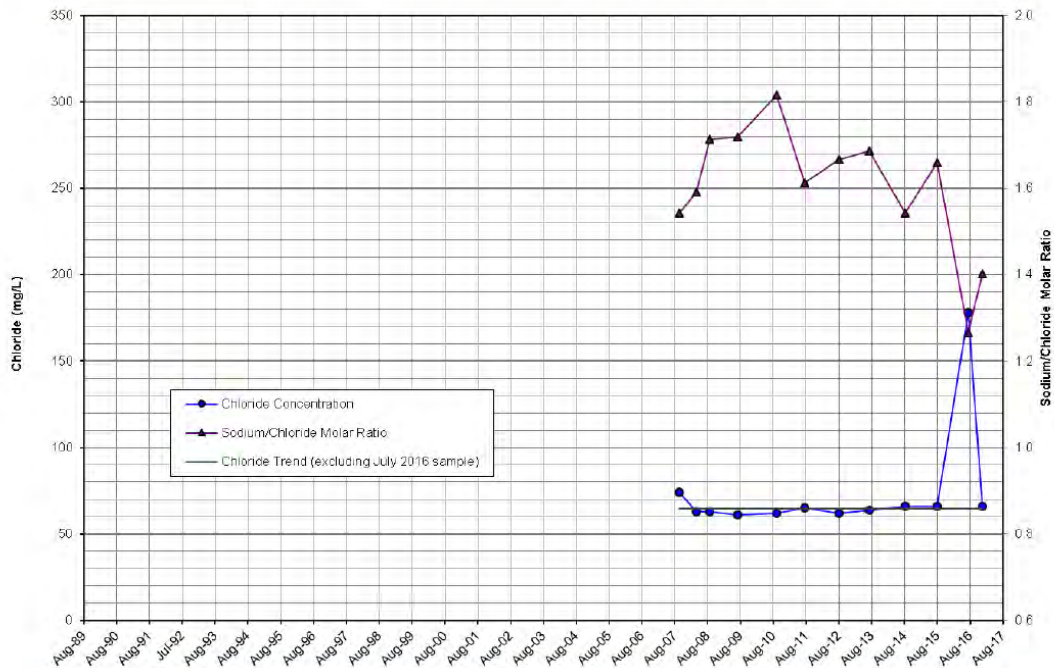
Figure 2: SBWM-2 (1,470 ft) Chloride Concentrations and Sodium/Chloride Ratios

The December 2016 sample, the chloride concentration in SBWM-2 (1,470 ft) returned to within the range of historical concentrations of less than 70 mg/L, following a reading of over 150 mg/L in the July 2016 sample. The piper (Figure 6) and stiff diagrams (Figure

10) both indicate that the anions and cations from the December 2016 sample returned to within their pre-July 2016 range. The high chlorides and anomalous sodium/chloride ratios observed in the July, 2016 sample may have been due to seasonal fluctuations, similar to what is observed in SBWM-1; or may have been the result of sampling/laboratory error. Continued monitoring of this well will determine whether seasonal fluctuations are responsible for the elevated chloride concentration observed in July 2016.

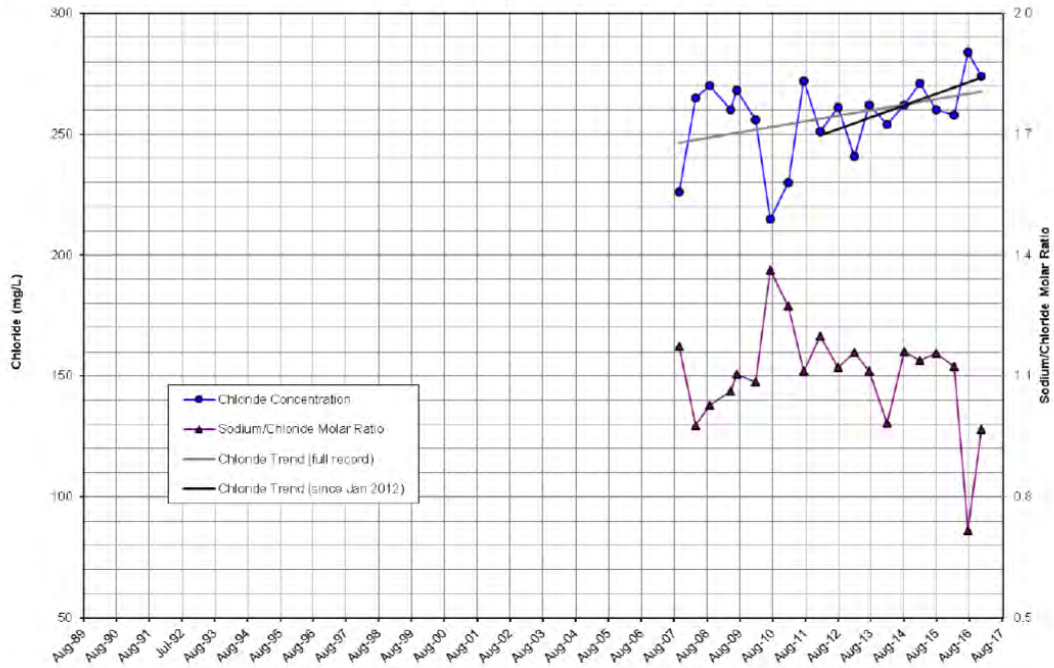
Figure 3: SBWM-4 (900 ft) Chloride Concentrations and Sodium/Chloride Ratios

- Well SBWM-4 (900 ft) chloride concentrations are slightly less than in July 2016 but still higher than historical values. The overall chloride trend at this depth in the well is increasing over the period of record and increasing at a higher rate since January 2012. The sodium/chloride ratio has increased from less than 0.86 in July 2016 to above 1 in December 2016.
- Ord Terrace Shallow well chloride concentrations have declined to 114 mg/L, which is within the range of historical concentrations. There is a very slight increasing chloride trend over the period of record. The sodium/chloride ratio is between 0.86 and 0.9.

The 274 mg/L chloride concentration in SBWM-4 (900 ft) from December 2016 is above historical concentrations prior to July 2016 concentrations, but slightly lower than the July 2016 concentration of 284 mg/L (Figure 3). The piper (Figure 7) and stiff (Figure 11) diagrams for this well show that the anions and cations have returned to within the range of pre-July 2016 conditions. The anomalous anion and cation distribution observed in the July 2016 sample may have been due to seasonal fluctuations, similar to what is observed in well SBWM-1. This well has the highest chloride elevations of all the coastal monitoring wells and appears to have an increasing chloride trend (Figure 3).

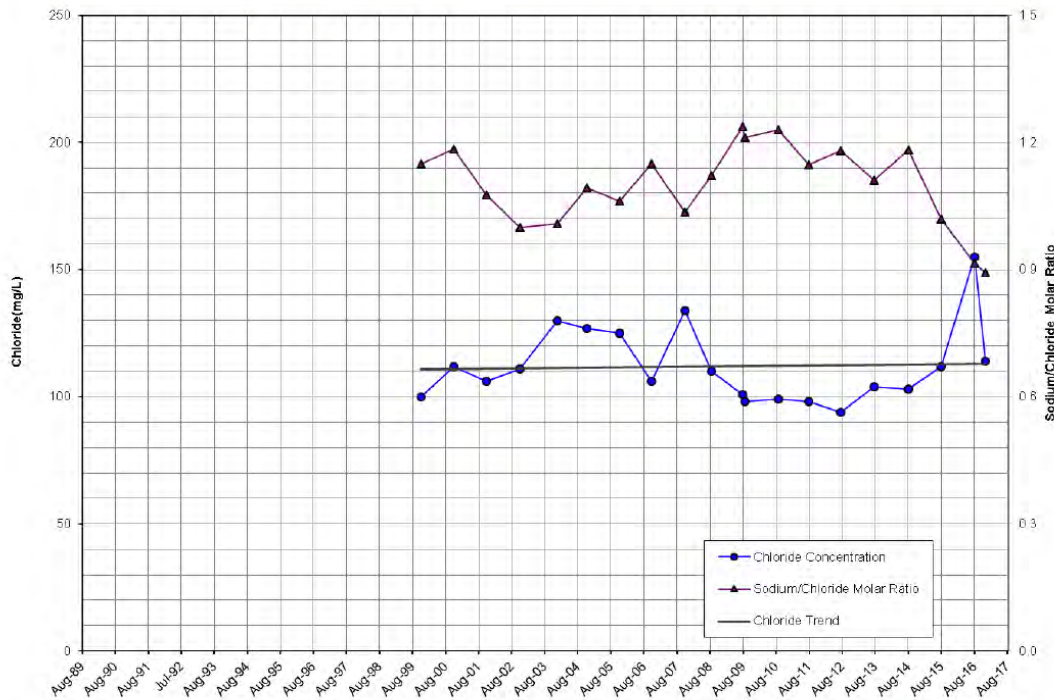
Figure 4: Ord Terrace Shallow Chloride Concentrations and Sodium/Chloride Ratios

The chloride concentration measured in the Ord Terrace Shallow well in December, 2016, returned to within its historical range of concentrations of less than 120 mg/L. In the 2016 SIAR, this well was ruled out as being potentially impacted by seawater because of its inland location, and because its piper and stiff diagrams did not indicate a seawater source of its anions and cations. The piper and stiff diagrams on Figure 7 and Figure 11, respectively, support this observation.

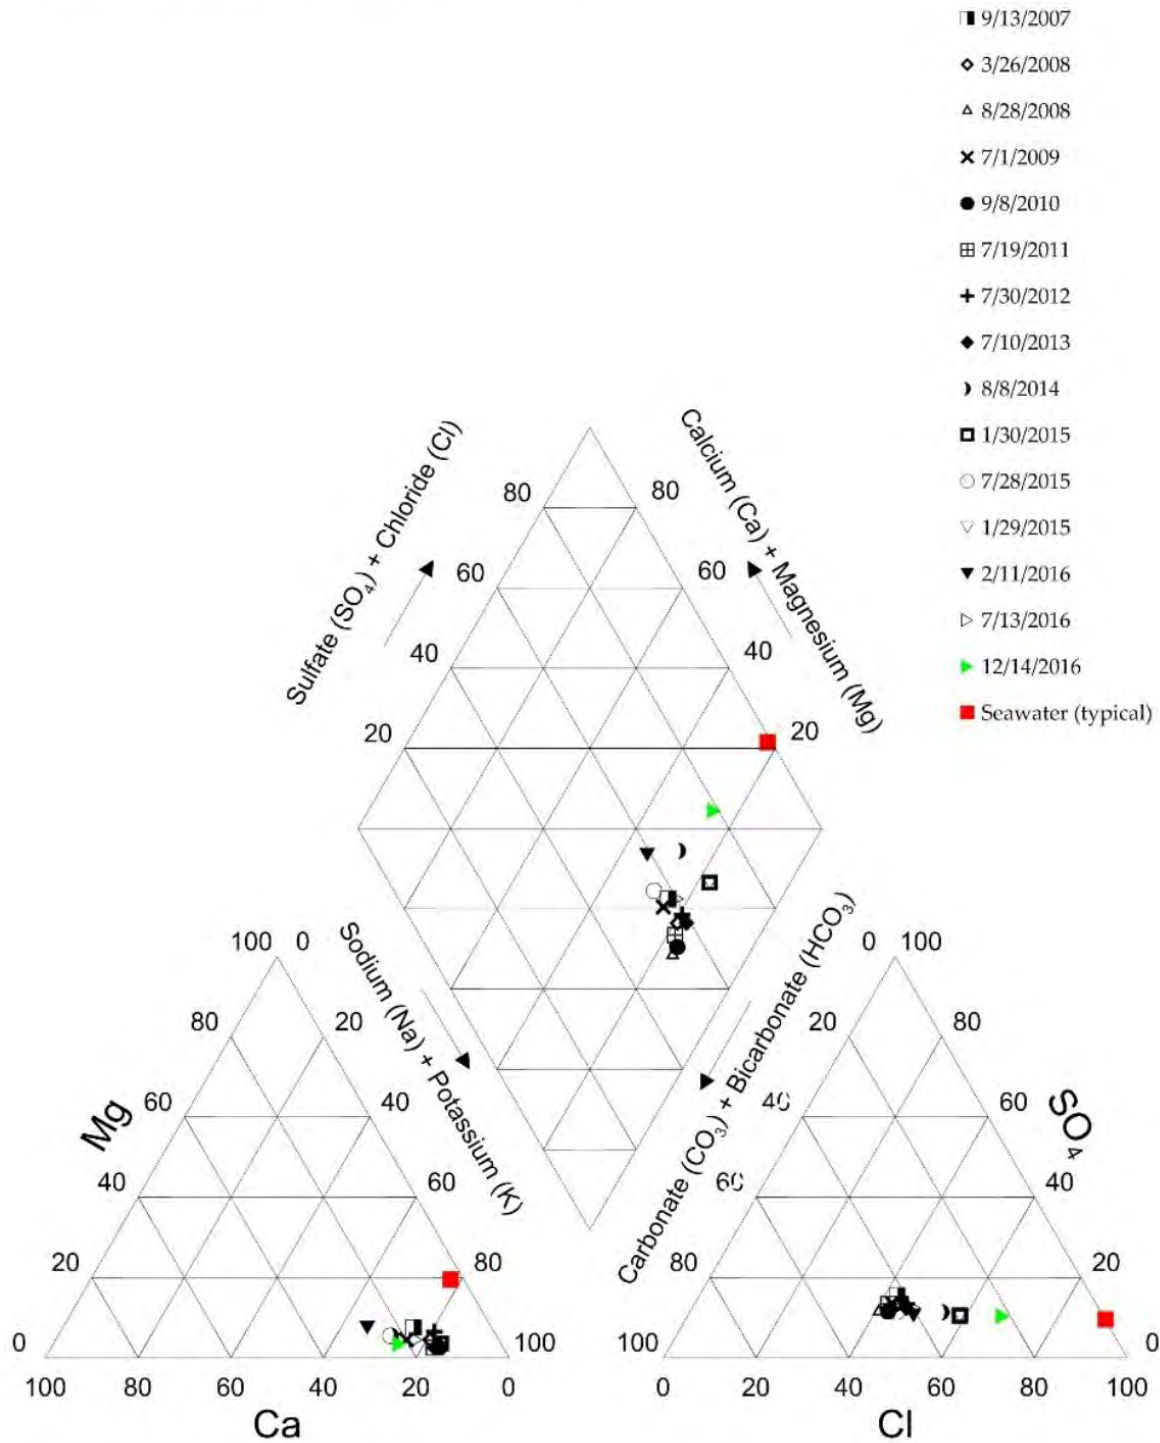
Figure 5: Piper Diagram for SBWM-1 (1,390 ft)

- Well SBWM-1 (1,390 ft)'s groundwater quality is generally of a sodium-chloride-bicarbonate type (Figure 5). The sample for December 2016, shown with the green solid triangle, has slightly increased calcium cations compared to the majority of the data points. Chloride anions increased such that the water type can be classified as more strongly sodium-chloride in character. The data points on the piper diagram show no consistent trend over time but rather appear to exhibit fluctuations.

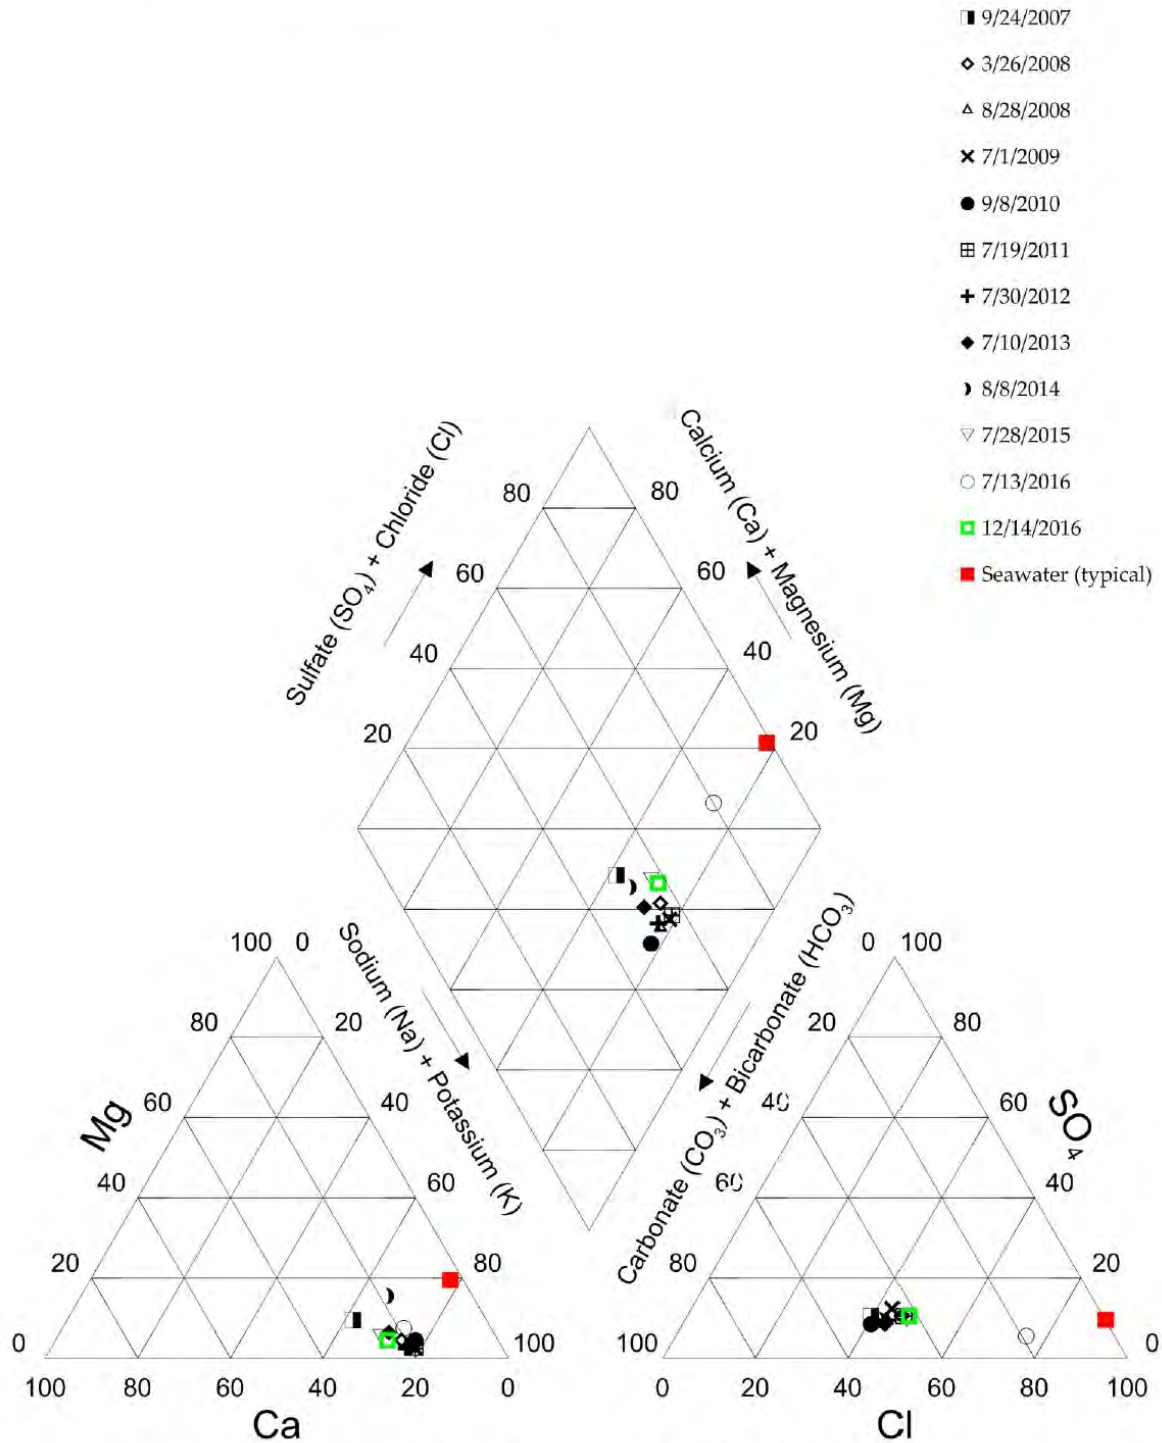
Figure 6: Piper Diagram for SBWM-2 (1,470 ft)

- Well SBWM-2 (1,470 ft)'s groundwater quality is generally of a sodium-chloride-bicarbonate type (Figure 6). The sample for December 2016, shown with the green open triangle, plots within its historical cluster of data points. This is in contrast with the July 2016 sample, shown with the open circle, which had no apparent change in cations compared to historical values but a large increase in chloride anions with correspond decrease in bicarbonate anions. The data points on the piper diagram show no consistent trend over time but rather appear to exhibit fluctuations.

Based on the piper diagram (Figure 6), and shape of the stiff diagram (Figure 10), the increased chloride concentration in the December 2016 sample is not clearly indicative of incipient seawater intrusion. This well has experienced fluctuating chloride concentrations since 2014 (Figure 1) with higher chloride concentrations being observed in winter and lower concentrations in summer. Prior to 2014, its chloride concentrations were fairly stable. It is possible the observed chloride fluctuations are being controlled by seasonal groundwater elevation fluctuations, and that may or may not be attributable to seawater intrusion. This is discussed in more detail in Section 5.5. However, the increasing trend of chloride and significant drop in sodium/chloride ratios that indicated seawater intrusion was occurring in the nearby Salinas and Pajaro valley are not apparent.

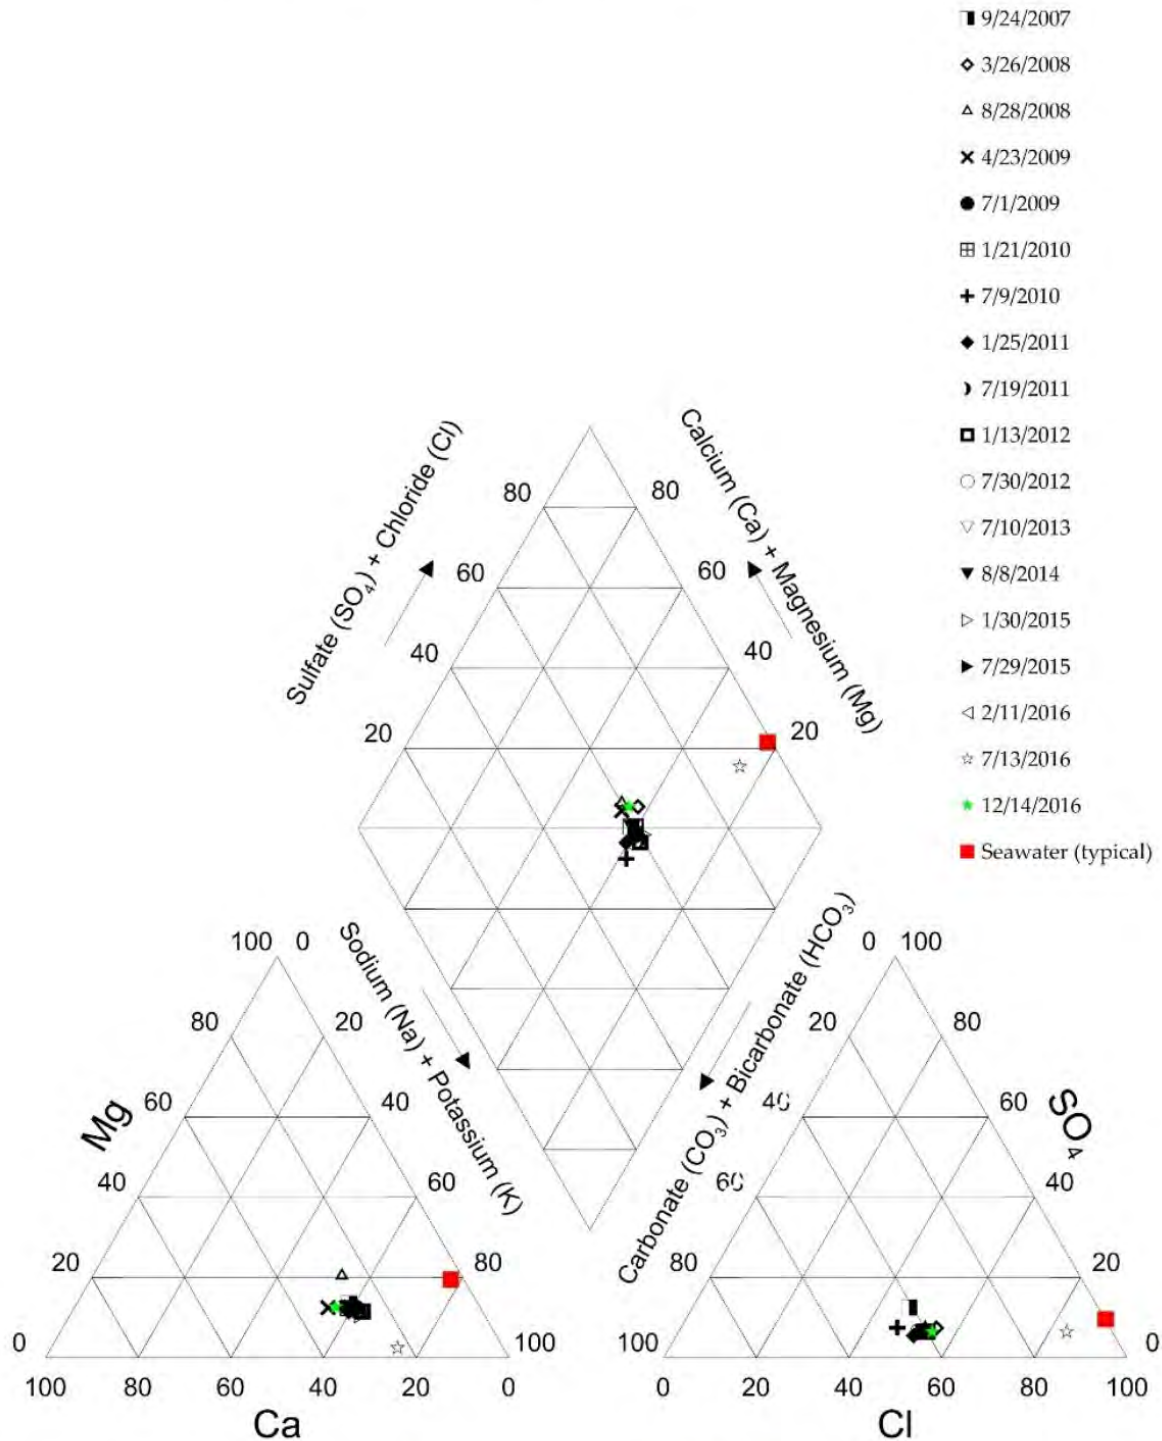
Figure 7: Piper Diagram for SBWM-4 (900 ft)

- Well SBWM-4 (900 ft)'s groundwater quality is generally of a sodium-chloride type (Figure 7). The sample for December 2016, shown with the green solid star, plots within its historical cluster of data points. This is in contrast with the July 2016 sample, shown with the open star symbol, which exhibits a more strongly sodium-chloride character than usual. The data points on the piper diagram show no consistent trend over time but rather appear to exhibit fluctuations.

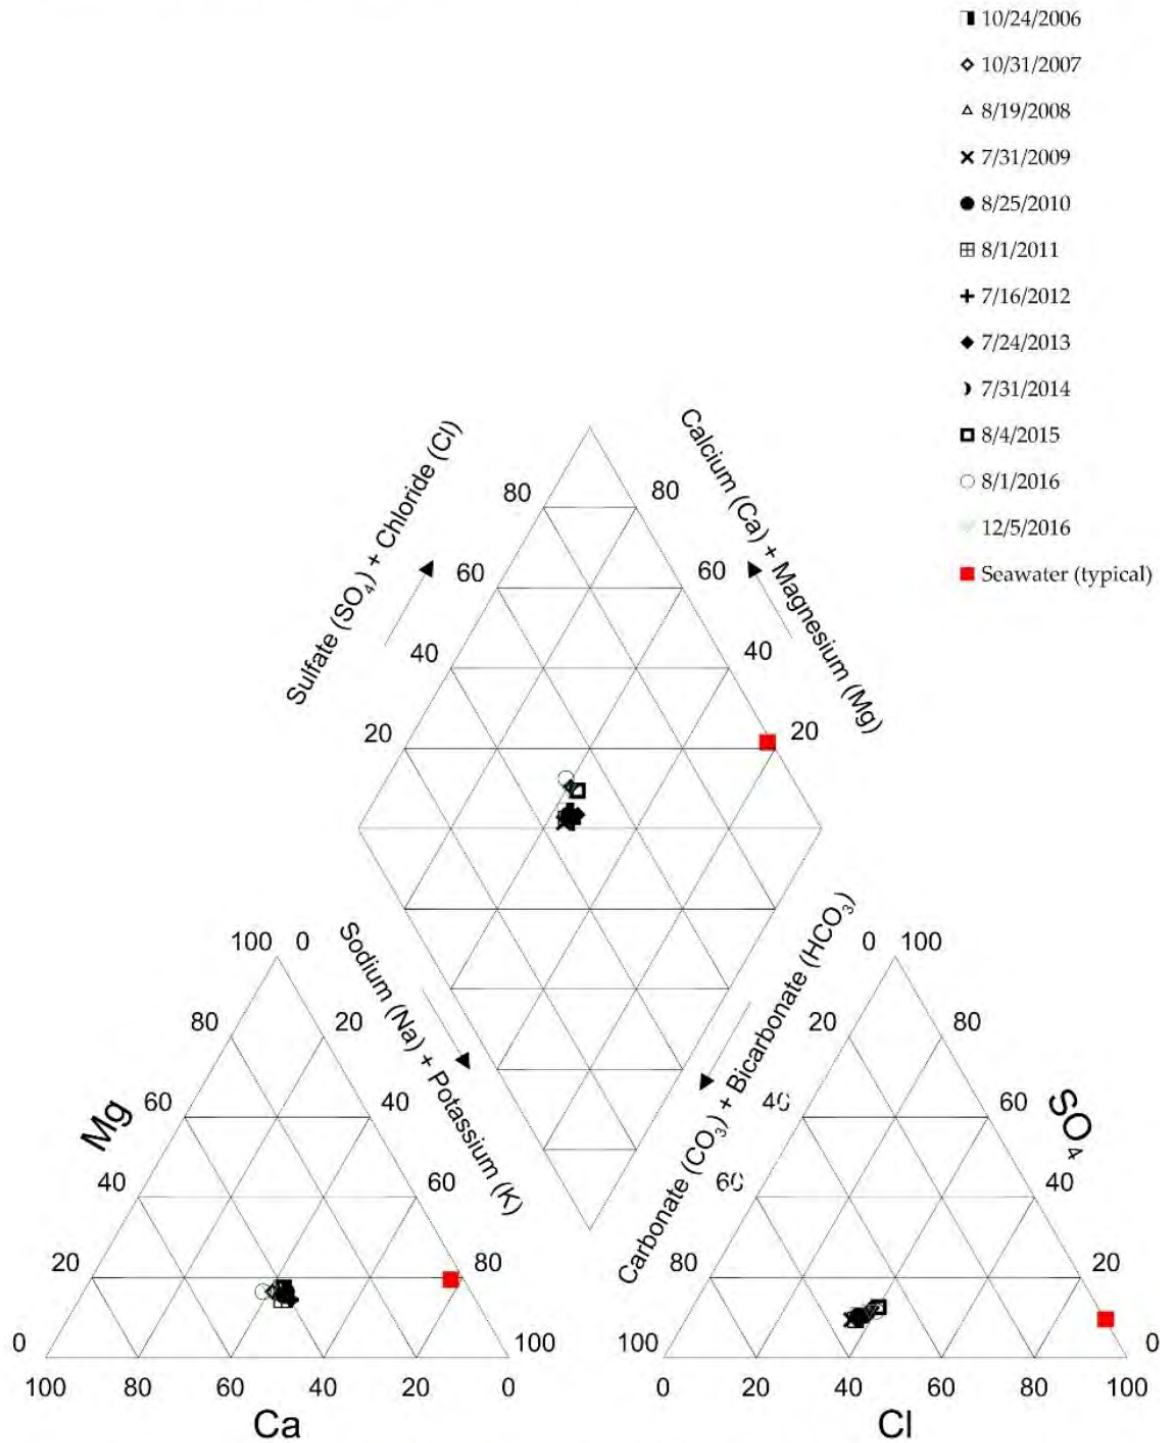
Figure 8: Piper Diagram for Ord Terrace Shallow

- Ord Terrace Shallow well's groundwater quality is generally of a calcium-bicarbonate type (Figure 8). The sample for December 2016, shown with the green open triangle, plots within its historical cluster of data points. The data points on the piper diagram show no trend over time.

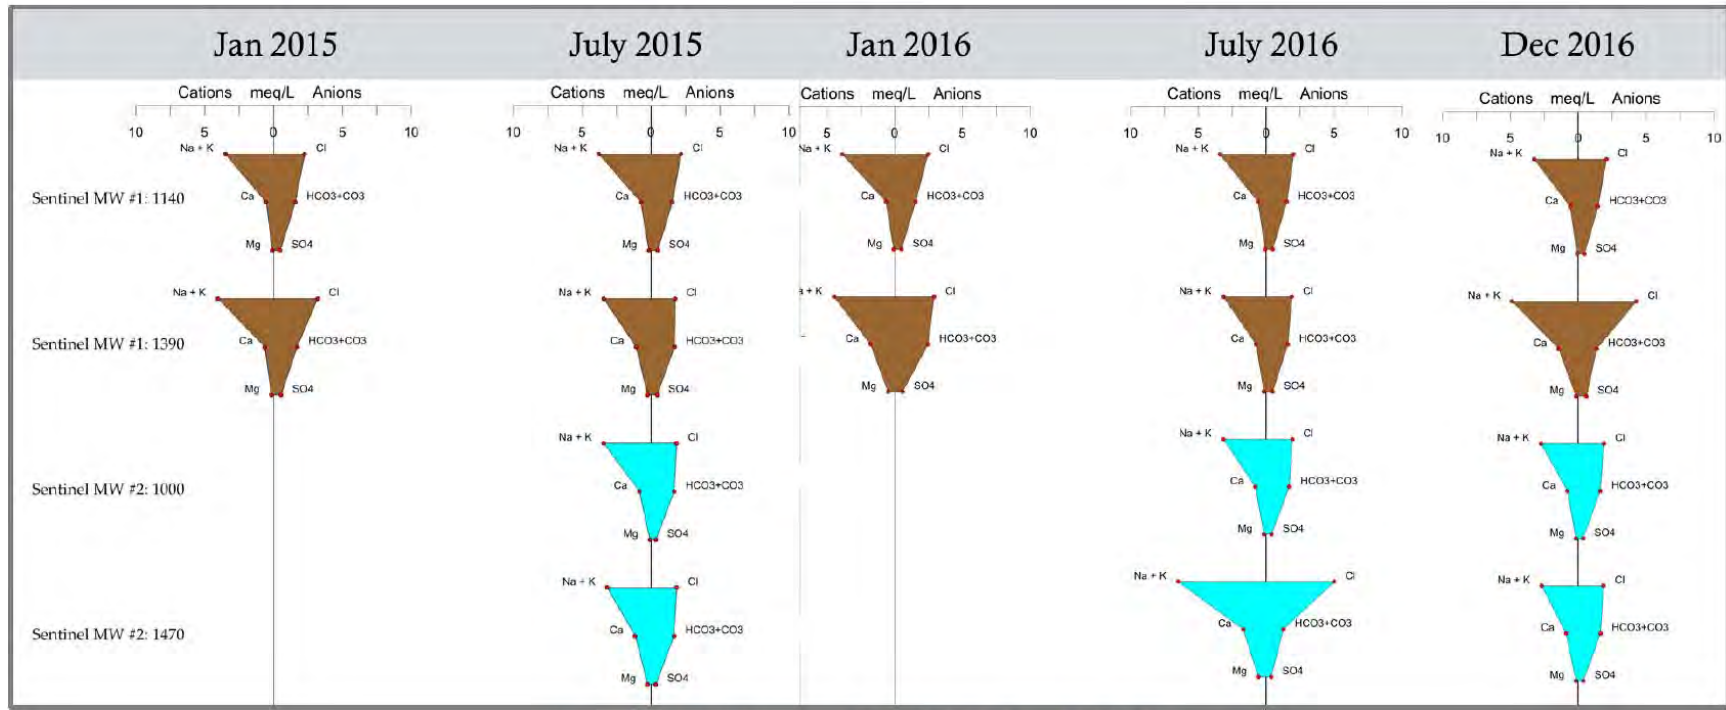
Figure 10: Stiff Diagram for SBWM-1 and SBWM-2

Stiff diagrams for SBWM-1 (1,470ft), SBWM-2 (1,390 ft), SBWM-4 (900 ft), and Ord Terrace Shallow are shown on Figures 10 and 11. Stiff diagrams for 2015 and 2016 are included to provide context, and show change over a two year period. All of the well's stiff diagrams for the December 2016 sample, except well SBWM-1 (1,390 ft)'s, are similar to historical diagrams before July 2016. Sentinel well SBWM-1 (1,390 ft)'s stiff diagram has a slightly different shape from previous years, but the shape of the stiff diagrams have varied over time for this well.

The stiff diagrams demonstrating what a seawater intruded sample might look like are provided on Figure 12. Comparing the stiff diagrams on Figure 10 and Figure 11 with Figure 12 reveals that none of the December sample's stiff diagrams are indicative of seawater intrusion, which is characterized on the stiff diagram as having calcium enrichment and a chloride spike. The stiff diagrams in Figure 12 came from locations where the native, unintruded groundwater was a calcium-bicarbonate type. It is unclear what the stiff diagrams of incipient seawater intrusion look like for areas where the native groundwater is of sodium-chloride or sodium-chloride-bicarbonate types.

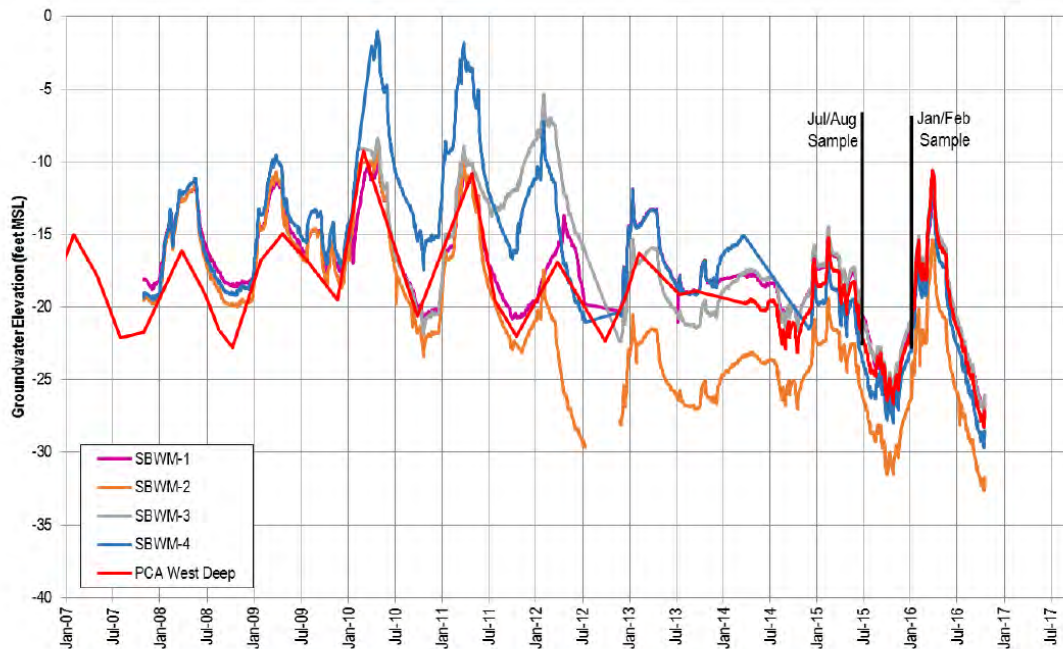
Figure 13: Hydrograph for Sentinel Wells and Monitoring Well PCA West Deep

The chloride fluctuations observed more recently in well SBWM-1 (1,390 ft) appear to be seasonal, with samples collected in January/February having higher concentrations than samples collected in July/August. It is apparent from groundwater level hydrographs of the coastal monitoring wells (Figure 13) that the current sampling periods do not correspond with seasonal low and high groundwater levels. Both sampling periods occur midway between the seasonal fluctuation in groundwater levels that occurs in response to groundwater pumping. It may be possible to identify the relationship between chloride concentrations and seasonal changes in groundwater elevations if samples were collected when the extreme low and high groundwater levels were occurring. However, this relationship likely results from a complex interplay of hydrogeologic structure and stratigraphy, pumping location, and seawater interface location.

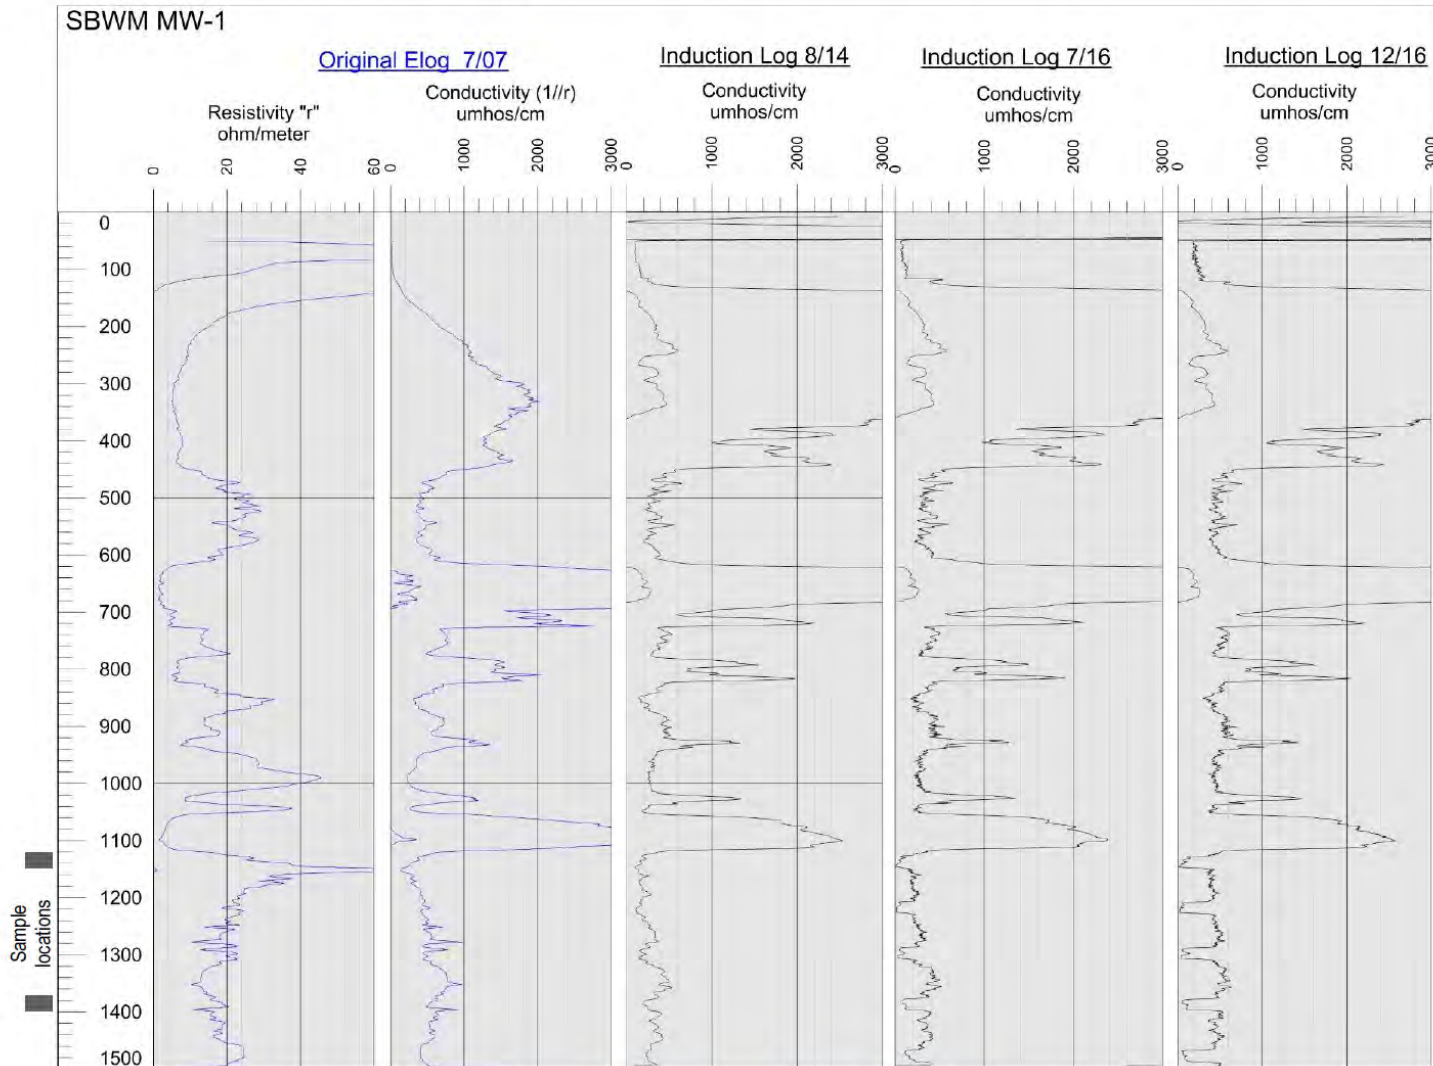
Figure 14: Sentinel Well 1 Induction Logs

The induction logs for well SBWM-1 shows there has been an increase in the shallow seawater intrusion zone above 450 feet depth since the well was constructed in 2007 (Figure 14). This intrusion was evident at the time SBWM-1 was constructed (HydroMetrics WRI, 2016). The deeper depths of well SBWM-1 show no clear evidence of increased salinity over time, although seasonal fluctuations are observed in the clays (zones with lower resistivity); summer conductivities (July 2015 and July 2016) plot close together and the conductivities in winter are more varied (Figure 17).

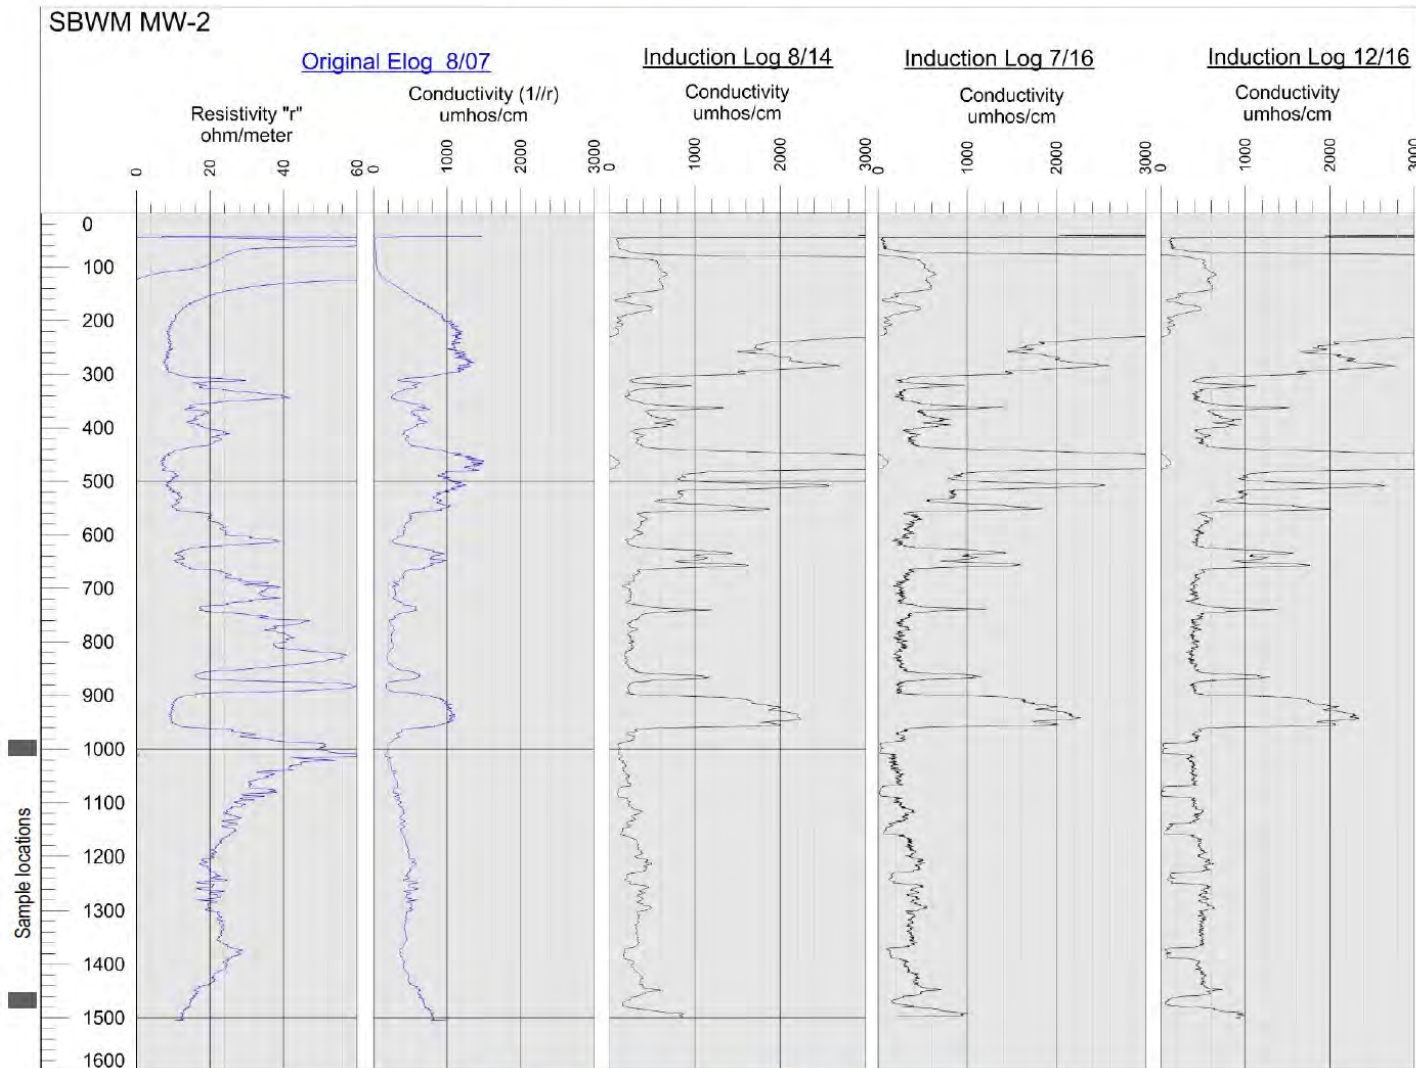
Figure 15: Sentinel Well 2 Induction Logs

The induction logs for well SBWM-2 shows that there has been an increase in the shallow seawater intrusion zone above 300 feet depth since the well was constructed in 2007 (Figure 15). The logs show seasonal fluctuations in the clays (zones with lower resistivity), with similar conductivities in January 2015 and February 2016, and increased conductivities in summer (August 2014, July 2015 and July 2016) (Figure 17). At a depth of 1,470 feet within the screened sandy part of the aquifer (higher resistivity), the July 2016 conductivity is higher than all previous conductivities, except the initial log in 2007 (Figure 17). This might corroborate the higher chloride concentration observed in the July 2016 sample and rule out sampling/laboratory error for this sample.

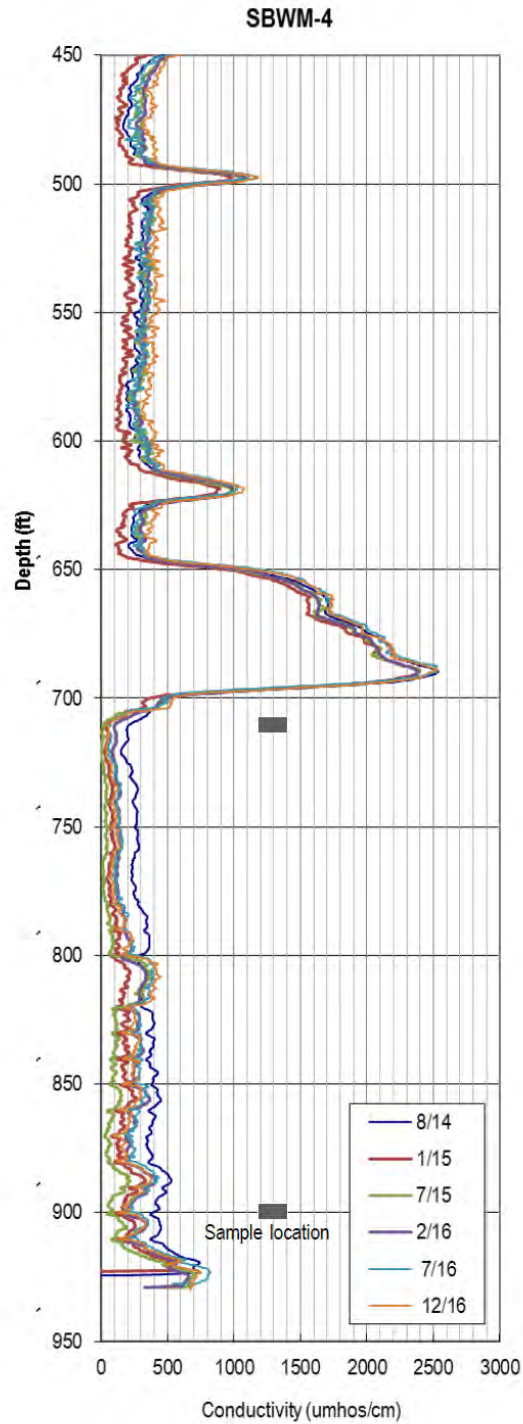
Figure 18: Induction Logs of Lowest 500 feet of Sentinel Well 4

At the 900 foot depth in well SBWM-4, it is difficult to see changes in conductivity because most of the logs plot too close together (Figure 18). These similar conductivities indicate that there has been no major increase in salinity at this depth. The seasonal fluctuations observed in SBWM-1 and SBWM-2 are not obvious in this well.
