**MONTGOMERY
& ASSOCIATES**

Seaside Groundwater Basin 2019 Seawater Intrusion Analysis Report

Seaside Groundwater Basin Watermaster
Monterey County, California

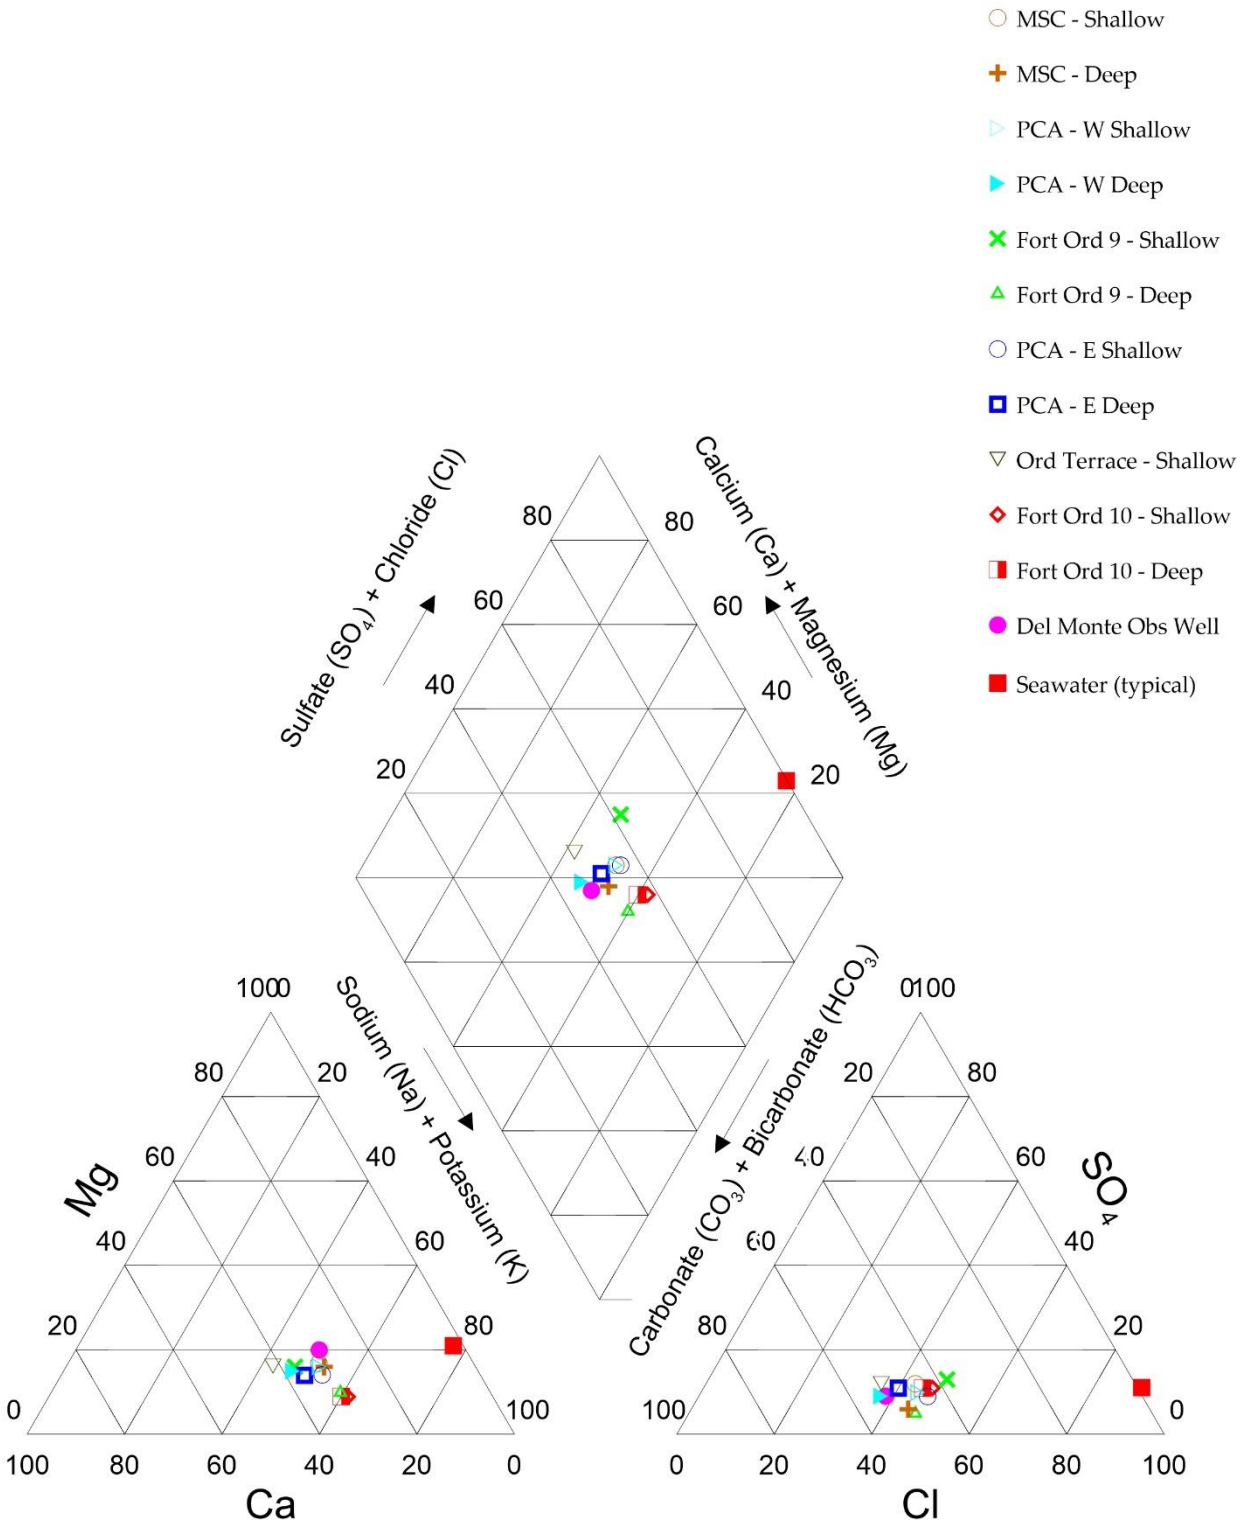
Figure 15. Piper Diagram for Seaside Groundwater Basin Monitoring Wells,
4th Quarter Water Year 2019 (July- September 2019)
(Data source: Watermaster)

Figure 15 shows groundwater quality data for the monitoring wells clustering generally in a single area on the Piper diagram, which is a pattern similar to that observed in previous SIARs. Groundwater is generally of a sodium-chloride/sodium-bicarbonate type and is not impacted by seawater.

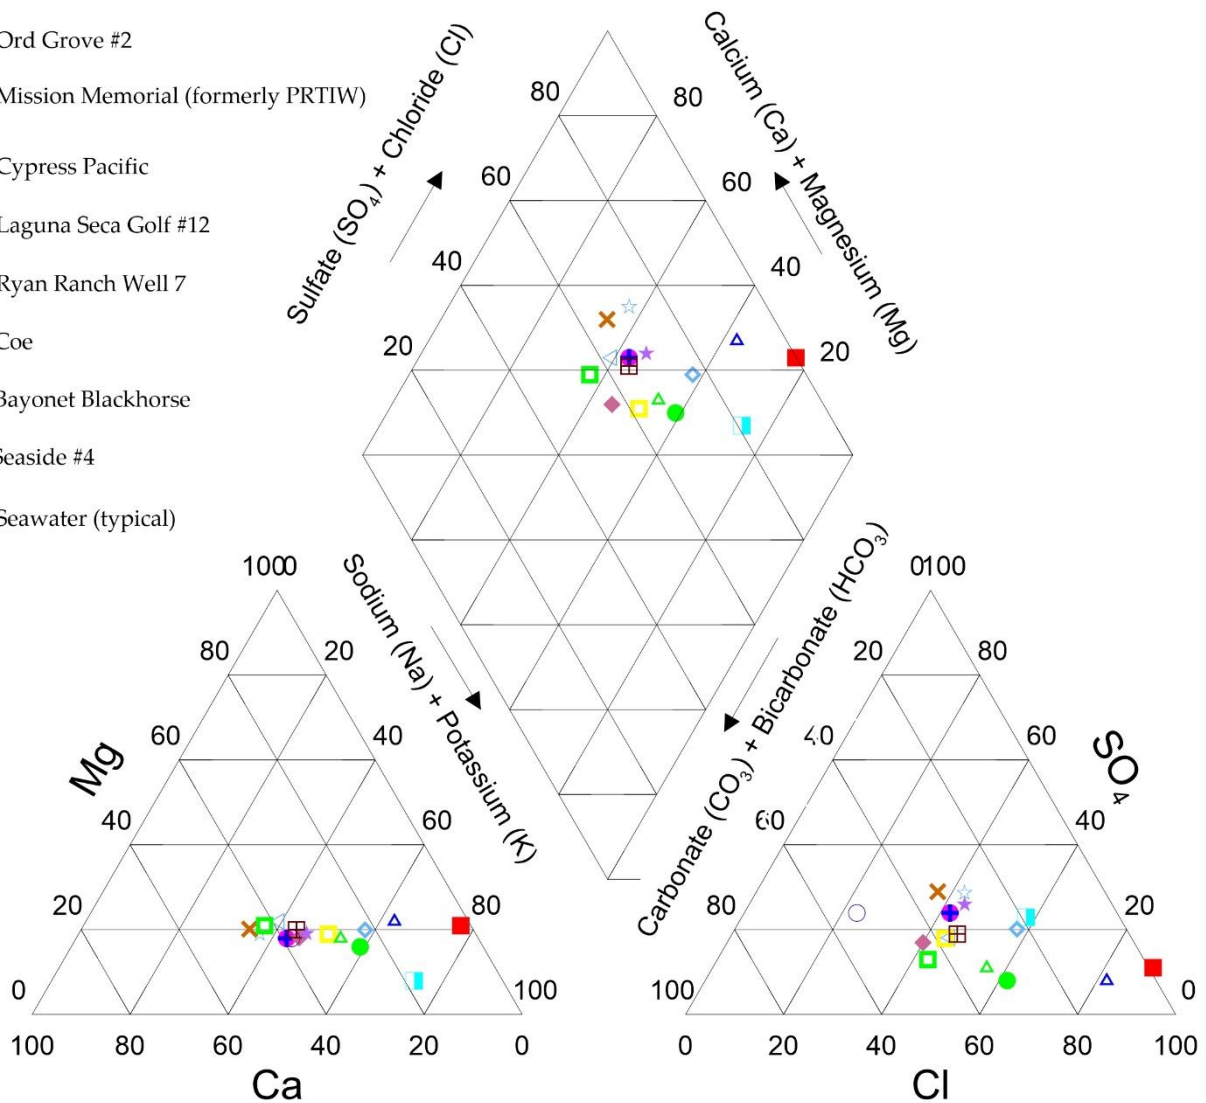
Figure 16. Piper Diagram for Seaside Groundwater Basin Production Wells,
4th Quarter Water Year 2019 (July-September 2019)
(Data source: Watermaster)

Figure 16 presents a Piper diagram for 4th quarter groundwater from production wells. The production wells plot in roughly the same location on the Piper diagram as the majority of monitoring wells on Figure 15. The variation of the plot location on the Piper diagram for production wells is due to higher sulfate and chloride anions than in the monitoring wells. Groundwater from these wells is characterized as sodium-sulfate-chloride type waters. The York School well plots closest to typical seawater on this diagram, however its inland location precludes seawater intrusion as the cause for the observed water chemistry at this well. Overall, the Piper diagrams show no indication of seawater intrusion at any of the production wells.

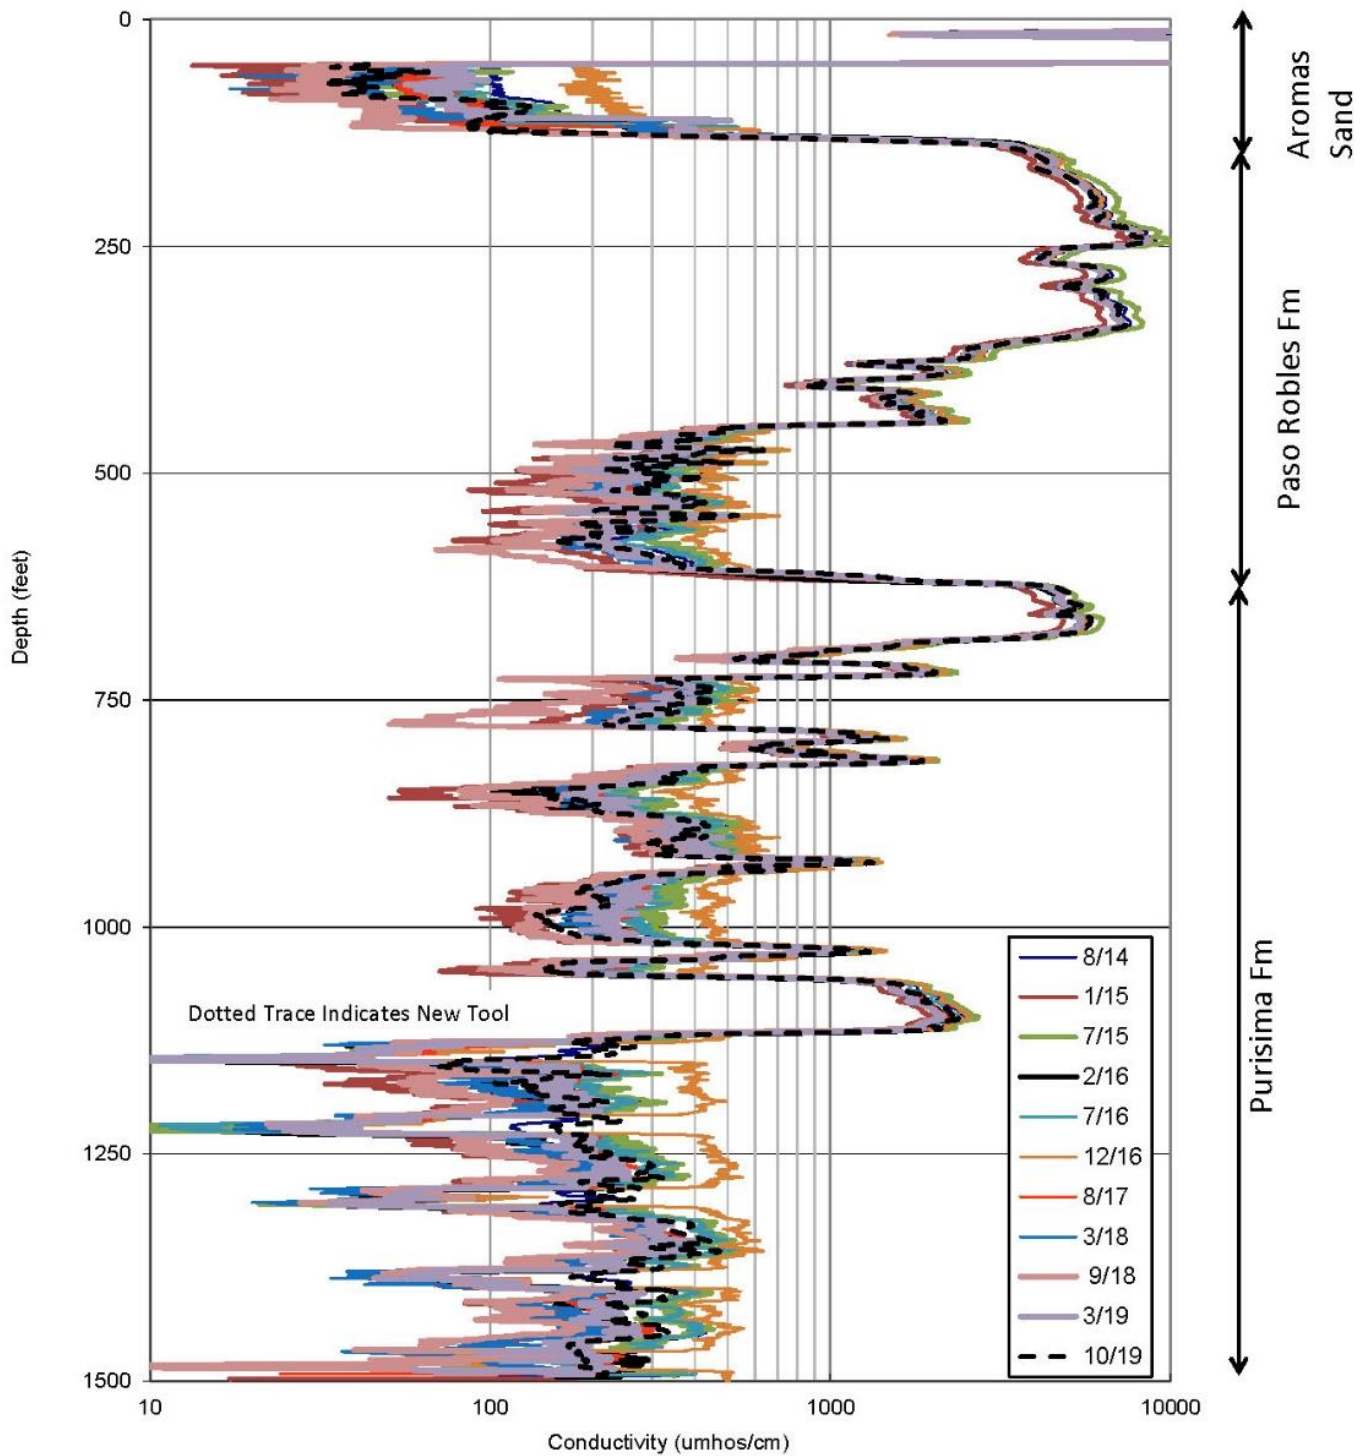
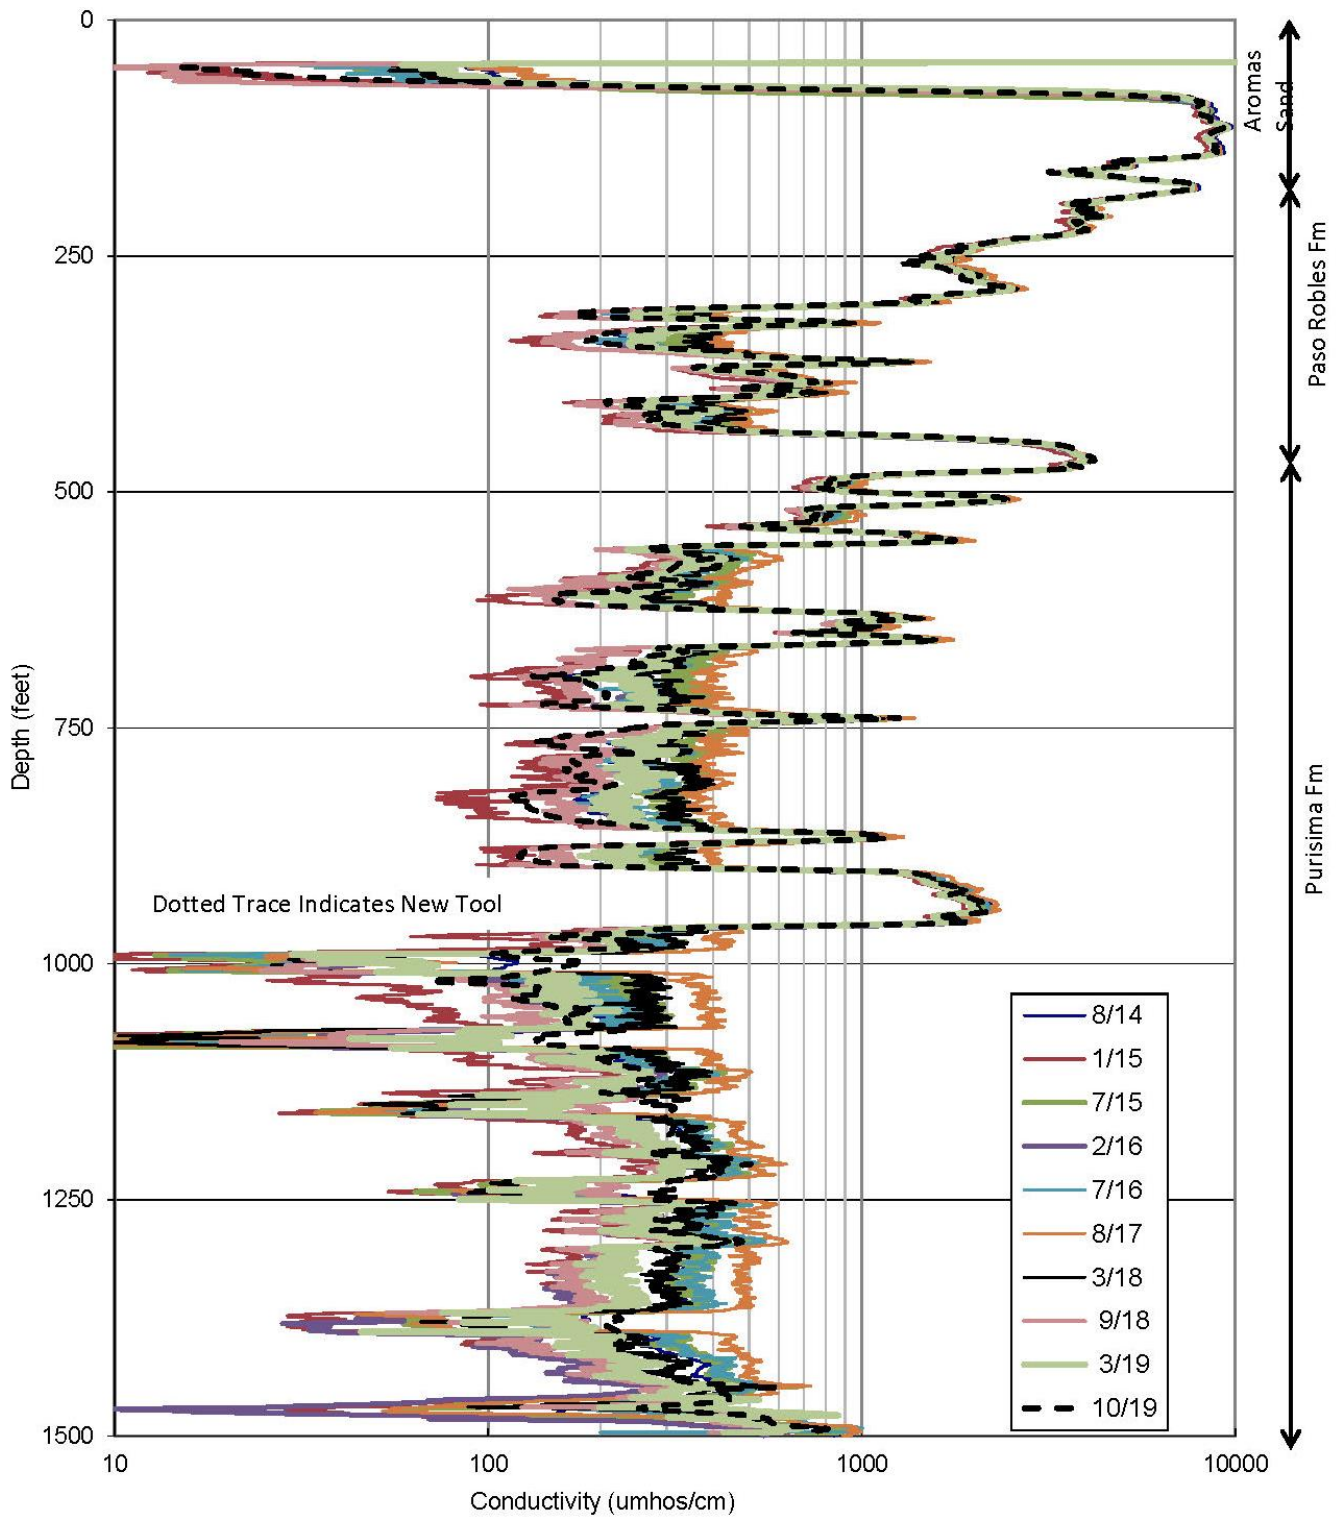
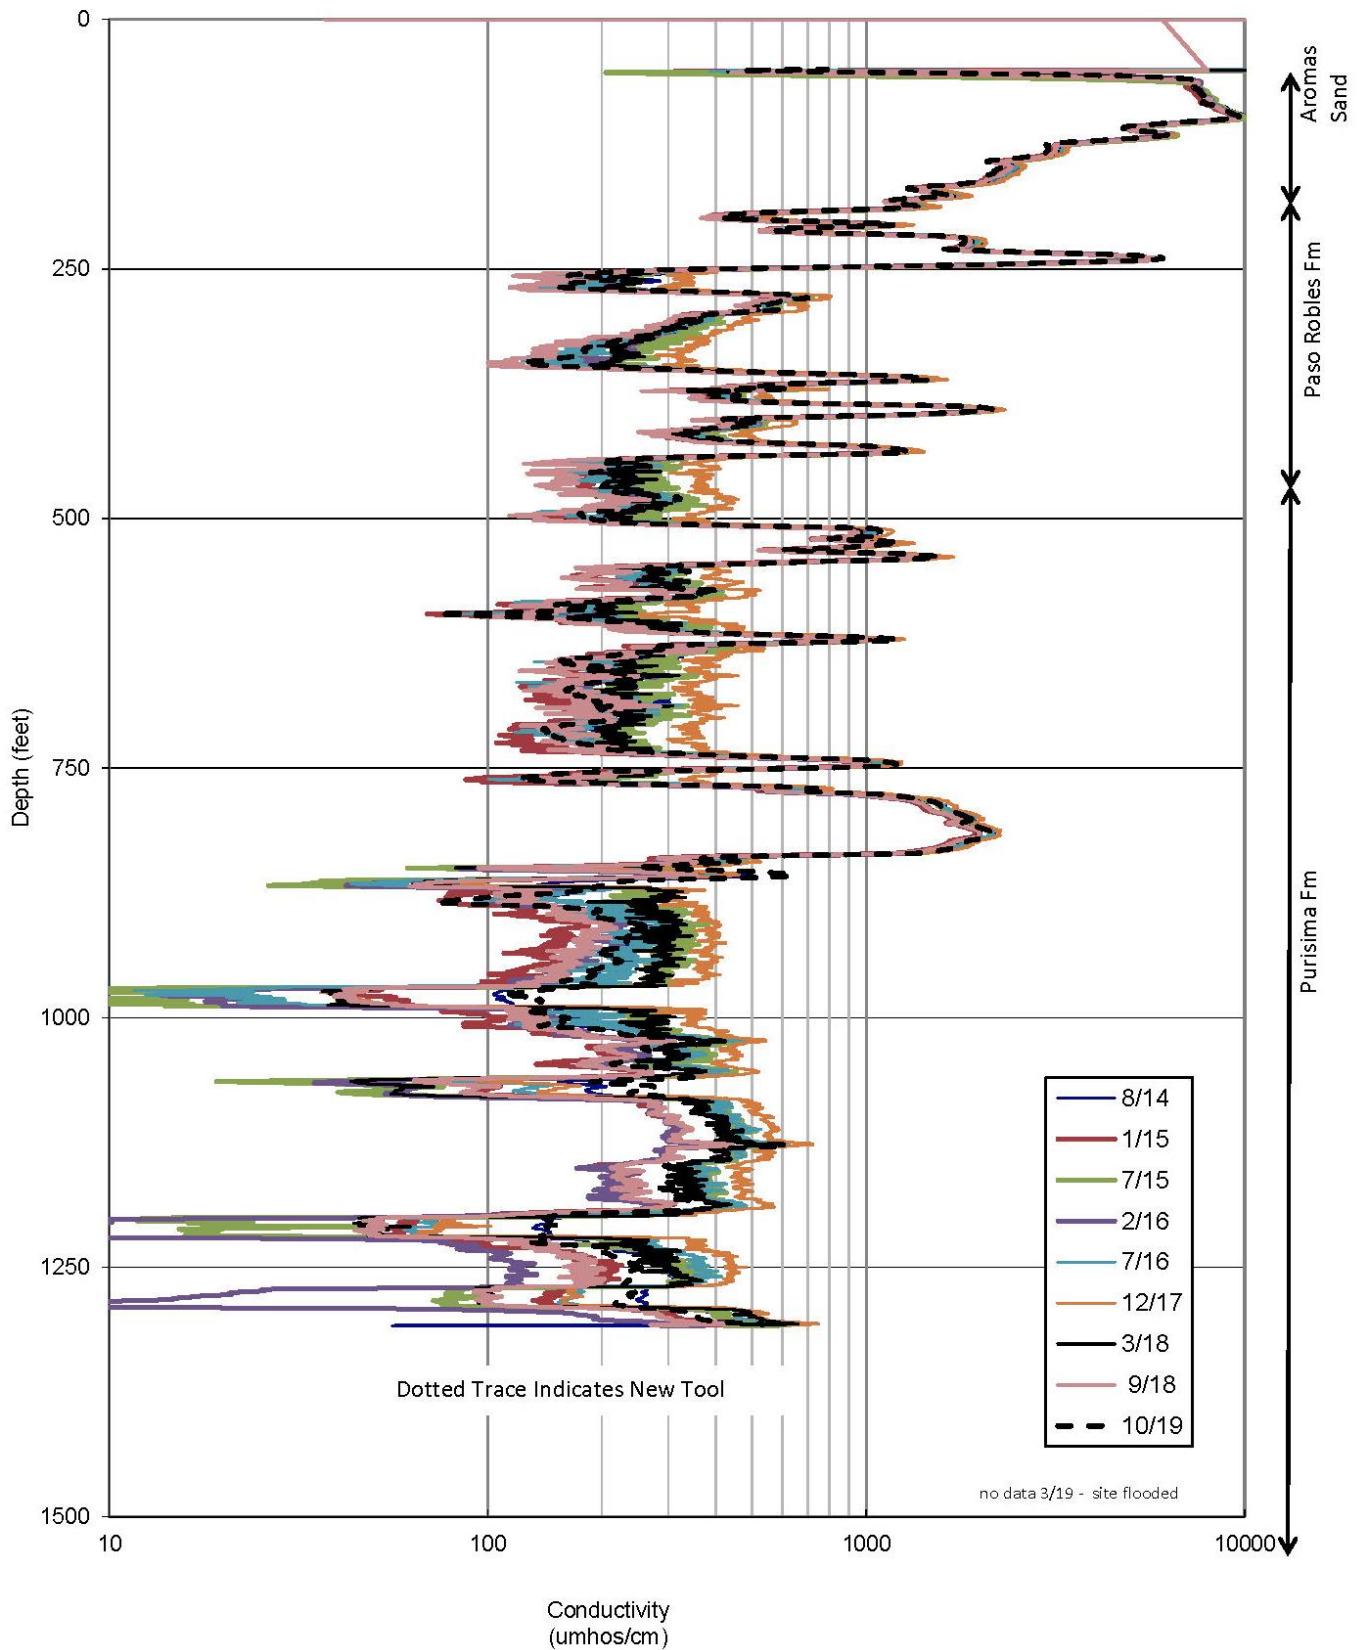
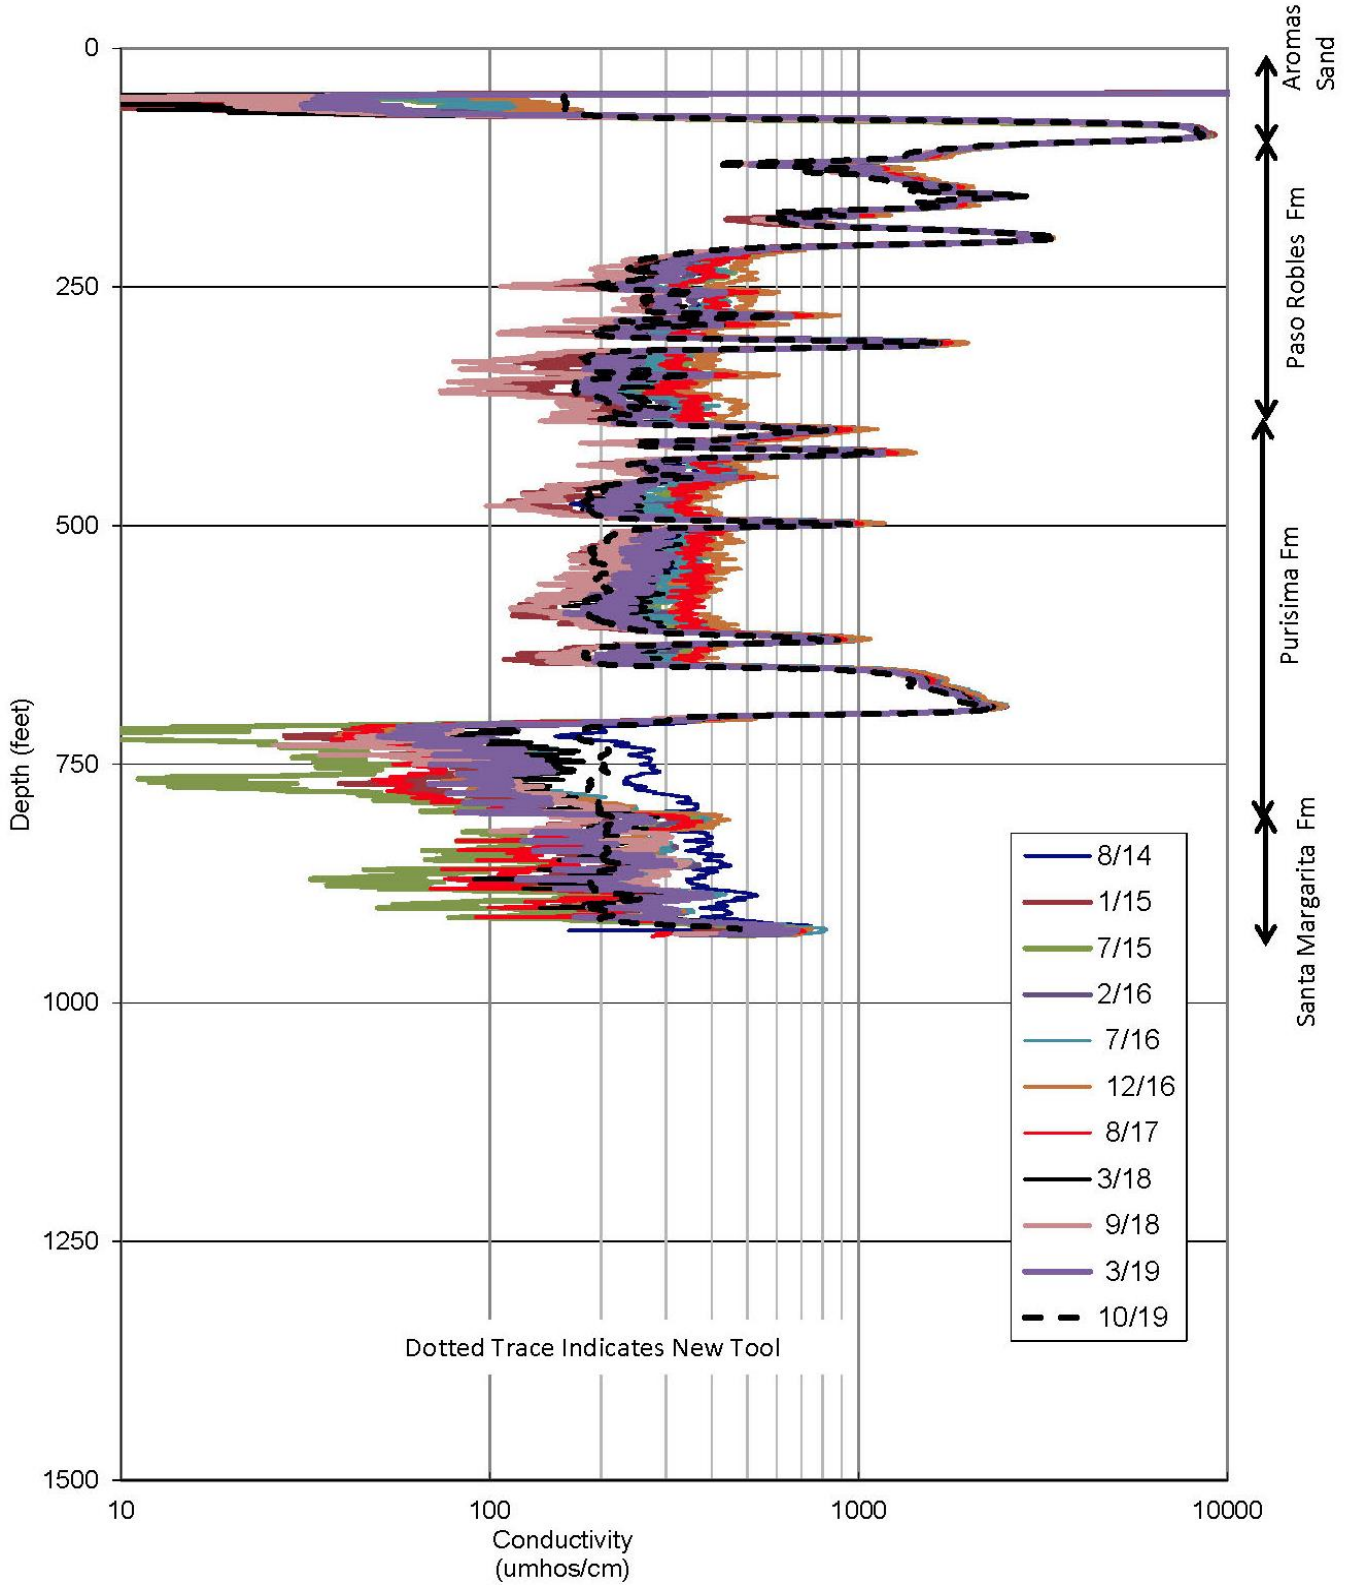
Salinity changes shown on Figure 24 through Figure 27 for Sentinel Wells 1 – 4, respectively, are only relative, and do not allow direct measurement of TDS or chloride concentrations in the aquifer. They do, however, provide a means to determine changes in salinity over time. It appears that the salinity in the Dune Sands and Aromas Formation overlying the main production aquifers fluctuates from season to season; becoming more saline in the summer months when stresses on the aquifer are greatest. As has been the case historically, none of the wells show detectable changes in conductivity to the deeper aquifers where production wells extract groundwater.

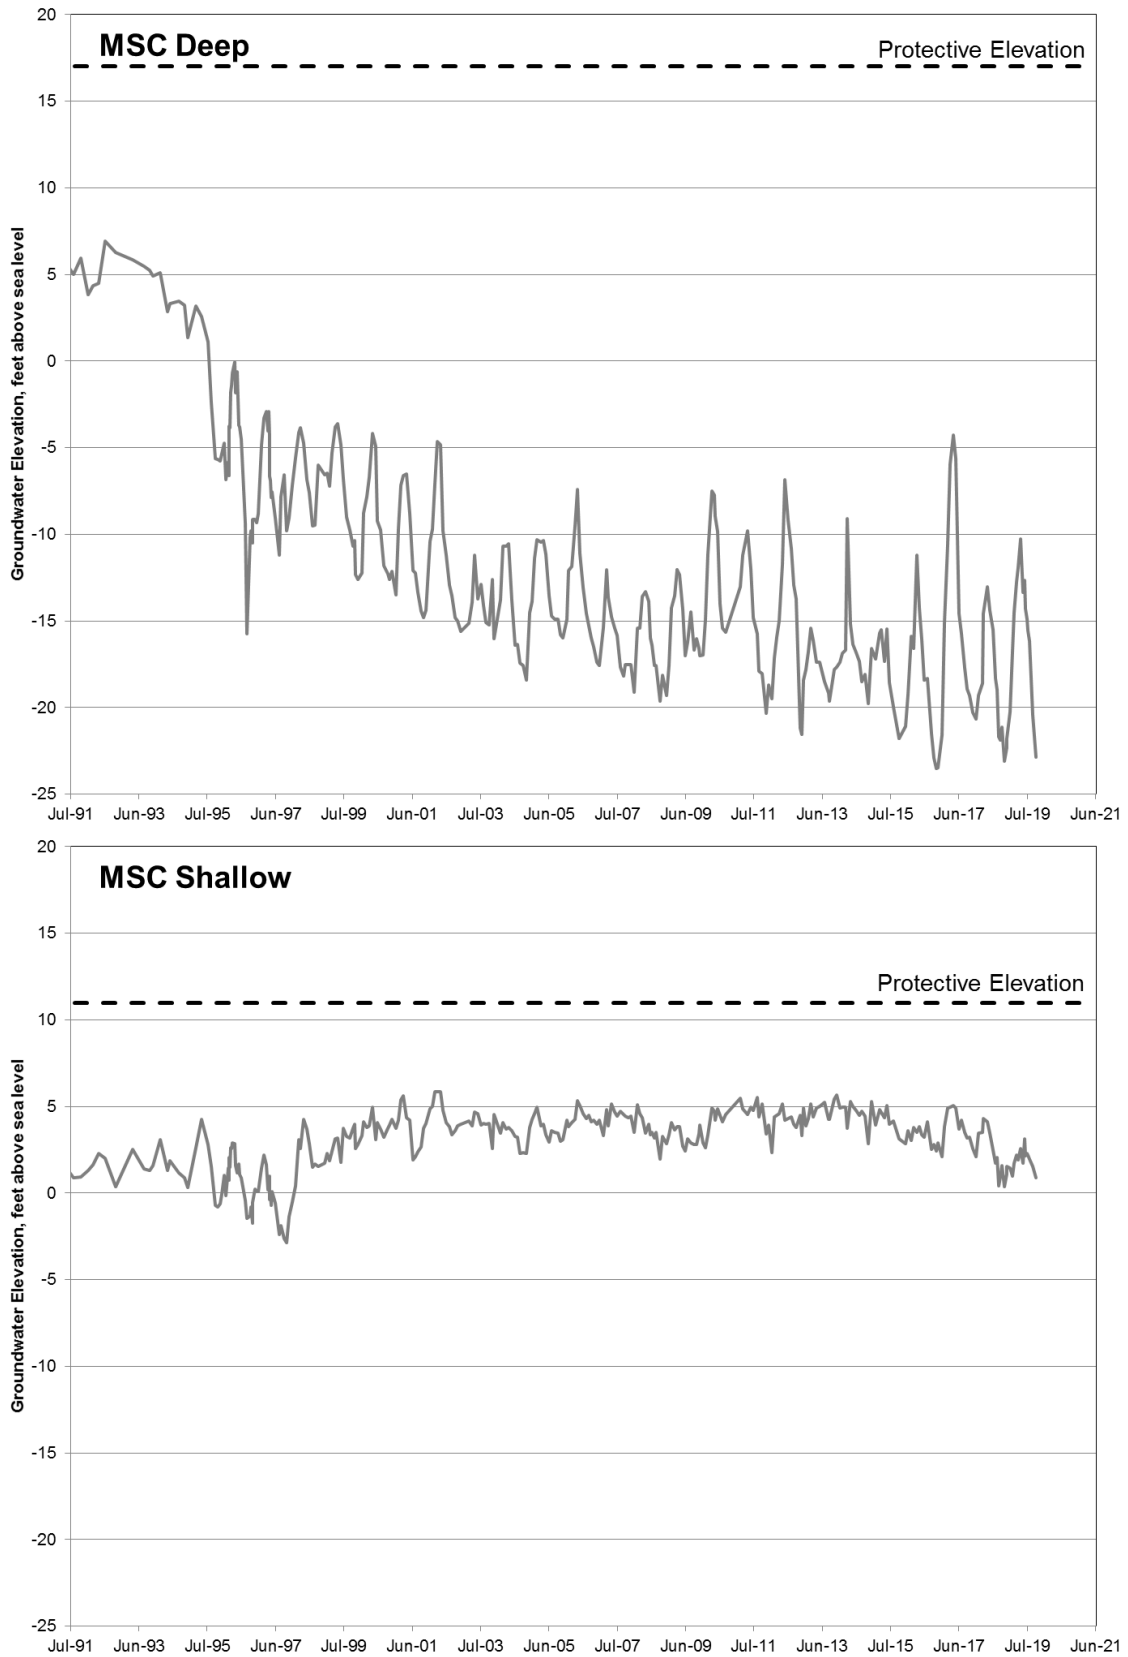
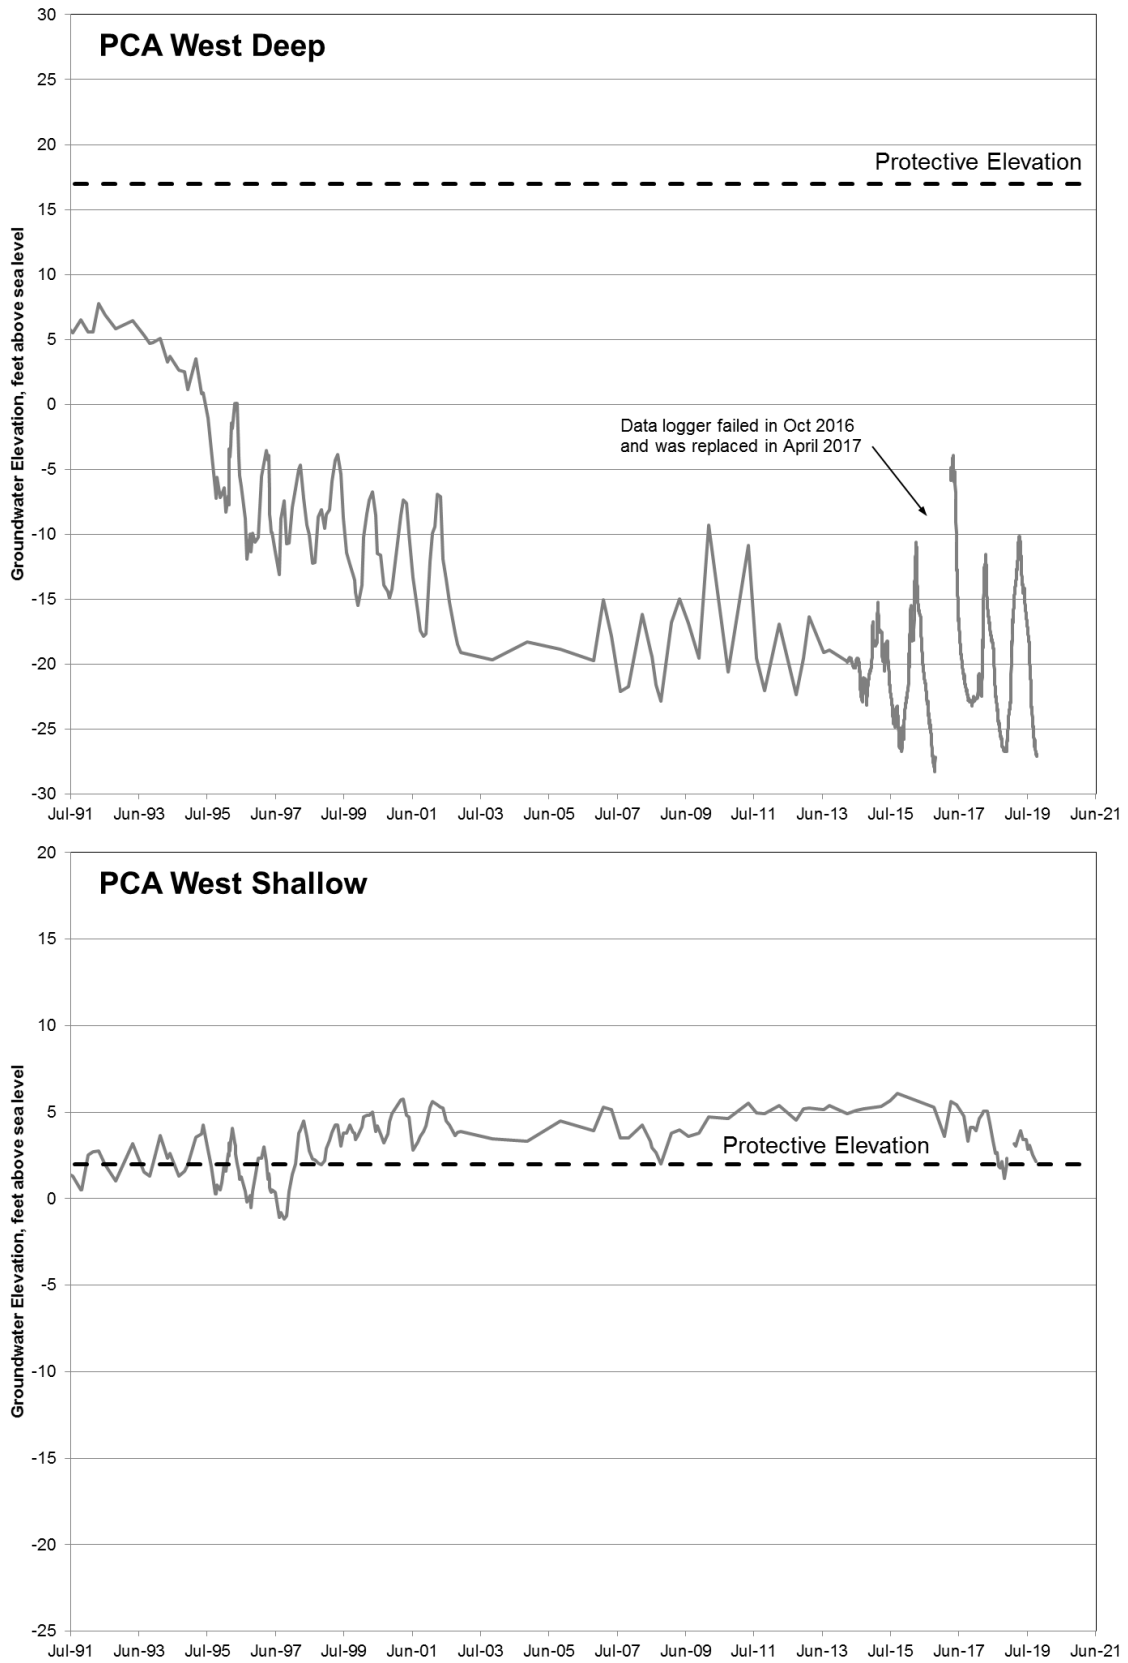
Figure 37 through Figure 40 show the historical groundwater elevations at each of the target protective elevation monitoring wells. Groundwater levels continue to be below protective elevations in all deep target monitoring wells (MSC deep, PCA-West deep, and Sentinel Well 3). Two of the three shallow wells' groundwater levels are again above protective elevations: the PCA-W shallow well and the CDM-MW4 well. In Water Year 2018, the PCA shallow well groundwater levels fell slightly below protective elevations. The greater seasonal fluctuations in this well are likely due to the recommencement of pumping from the shallow aquifer in 2015 at the Coe Ave well. Groundwater levels in the MSC shallow well continue to be below its protective elevation.

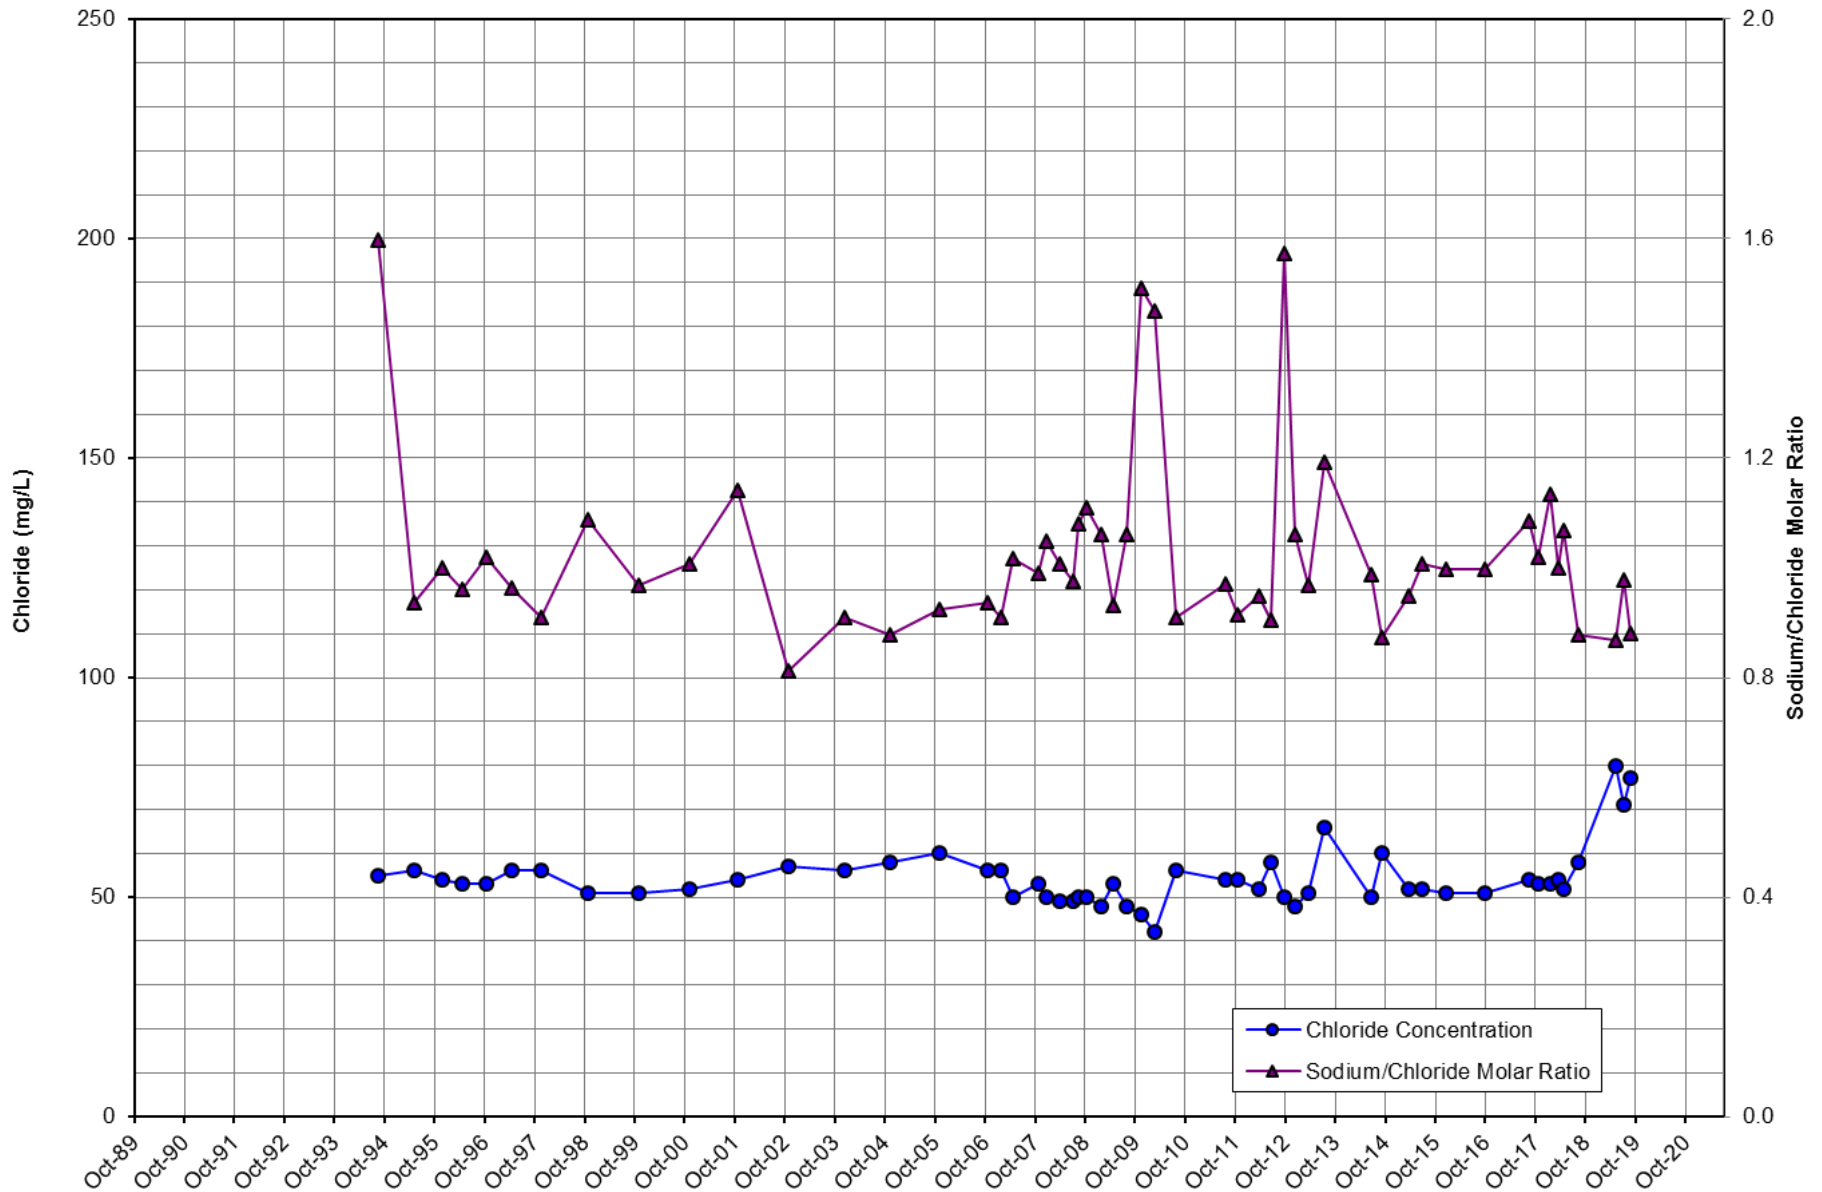
Figure D-11. Fort Ord 9 Shallow Well Chloride and Sodium/Chloride Molar Ratio Graph

- Chloride concentration trends were stable for most monitoring wells. One monitoring well, FO-09 shallow, has sustained increased chloride concentrations in all three samples taken during Water Year 2019. The increase in concentrations from the previous year are between 20 and 30 mg/l. The increase is greater than fluctuations observed historically over the period of record. Elevated concentrations in themselves do not indicate seawater intrusion, however, this well should be carefully observed over the next year to determine if the increasing chloride concentrations are temporary or not.

Based on recent increases in chloride concentrations at monitoring well FO-9 shallow and its proximity to known intrusion in the Salinas Valley, it is recommended that groundwater quality results from it be reviewed after each sampling event to identify if the recent increases are part of natural fluctuations or an ongoing increasing trend. If the March 2020 sample has a greater concentration than this year's highest concentration of 80 mg/L, it is recommended that its sampling frequency be increased to quarterly as a precaution.
