**MONTGOMERY
& ASSOCIATES**

Seaside Groundwater Basin 2022 Seawater Intrusion Analysis Report

Seaside Groundwater Basin Watermaster
Monterey County, California

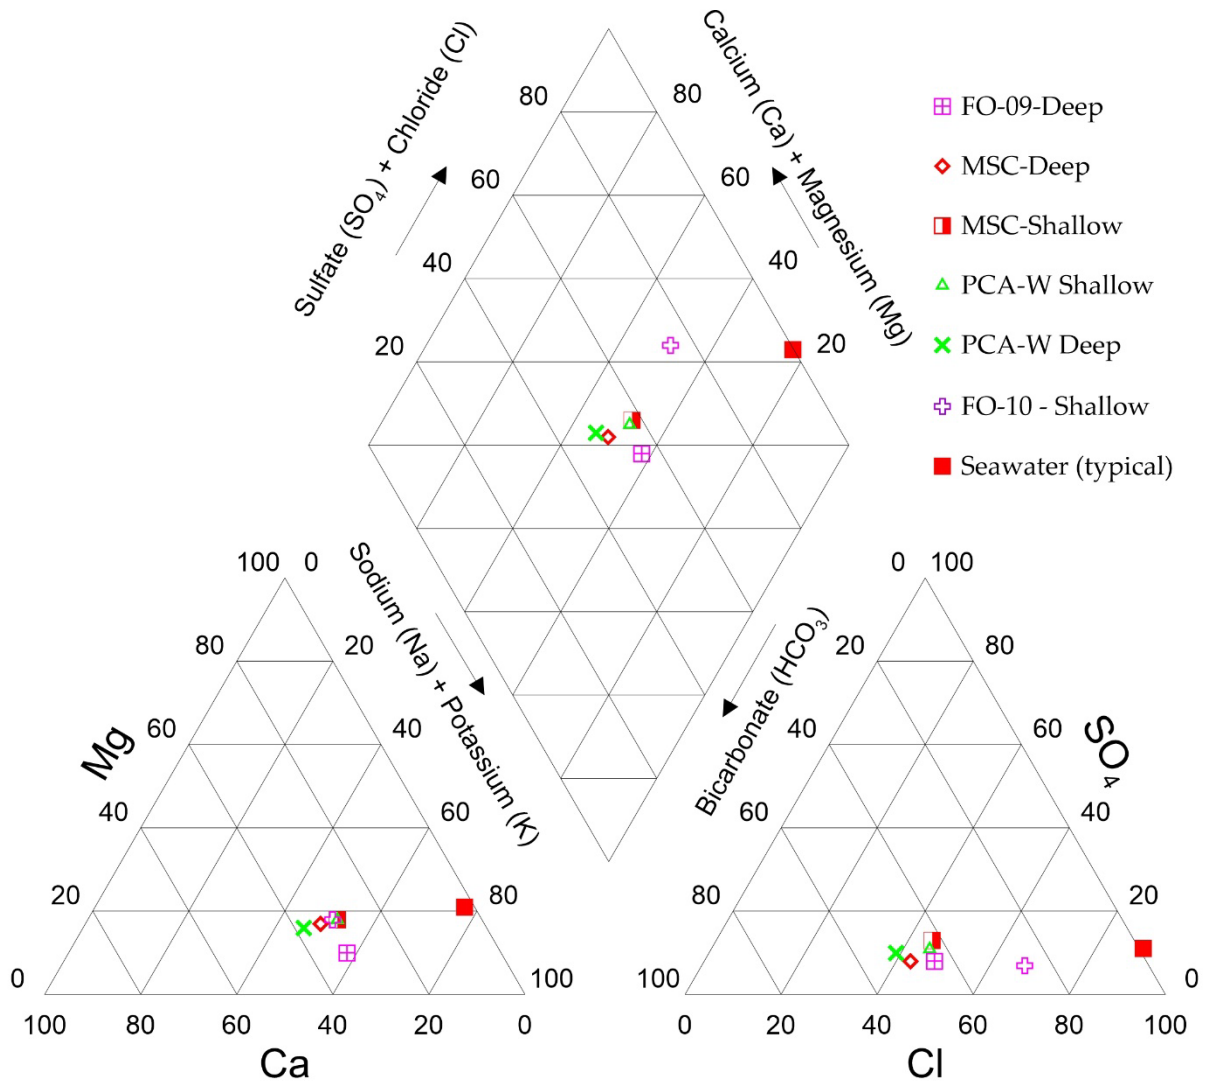
Figure 11. Piper Diagram for Seaside Groundwater Basin Monitoring Wells,
2nd Quarter Water Year 2022 (January-March 2022)
(Data source: Watermaster)

As noted in the previous 2 SIARs (M&A, 2020; M&A, 2021) and shown on Figure 11, monitoring well FO-10 Shallow plots differently than the other wells on the Piper diagram and has exhibited a marked increase in chloride over the past 3 years, departing significantly from its historical trends (Appendix D: Figure D-9). This year FO-10 Deep also plots differently than other wells due to increased chloride (Appendix D: Figure D-10). Downhole logging at the FO-10 site and subsequent historical record search identified a 1,300 foot, 2-inch steel tremie pipe that has been stuck in the FO-10 borehole since the well's construction (Feeney, 2021; Feeney 2022). While comparison of WY 2021 resistivity at the well with a historical log does show increased conductivity in the well, which may be a sign of seawater intrusion, the presence of the steel pipe obfuscates water quality determinations by muting the induction log response. Further, this steel pipe may act as a conduit allowing flow between overlying intruded Dune Sands sediments and the underlying aquifer. In WY 2022, FO-10 Shallow and FO-10 Deep's anions and cations drifted further on the piper diagram, following the paths of intruded groundwater shown on Figure 4.

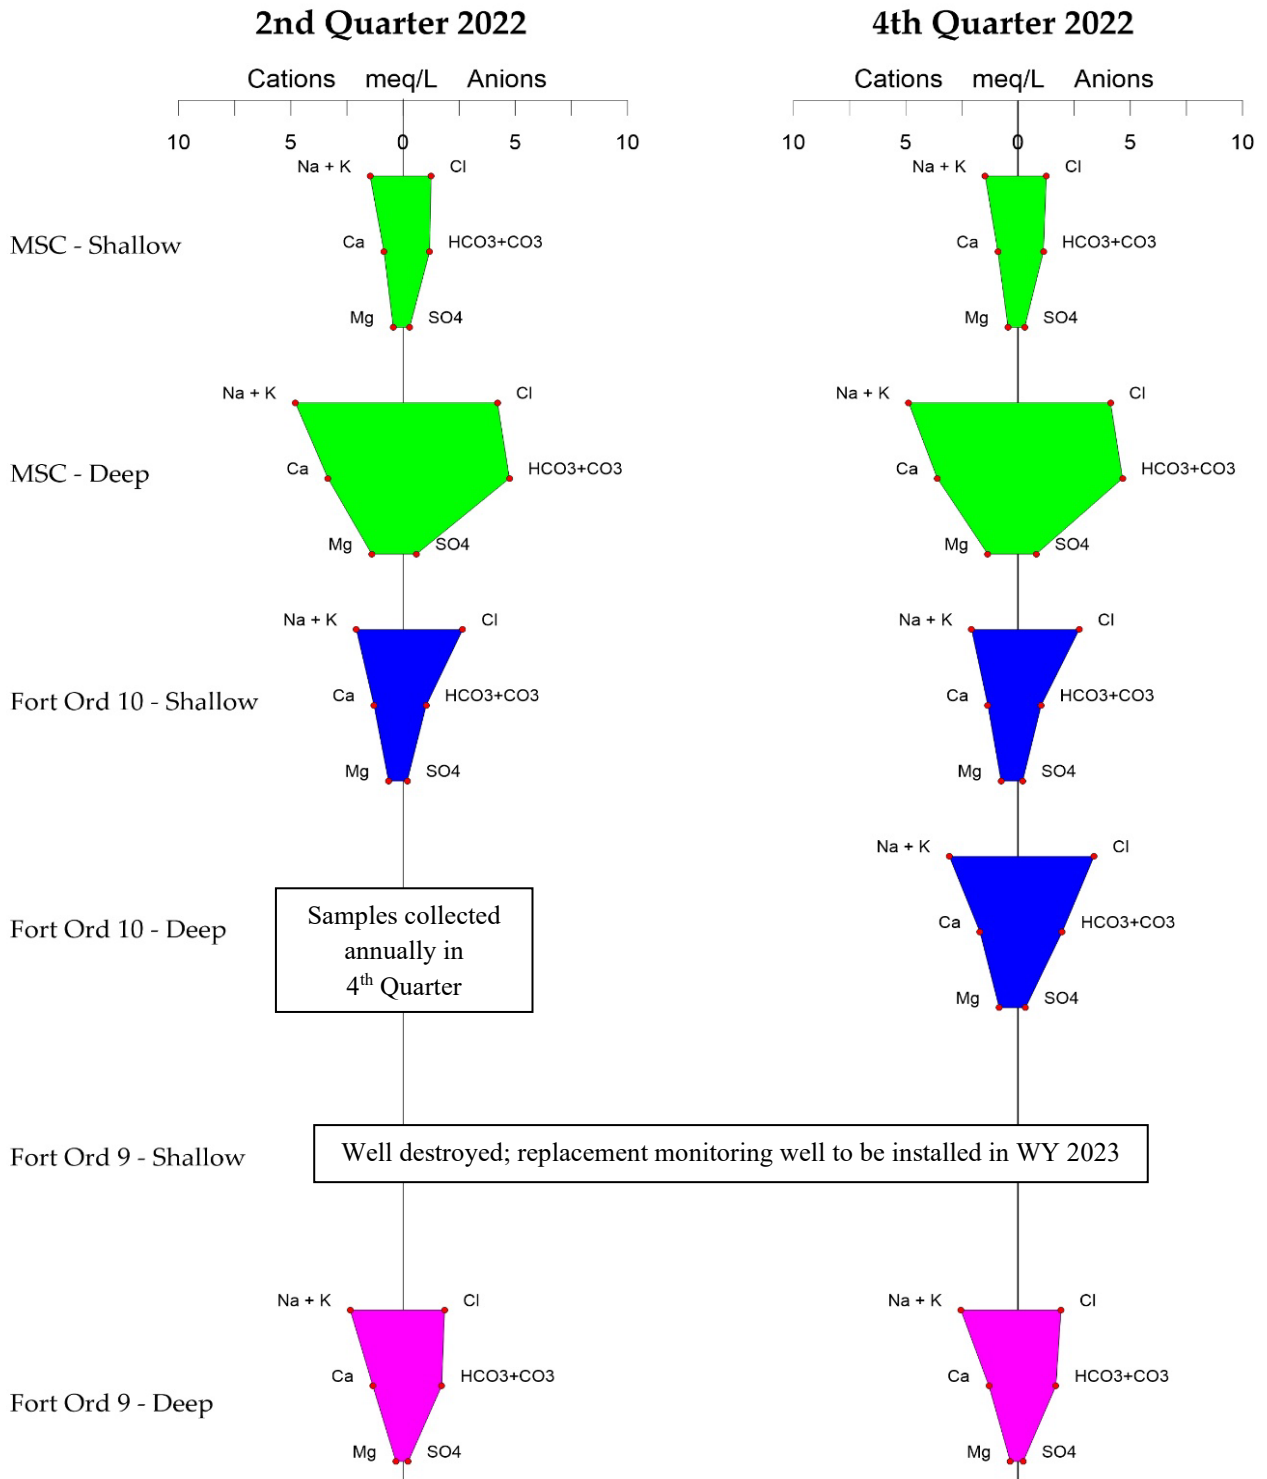
Figure 12. Stiff Diagrams for Monterey Sand Company (MSC), Fort Ord 9, and Fort Ord 10 Wells
(Data source: Watermaster)

Stiff diagrams for the monitoring wells sampled during the second quarter of WY 2022 are shown in the left column on Figure 12 through Figure 14. None of the Stiff diagrams, including monitoring well FO-10 Shallow and FO-10 Deep, show the high chloride spike shown on Figure 7 that indicates seawater intrusion. FO-10 Shallow and FO-10 Deep do show a slightly different shape than other shallow wells because of their increased chloride. As described above, the exact mechanism behind the evolving shape of these wells on the stiff diagrams is not currently known, and it is recommended that the well nest is destroyed and replaced.

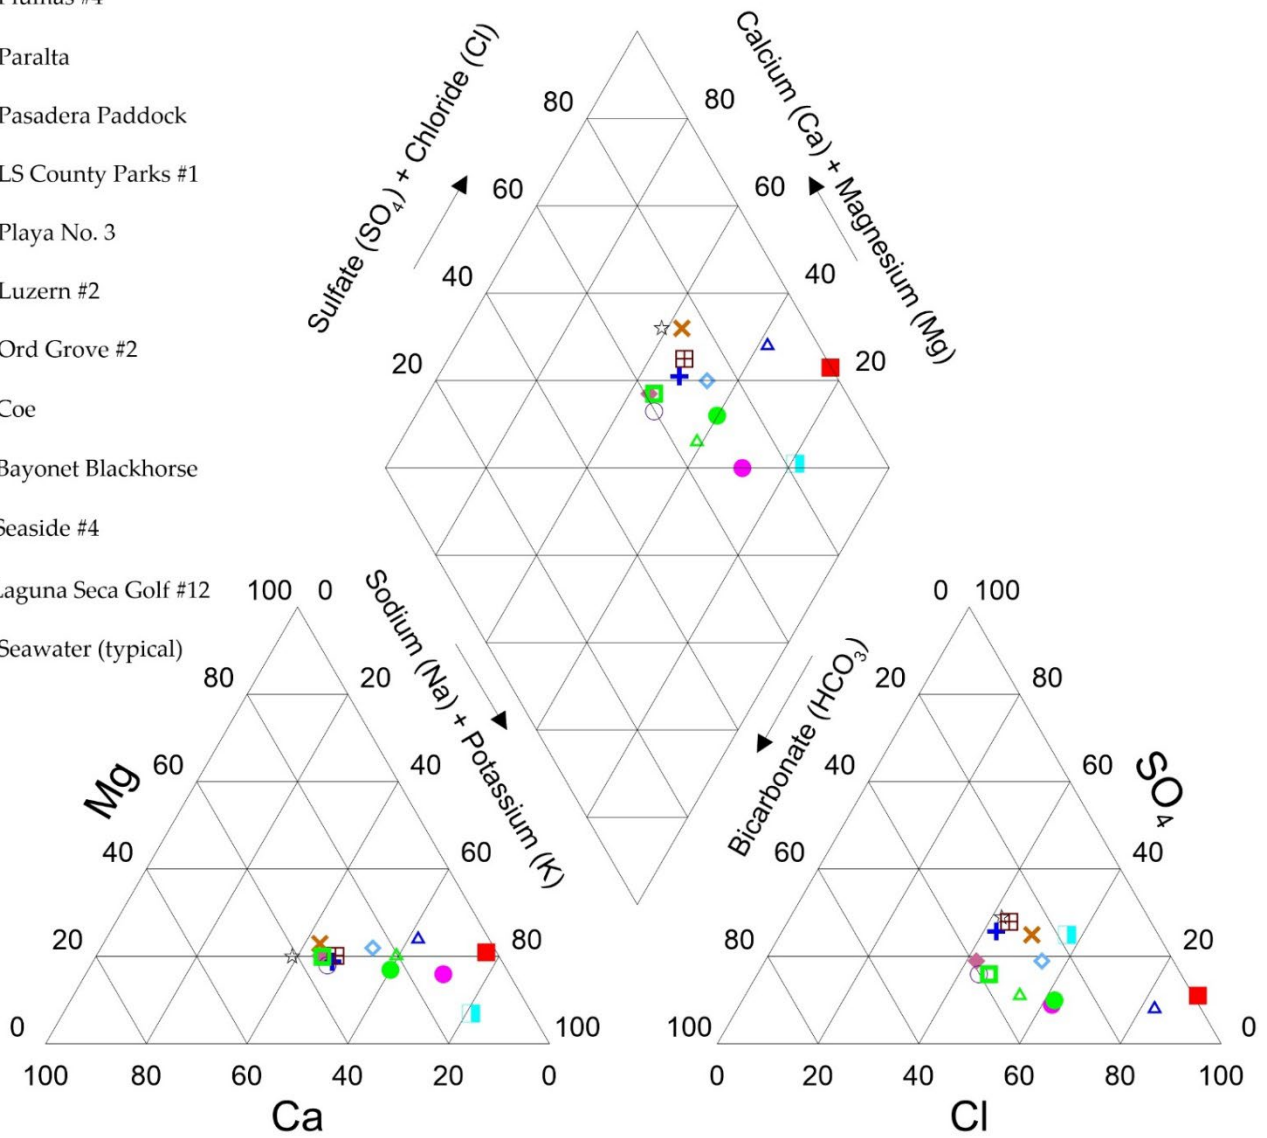
Figure 16. Piper Diagram for Seaside Groundwater Basin Production Wells,
4th Quarter Water Year 2021 (July-September 2021)
(Data source: Watermaster)

Figure 16 presents a Piper diagram for fourth quarter groundwater from production wells. The production wells plot in roughly the same location on the Piper diagram as most monitoring wells on Figure 15. The variation of the plot location on the Piper diagram for production wells is due to higher sulfate and chloride anions than in the monitoring wells. Groundwater from these wells is characterized as sodium-sulfate-chloride type waters. The York School well plots closest to typical seawater on this diagram, however its inland location precludes seawater intrusion as the cause for its observed water chemistry. Overall, the Piper diagram shows no indication of seawater intrusion at any of the production wells.

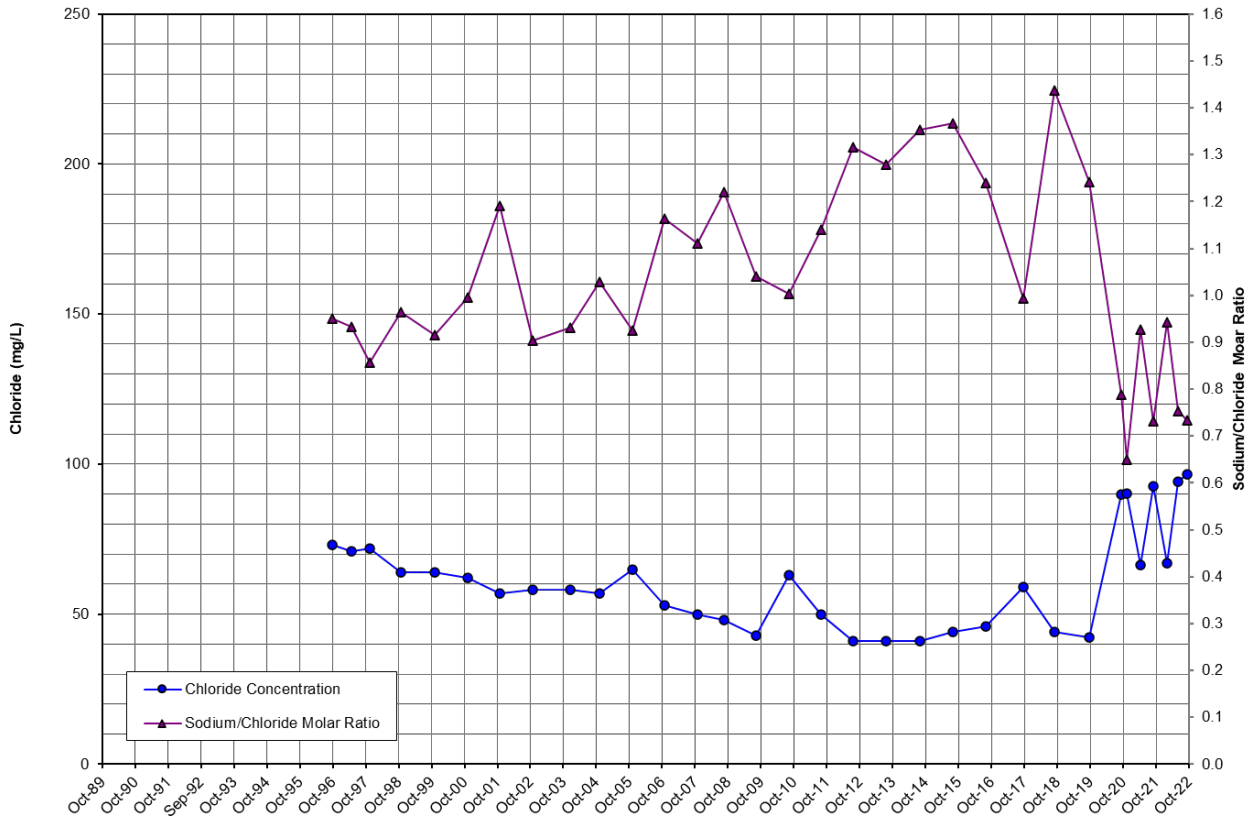
Figure 22. Historical Chloride and Sodium/Chloride Molar Ratios, FO-10 Shallow

- Chloride concentration trends are stable for most monitoring wells, with the notable exception of FO-10 Shallow and FO-10 Deep. FO-10 Shallow experienced a 48 mg/L increase in chloride concentrations in WY 2020 and has risen by another 8 mg/L since then. FO-10 Deep experienced a 60 mg/L increase in WY 2022. However, the sustained elevated concentrations in themselves do not indicate seawater intrusion. As noted above, recent induction logging was unable to conclusively determine whether seawater intrusion is the source of the elevated chloride level, and the well's integrity for water quality sampling may be compromised by a steel tremie pipe stuck in the borehole since 1997.

water quality results and may act as a conduit for groundwater in overlying sediments to enter underlying aquifers, it is recommended that both FO-10 Shallow and FO-10 Deep are destroyed and replaced to maintain a consistent water quality record in the area.

intrusion north of the Basin in the Monterey Subbasin. Therefore, it is recommended that Monterey Peninsula Water Management District (MPWMD) develop plans to destroy both FO-10 Shallow and FO-10 Deep, and that MCWD install similarly constructed monitoring wells to maintain a continuous water quality record at the location. Because seawater intrusion cannot be excluded as the source of increasing chloride concentrations at FO-10 Shallow over the past several years, groundwater quality sampling at this well should continue at the increased quarterly frequency until the well is destroyed. When the well is replaced, the replacement well should likewise be sampled at a quarterly frequency. As detailed in the Monterey Subbasin GSP (MCWDGSA and SVBGSA, 2022) Section 9.4.7, additional monitoring wells may be installed in both the Lower 180-Foot and 400-Foot Aquifer and the Deep aquifers of the Monterey Subbasin. The proposed location for these wells is in an identified data gap area northeast of FO-10 Shallow (see Monterey Subbasin GSP Figures 7-7 and 7-8). When these wells are installed, they may provide additional insight into potential seawater intrusion in the area.

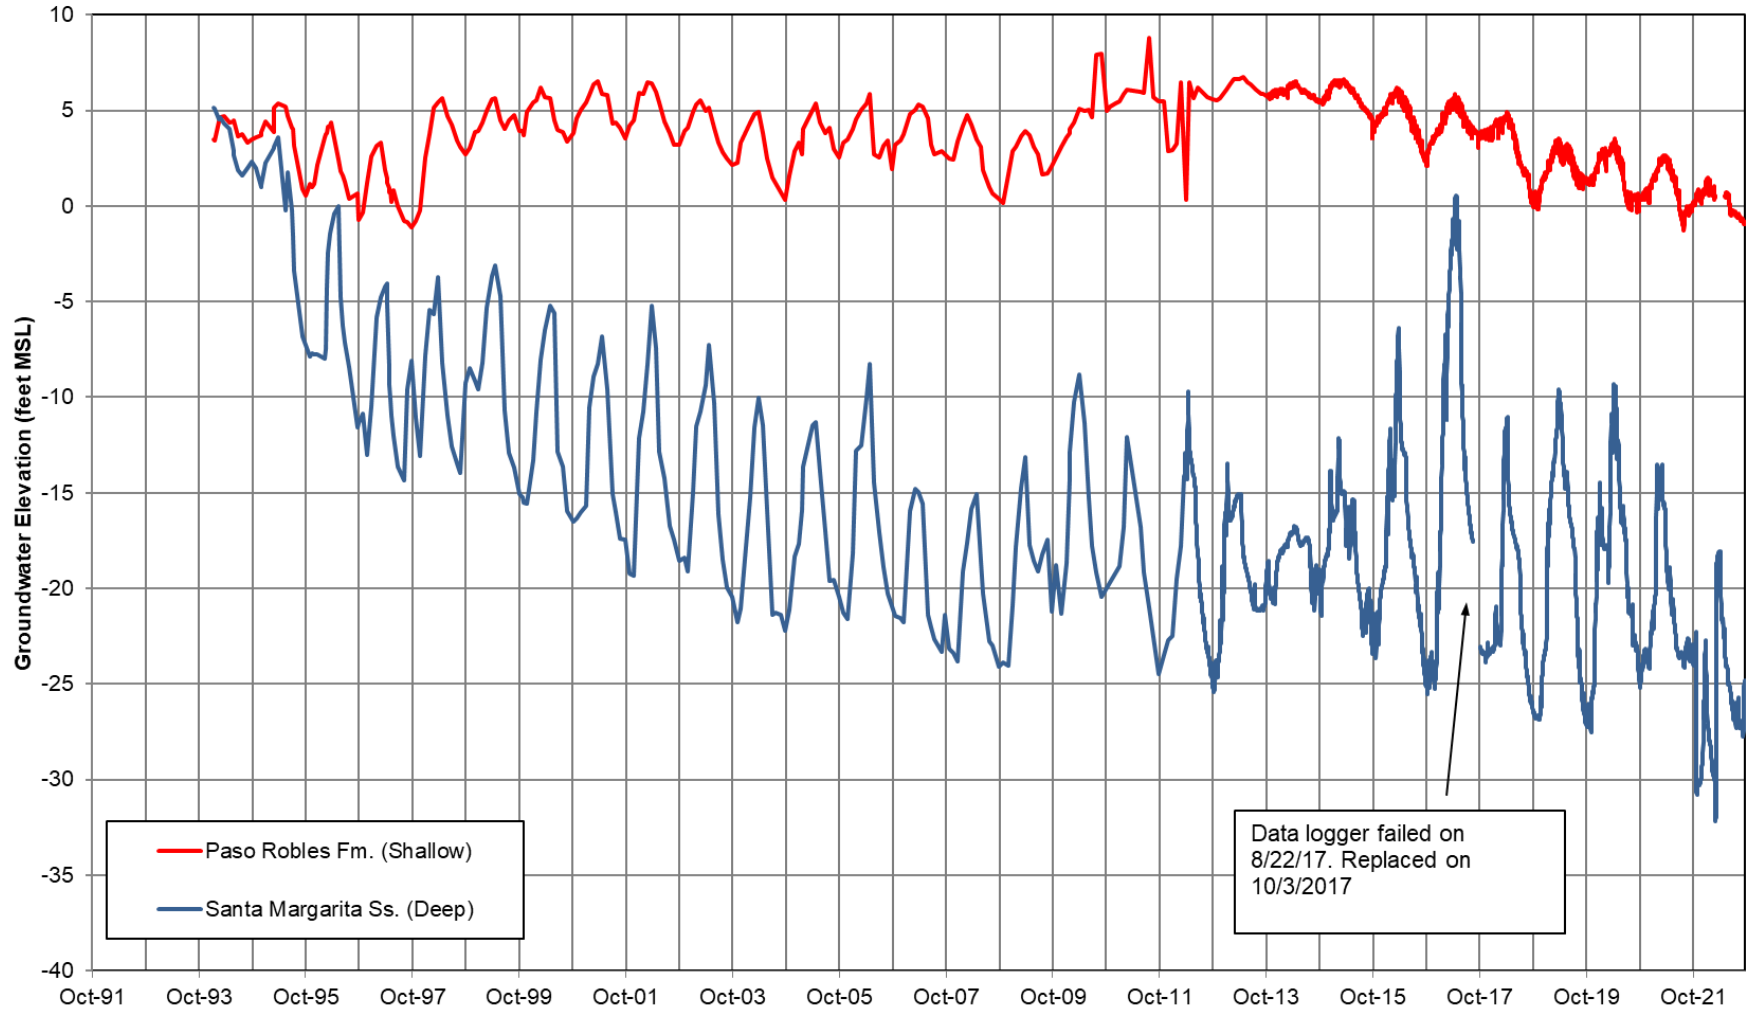
Figure 30. PCA-East Deep and Shallow Monitoring Well Hydrograph (Source: Watermaster)

Seasonal fluctuations are noticeable in the winter season when deep groundwater elevations are at their highest for the year. For example, the 2017 winter high in PCA-East deep increased to a level last seen in 1995, because 2,345 acre-feet of excess Carmel River water was injected as it was a very wet year. As described in Section 2.6.1, WY 2022 was a very dry year, resulting in a limited excess Carmel River Water for ASR injection. Dry conditions and limited ASR injection resulted in some of the lowest on record seasonal high elevations shown on Figure 30. The well has since then experienced decline over the past 2 years; in WY 2022 both seasonal high and seasonal lower groundwater elevations were amongst the lowest on record. Despite dry conditions, the groundwater level decline is likely ameliorated by PWM injection of 3,647 acre-feet.

The hydrograph of Paso Robles aquifer groundwater levels in PCA-East shows a steadily declining trend since WY 2014, where levels have dropped about 7 feet over the past 8 years (Figure 30). The decline in Paso Robles aquifer groundwater levels and greater seasonal fluctuations corresponds with the recommencement of pumping at the Coe Ave and Black Horse Bayonet golf course irrigation wells after being supplied water by Marina Coast Water District from WY 2009 through 2014/2015. Since WY 2018, groundwater levels are below protective elevations at this coastal monitoring well as described further in Section 2.6.4. Seasonal level increases in the Paso Robles aquifer are usually related to reduced wintertime production and increased pumping during summer. Although the Paso Robles aquifer seasonal fluctuations correspond with Santa Margarita aquifer fluctuations, it is because seasonal pumping occurs in both aquifers, and not because the aquifers are closely connected.

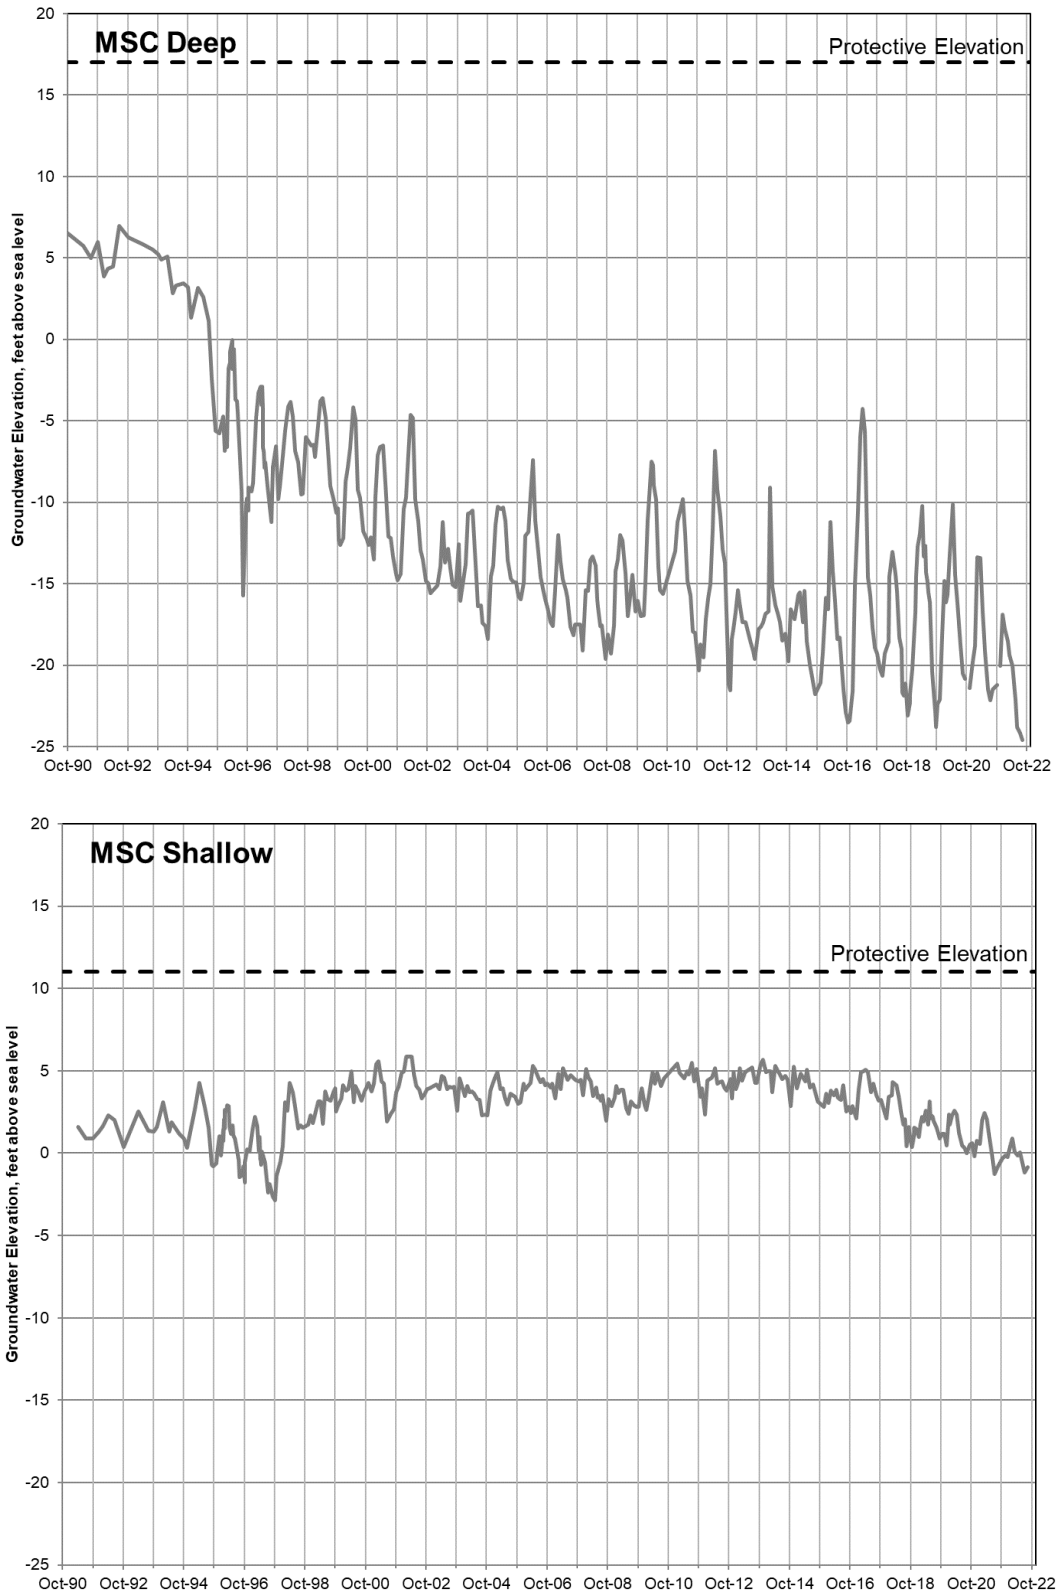
Figure 41. MSC Deep and Shallow Groundwater and Protective Elevations

Figure 41 through Figure 44 show the historical groundwater elevations at each of the target protective elevation monitoring wells. Groundwater levels continue to be below protective elevations in all Santa Margarita target monitoring wells (MSC deep, PCA-West deep, and Sentinel Well 3). All 3 Santa Margarita monitoring wells' groundwater levels are now at the lowest in their historical records. Monitoring well CDM-MW4 is the only 1 Paso Robles well (1 of 3 Paso Robles wells total) with its groundwater level above its protective elevation. Groundwater levels in the PCA West Shallow well fell below protective elevations in WY 2020 and remain below through WY 2022. Groundwater levels in the MSC Shallow well continue to be below its protective elevation. Other than CDM-MW4, all of these wells exhibit declining trends in elevation.
