MONTEREY PENINSULA
WATER MANAGEMENT DISTRICT

SEASIDE BASIN WATERMASTER MEMORANDUM 2012-02

Subject: **Summary of Seaside Groundwater Basin Cross-Aquifer Contamination Wells Investigation Process and Conclusions**

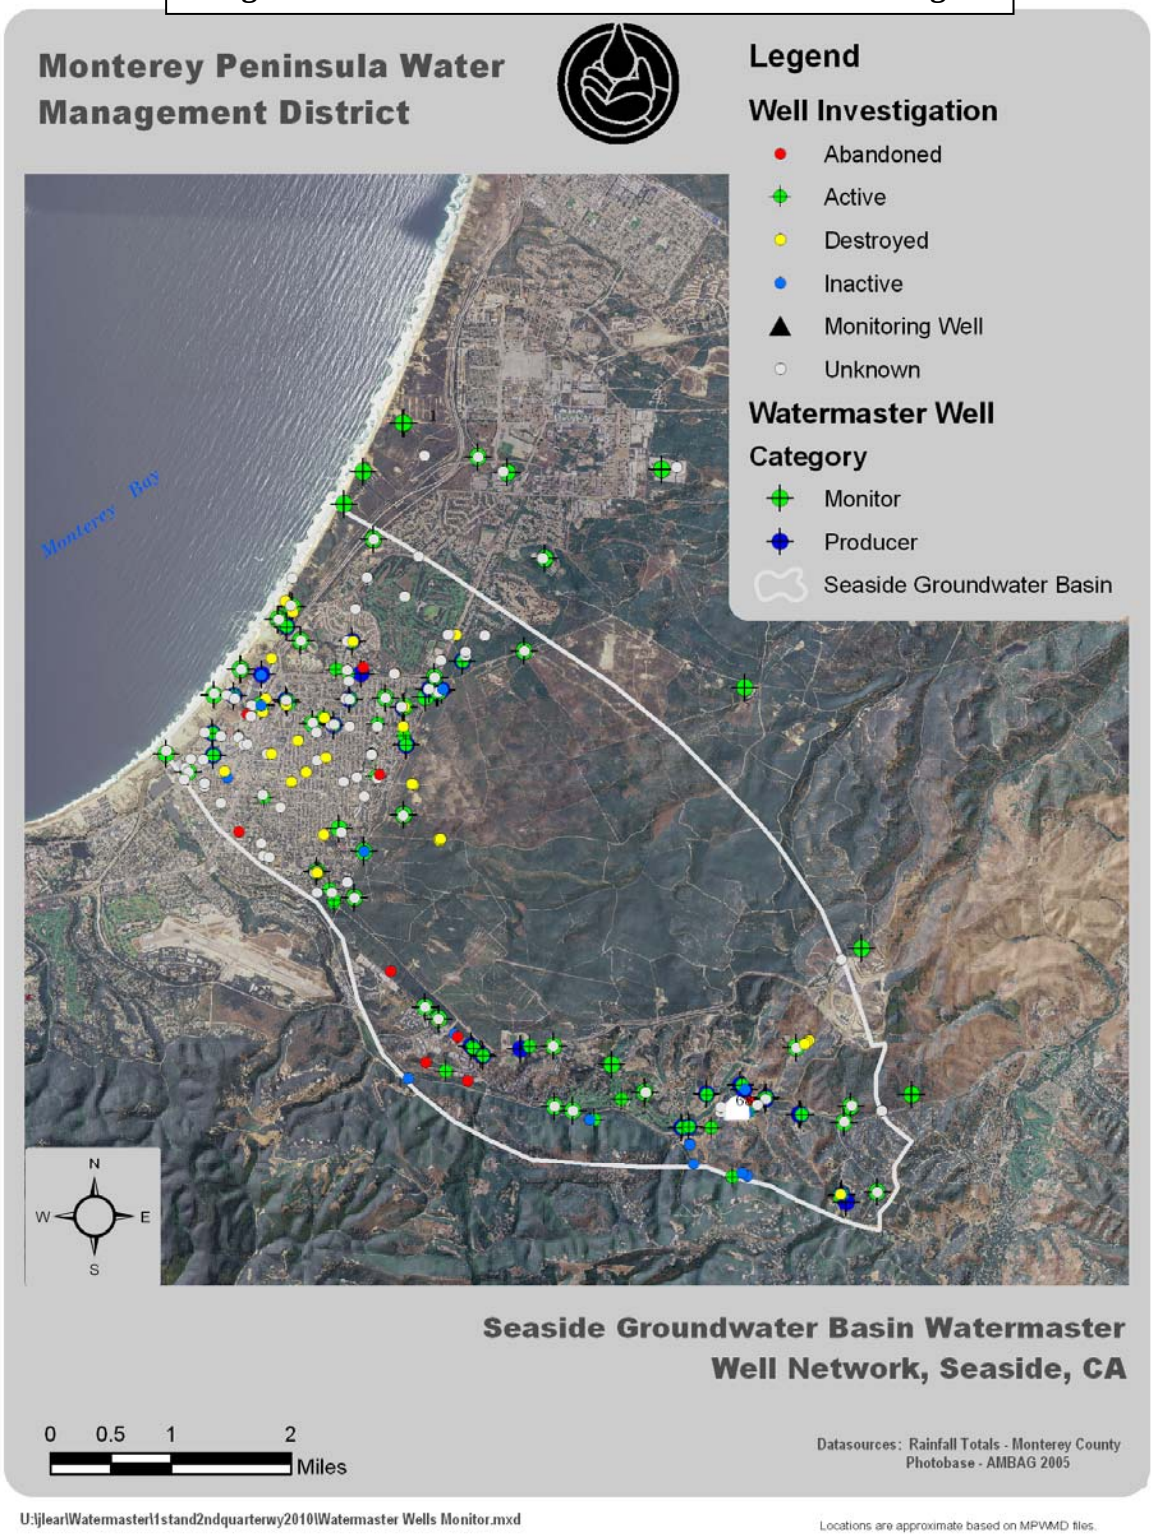
Figure 2. Well Locations as Inferred from Driller Logs.

The current status of identified well records within the basin was categorized as destroyed, abandoned, active, inactive, or unknown (Table 3) across a suite of well use types (industrial, irrigation, domestic, etc.). The status of over 52% of the identified well records within the basin are unknown. Roughly 18% of the well records are categorized as active, 10 % are inactive, 15 % are destroyed, and 5% are abandoned. Well status by subarea is shown in Table 4 panels A-E.
Reported well ages (binned by decade) and casing construction materials (PVC, steel, none, and unknown) are shown in Table 5 and Figure 1. The reported ages of 33% of the wells are unknown. The reported casing material of roughly 56% of the wells are unknown, but wells completed prior to 1970 are likely to be cased with steel and are highlighted in Table 5. Steel casings (susceptible to deterioration over time) line 19% of the wells whereas PVC casings line the remaining 25%. Two wells were not cased. Table 6 displays casing construction materials as a function of data source and basin subarea. Table 7 includes the status of the identified wells by subarea. Figure 2 shows locations of all identified well records during this effort.

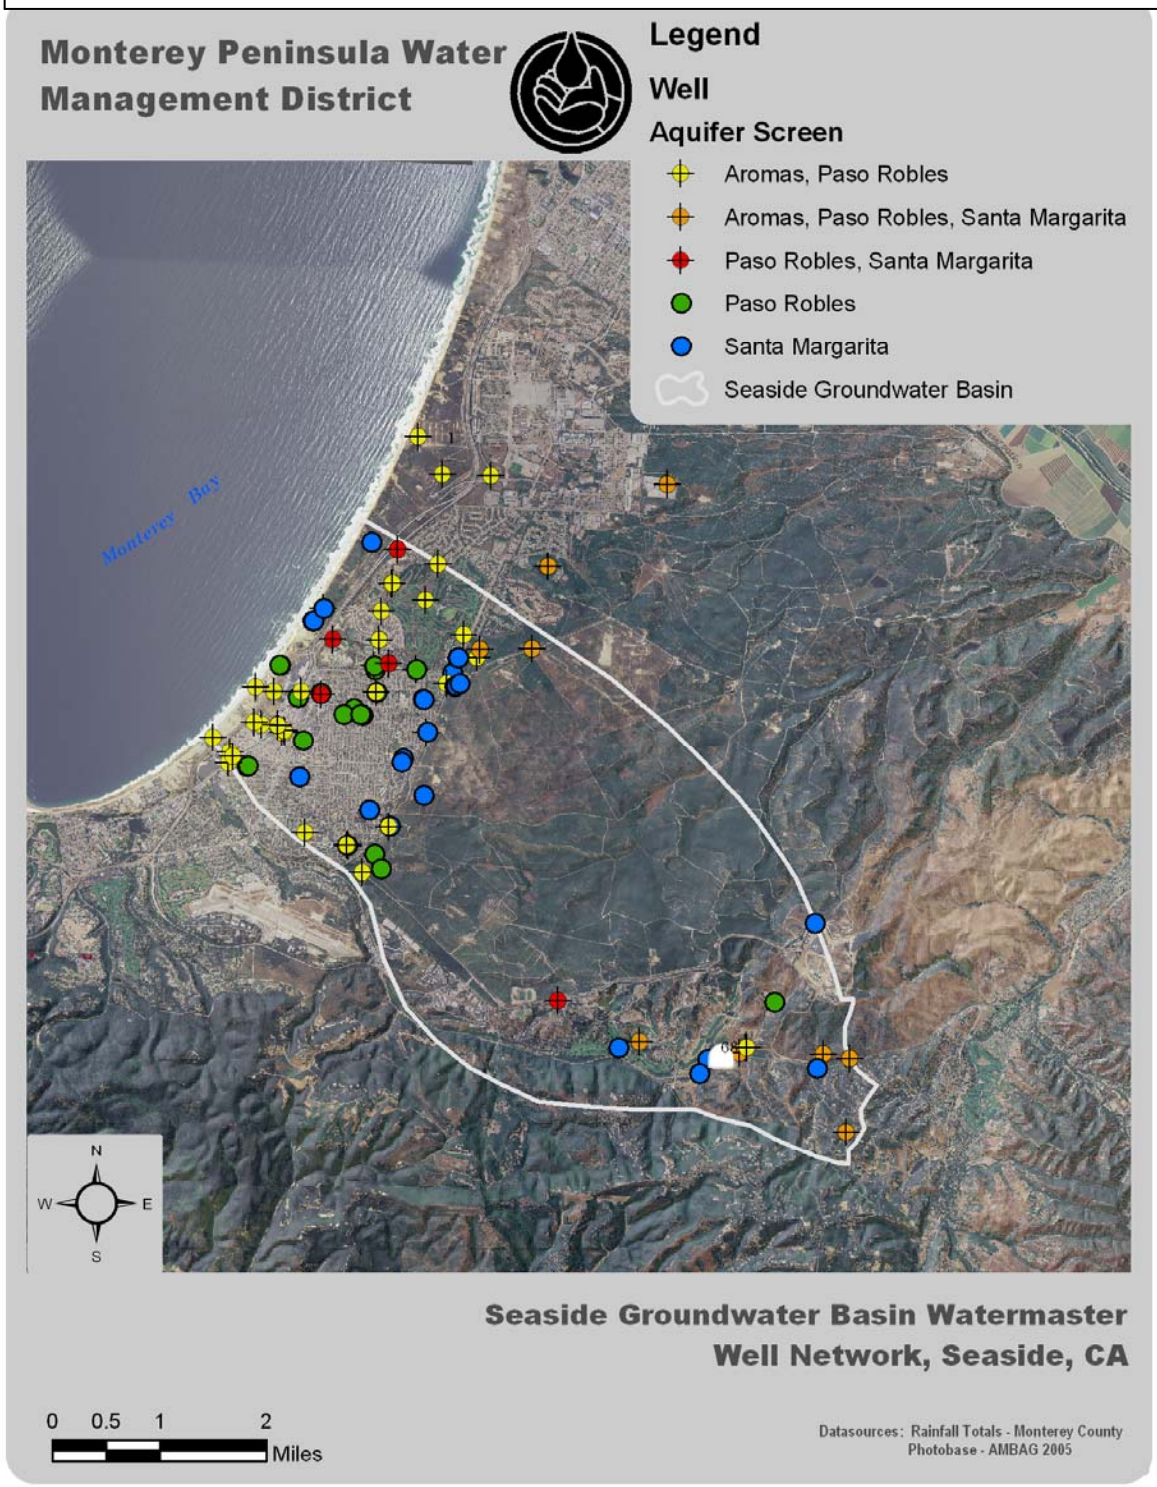
Figure 3. Well Locations and Aquifer Units Screened.

There are 176 identified wells in the coastal subareas of the basin. Lithological analysis suggests that roughly 60% (104 wells) are screened in multiple aquifers (Table 8 and Figure 3). Of these cross-screened wells, 66 are screened in two aquifers and 38 are screened in three aquifers.

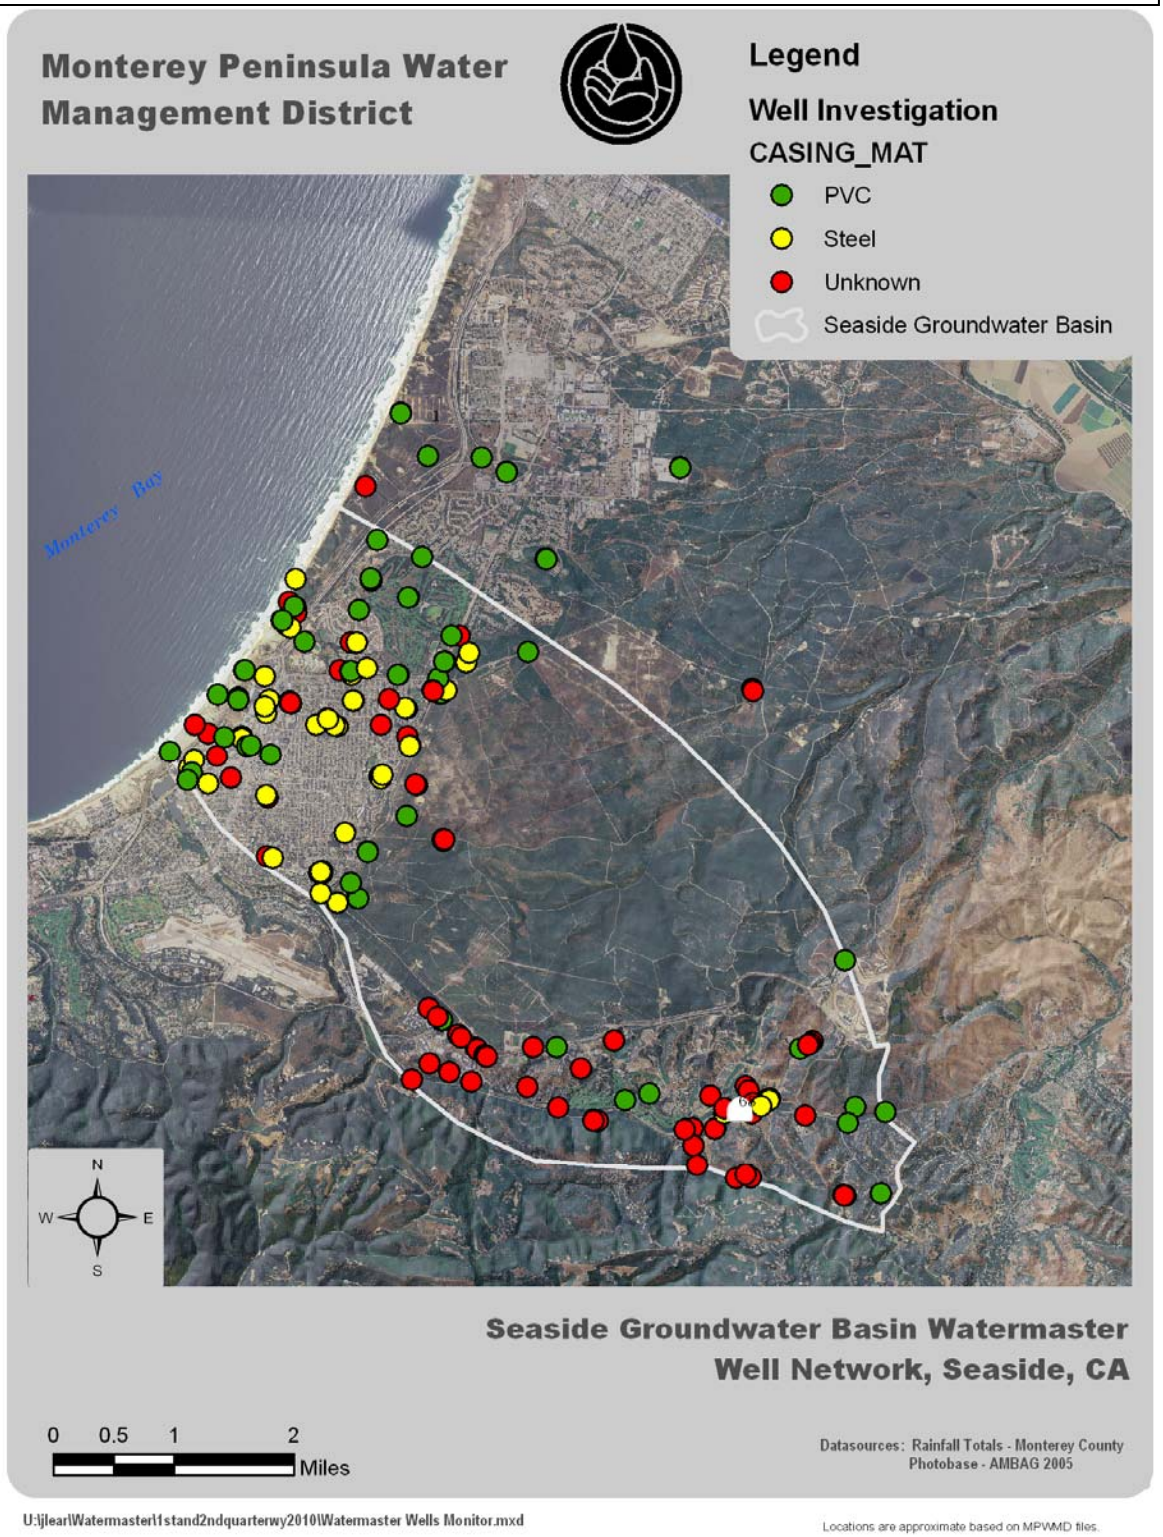
Figure 4. Well Locations Inferred from Drillers Logs and Construction Material.

Twenty six of these cross-screened wells are over 40 years old and have steel casing materials which are susceptible to deterioration (Figure 4).

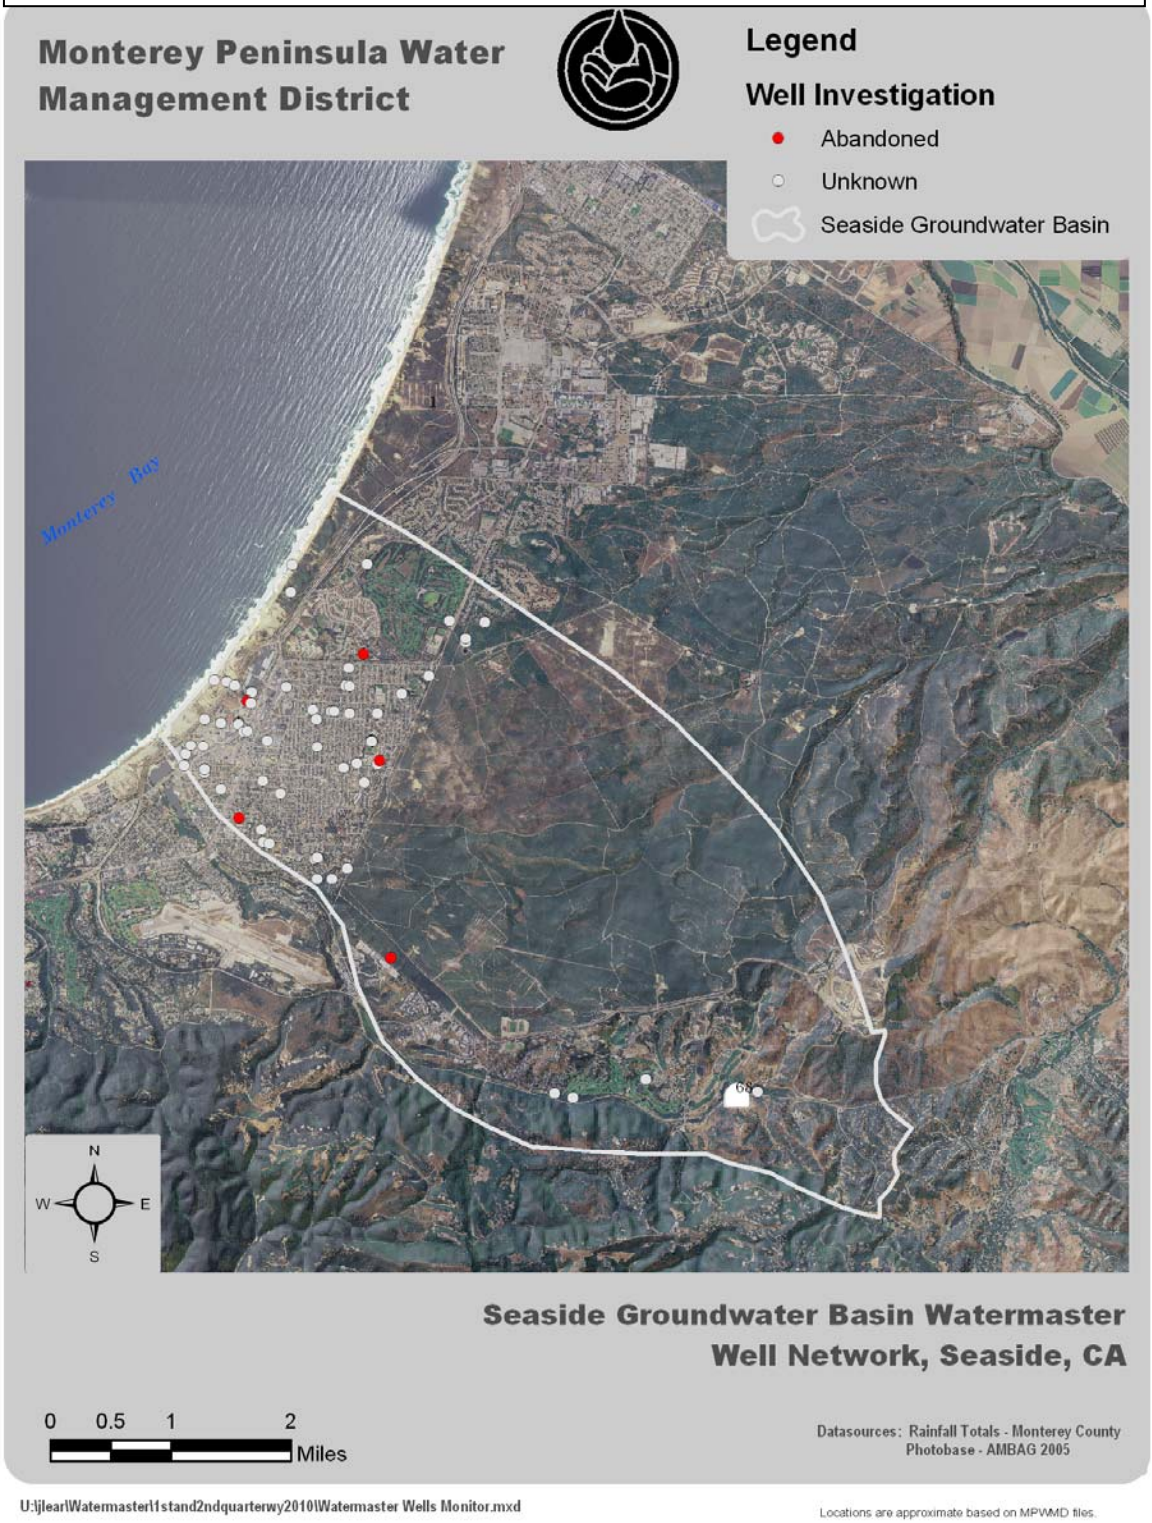
Figure 5. Wells Identified for Location Validation.

Out of the cross-screened wells and wells identified that may be susceptible to deterioration, 59 wells were scheduled for field investigation (Figure 5). Over August 2011, District staff performed site investigations into the status of these wells. Out of the 59 wells identified for field inspection, 18 are cross-screened over multiple aquifers or penetrate through one aquifer and are screened in a deeper aquifer (Figure 6), 33 were destroyed, and 8 were not locatable.

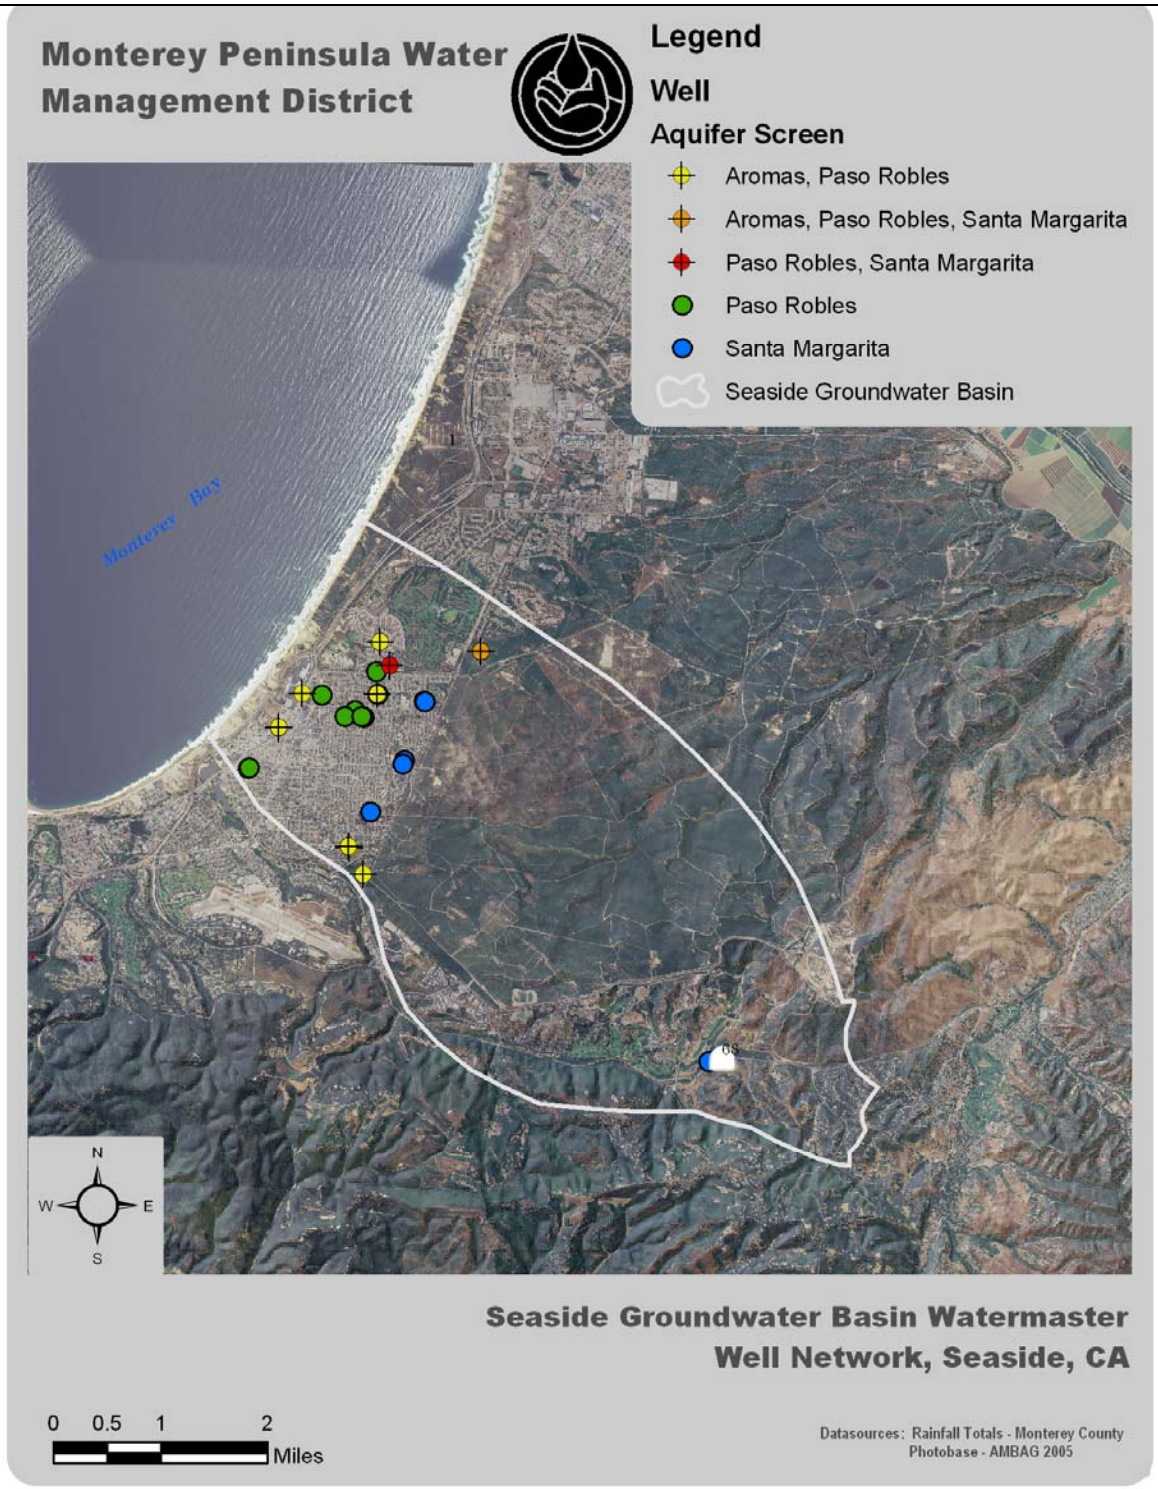
Figure 6. Field Verified Cross-Screened or Multiple Aquifer Penetrating Wells.

All of the locatable 18 cross-screened wells are owned maintained by entities named in the Seaside Basin Adjudication Decision. Based on the level of analysis performed in the scope of this study, no obvious structural breakdowns are evident or have been reported. These wells are currently being used as active production wells, backup production wells, and monitoring wells. Because seawater intrusion has not been documented, currently these wells do not pose a threat of providing a migration pathway for saline water across aquifer zones. If seawater intrusion were detected in the locality of any of these wells, the potential of them acting as a conduit for cross-aquifer contamination will need to be revisited.
