**MONTGOMERY
& ASSOCIATES**

Seaside Groundwater Basin 2019 Seawater Intrusion Analysis Report

Seaside Groundwater Basin Watermaster
Monterey County, California

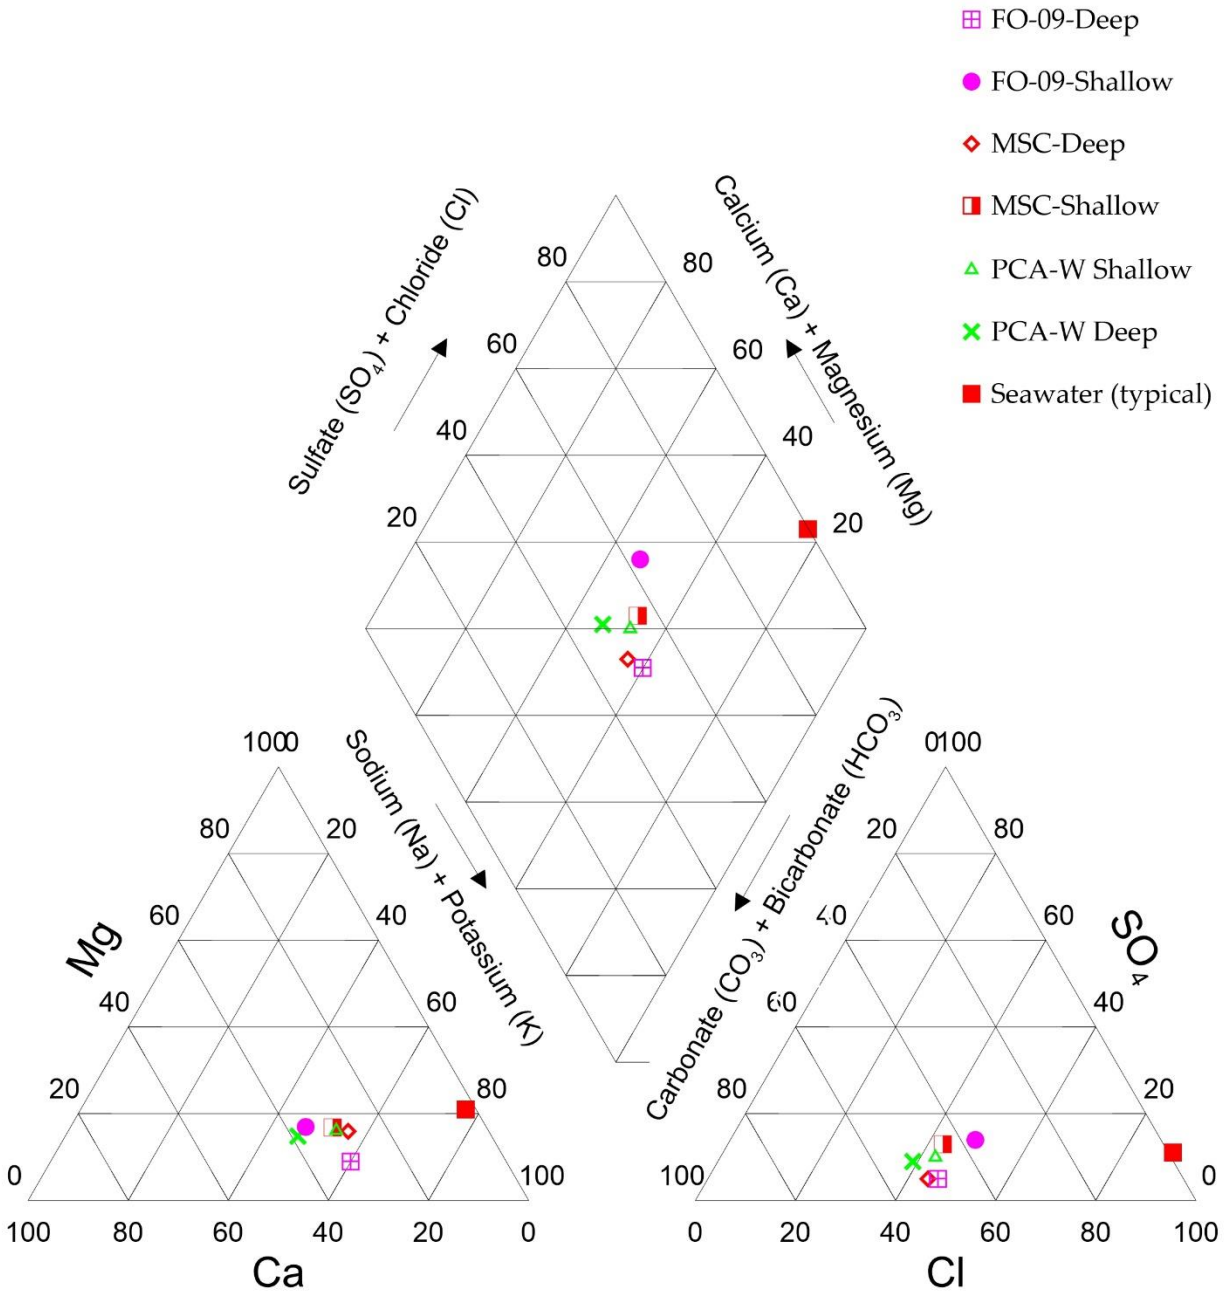
Figure 11. Piper Diagram for Seaside Groundwater Basin Monitoring Wells,
2nd Quarter Water Year 2019 (January-March 2019)
(Data source: Watermaster)

The monitoring wells generally cluster in a single area on the Piper diagram that is consistent with previous data. The location on the Piper diagram indicates that groundwater from both the deep and shallow well pairs straddle the sodium-chloride and sodium-bicarbonate type water¹. On Figure 11, monitoring well FO-9 shallow plots slightly differently than the other wells on the Piper diagram. For more detail on this well, Appendix D: Figure D-11 shows that the last three samples from this well all sampled within this water year indicate a greater concentration of chloride anions than in previous water years.

Based on recent increases in chloride concentrations at monitoring well FO-9 shallow and its proximity to known intrusion in the Salinas Valley, it is recommended that groundwater quality results from it be reviewed after each sampling event to identify if the recent increases are part of natural fluctuations or an ongoing increasing trend. If the March 2020 sample has a greater concentration than this year's highest concentration of 80 mg/L, it is recommended that its sampling frequency be increased to quarterly as a precaution.

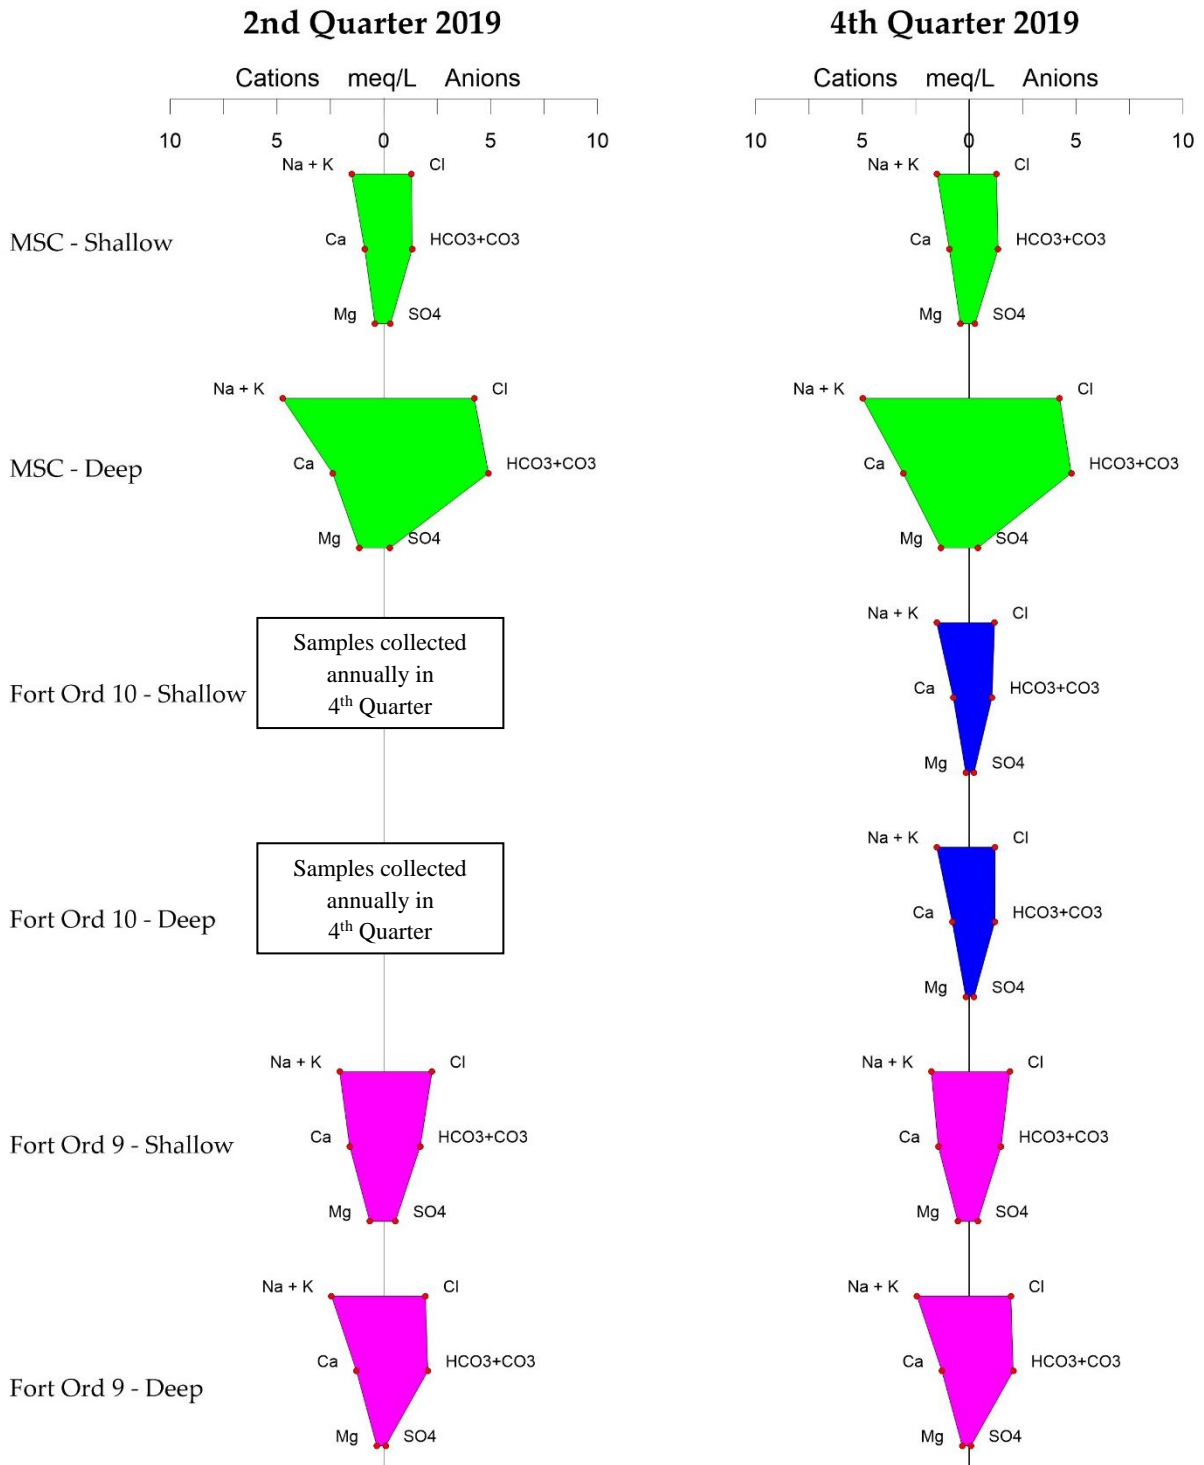
Figure 12. Stiff Diagrams for MSC, Fort Ord 9, and Fort Ord 10 Wells
(Data source: Watermaster)

Stiff diagrams for the monitoring wells sampled during the 2nd quarter of Water Year 2019 are shown in the left column on Figure 12 through Figure 14. None of the Stiff diagrams show the high chloride spike shown on Figure 7 that indicates seawater intrusion, this includes FO-9 shallow which has shown a recent change in chloride anions, as mentioned in the above paragraph.

Stiff diagrams for the 12 monitoring wells sampled during the 4th quarter of Water Year 2019 are shown in the right column on Figure 12 through Figure 14. The shapes of the Stiff diagrams for the paired monitoring wells are similar to the shapes of the Stiff diagrams for the majority of prior years.

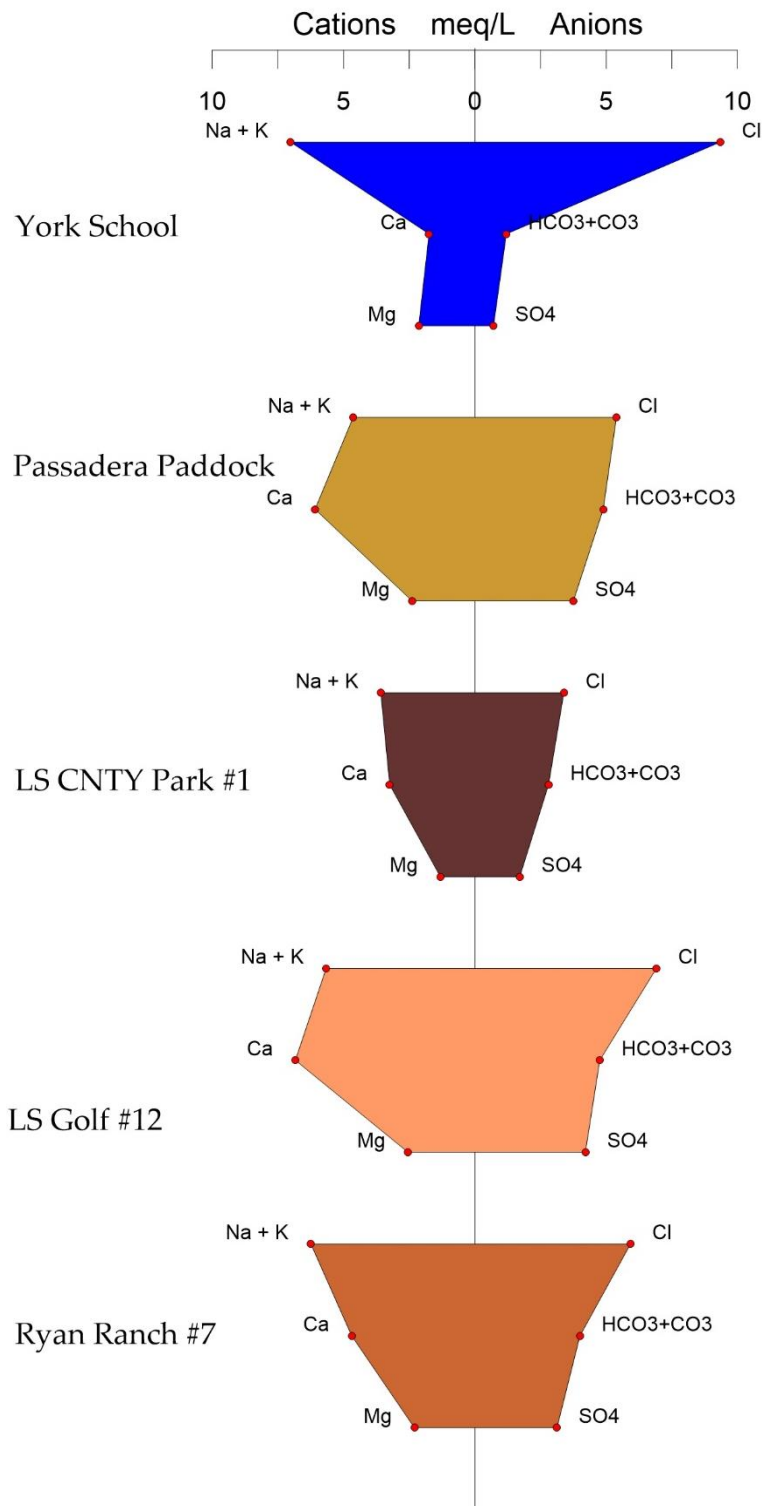
Figure 18. Stiff Diagrams for Laguna Seca Subarea Production Wells
(Data source: Watermaster)

The York School production well, in the Laguna Seca subarea, and Sand City's Public Works Corp Yard production well, in the Southern Coastal subarea both have Stiff diagrams different from most other wells' water quality (Figure 18). Although the shapes are different, they do not display the large chloride spike associated with seawater intrusion as shown on Figure 7. None of the production wells analyzed using Stiff and Piper diagrams show an indication of seawater intrusion.

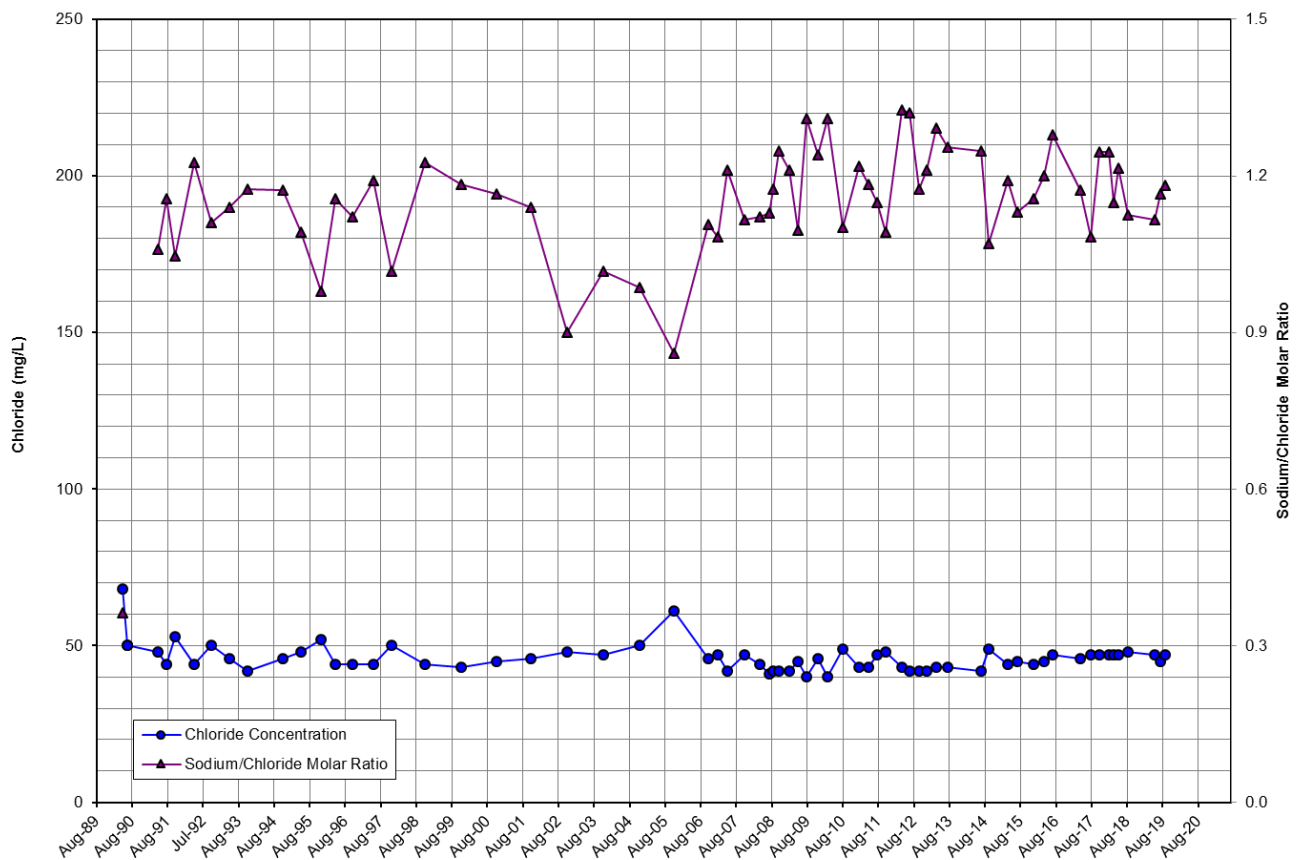
Figure 21. Historical Chloride and Sodium/Chloride Molar Ratios, PCA West Shallow

Chemographs showing chloride concentrations over time are plotted for each of the monitoring wells shown on the Piper and Stiff diagrams and one production well. An example plot displaying chloride concentrations for the shallow PCA West well is shown on Figure 21. The complete set of chemographs is included in Appendix D. Chloride trends for most monitoring wells remain stable, or fluctuate within a historical range. One monitoring well, FO-09 shallow, has sustained increased chloride concentrations in all three samples taken during Water Year 2019 (Appendix D: Figure D-11). The increase is greater than fluctuations observed historically over the period of record but the elevated concentrations in themselves do not indicate seawater intrusion.

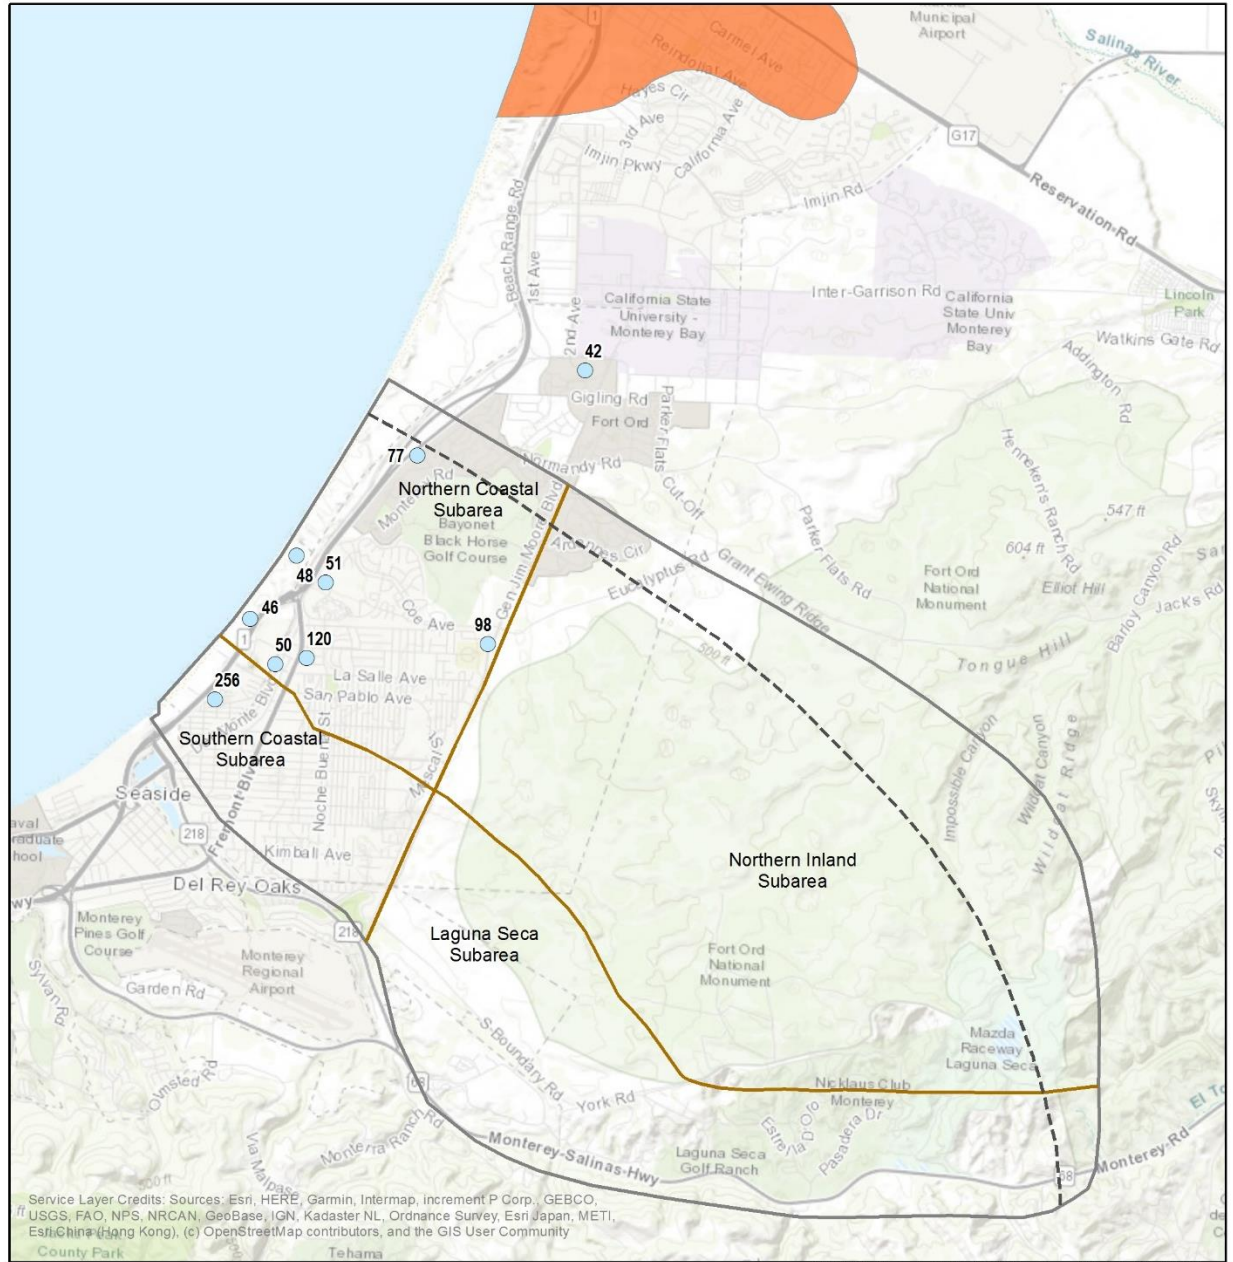
Figure 22. Shallow Zone Chloride Concentration Map – 4th Quarter WY 2019

For the data available in the shallow zone, chloride concentrations near the coast now average slightly higher than 50 mg/L in the Northern Coastal subarea because of the increase in FO-9 shallow concentrations. The more inland Northern Coastal subarea wells have slightly higher chloride concentrations that may be due to depositional mineralization differences in the Paso Robles Formation. Based on available data, there is no discernible spatial trend of higher coastal chloride concentrations, and therefore no indication of seawater intrusion within the shallow aquifer. Sand City's Public Works Corp Yard well continues to be the only coastal well in the Southern Coastal subarea with measured chloride data, which has historically had the highest concentration of all shallow coastal monitoring wells (Appendix D: Figure D-13). The Piper and Stiff diagrams and sodium/chloride molar ratio for the well continue to suggest that the source of high chloride is not seawater.

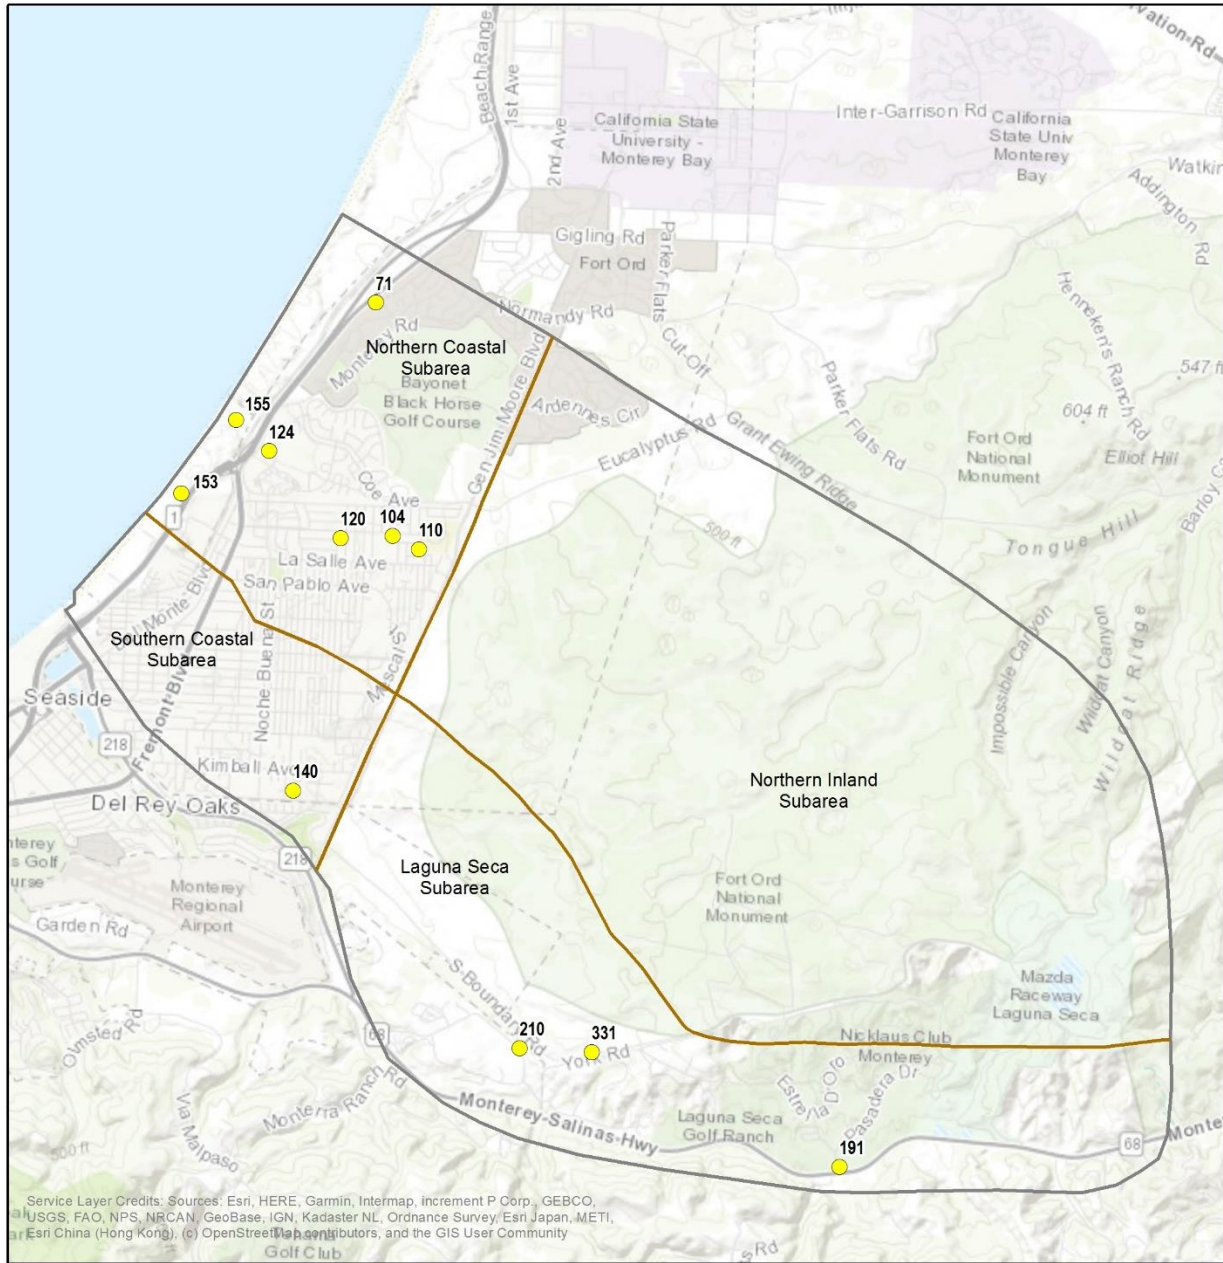
Figure 23. Deep Zone Chloride Concentration Map – 4th Quarter WY 2019

The deep zone 4th quarter Water Year 2019 chloride concentration map is shown on Figure 23. Chloride concentrations for the Sentinel Wells are not shown on this map anymore because it was found that their groundwater samples are not representative of the aquifer. Since the chloride data shows no discernible spatial distribution, with high concentrations in close proximity to low concentrations, the data cannot be readily contoured. Deep zone chloride concentrations near the coast range between 70 mg/L and 159 mg/L.

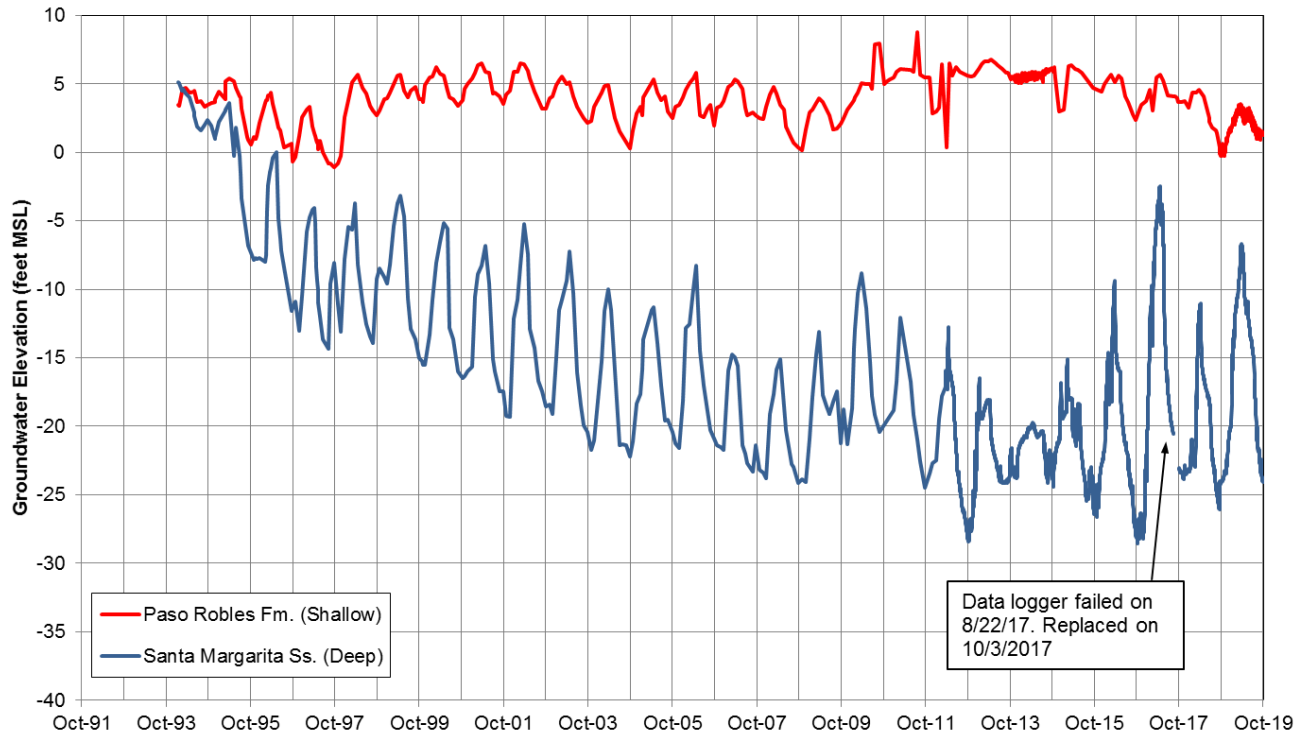
Figure 28. PCA-East Deep and Shallow Monitoring Well Hydrograph (Source: Watermaster)

PCA-East deep on Figure 28 shows an overall decline in groundwater levels until 2009, levels increase and then more or less stabilize over the next two years, and then from 2011 to 2016 experienced a continued decline. Groundwater levels recovered slightly in 2017 due to record rainfall to levels similar to those experienced during the drought (2012 – 2015). Groundwater levels have remained at a somewhat similar level since 2017, with no clear increasing or decreasing trend (Figure 28). The start of the overall decline in groundwater levels in the deep completion of PCA-East corresponds with the shift in CAWC's production from their shallow Paso Robles wells to deeper Santa Margarita wells.

Seasonal fluctuations are noticeable in the winter season when groundwater elevations are at their highest for the year. For Water Year 2017, the winter high in PCA-East deep increased to a level last seen in 1995, which is 17 feet higher than the lowest winter high level experienced during the recent drought. This is because 2,345 acre-feet of excess Carmel River water was injected as it was a very wet year. A volume of 744.4 acre-feet was injected in Water Year 2019

The hydrograph of shallow groundwater levels in PCA-East shows a declining trend since Water Year 2014, where levels have dropped about five feet over the past four years (Figure 28). The decline in shallow groundwater levels and greater seasonal fluctuations corresponds with the

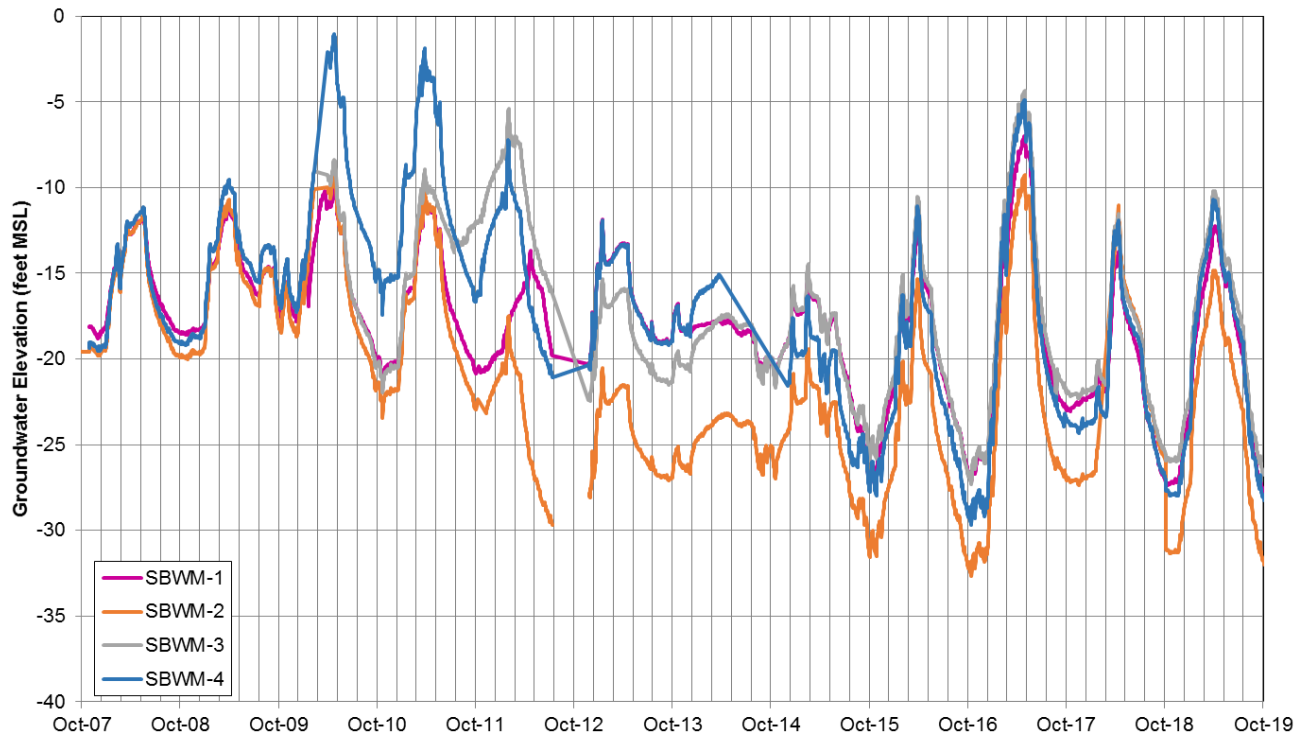
Figure 29. Sentinel Well Hydrographs (Source: Watermaster)

Figure 29 includes hydrographs of groundwater elevations for the four deep coastal Sentinel Wells. Groundwater elevations on this chart are collected using data loggers in each well that record levels every 30 minutes. The hydrographs plot daily average elevations, thereby smoothing out the more detailed data which are affected by tidal variations. The hydrographs for the Sentinel Wells are similar to the PCA-East deep hydrograph and show that groundwater elevations over winter and spring were the highest in Water Year 2017 because of increased injection. Groundwater levels in Water Year 2019 are similar to 2018 levels and there is no clear increasing or decreasing trend since 2015.

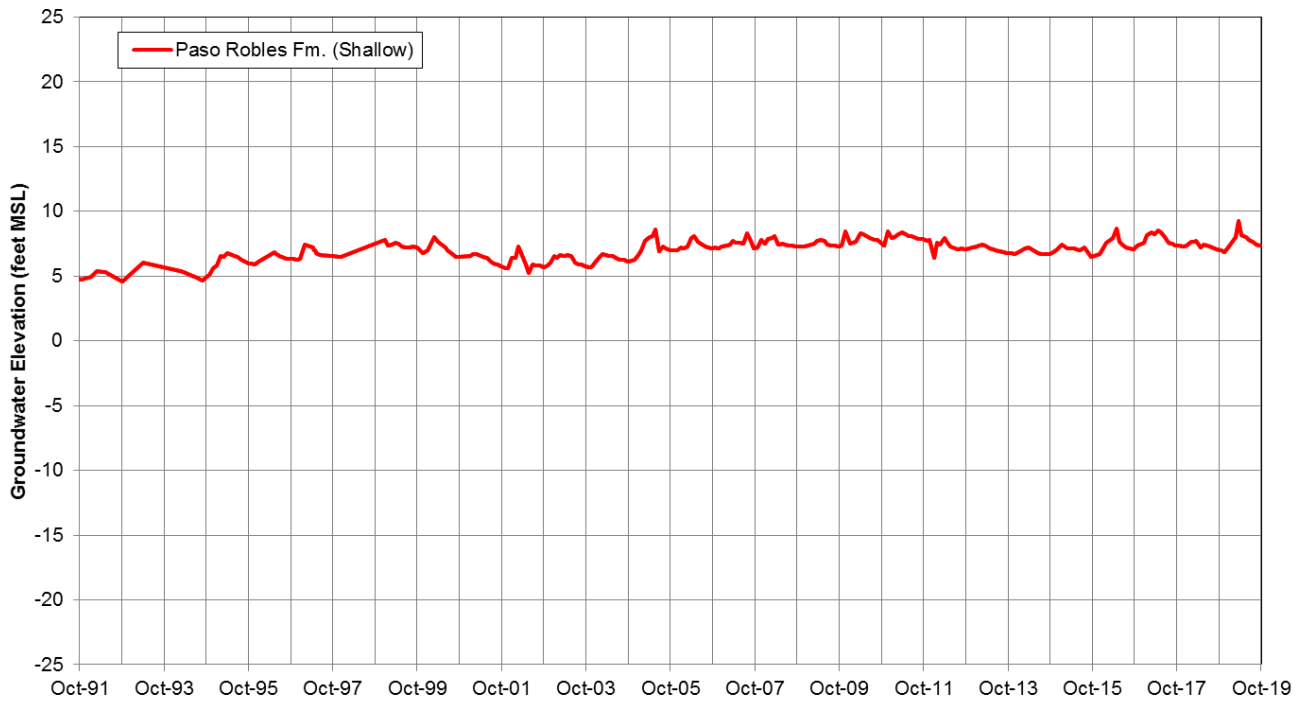
Figure 30. K-Mart Well Hydrograph (Source: Watermaster)

In the Southern Coastal subarea, the KMART monitoring well is representative of groundwater levels near the coast (Figure 30). The hydrograph shows that groundwater elevations have always been above sea level and continue to remain fairly stable over time.

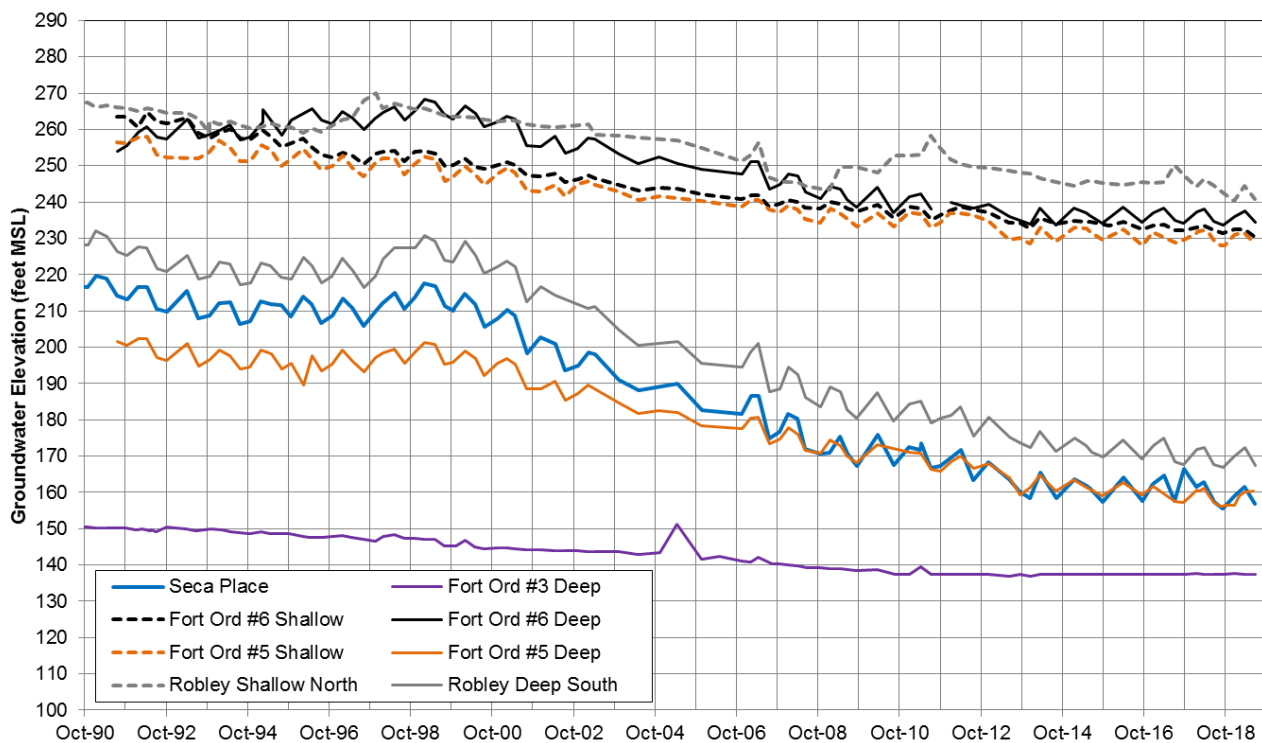
Figure 31. Eastern Laguna Seca Subarea Hydrographs

Although wells in the Laguna Seca subarea are far enough from the coast not to induce seawater intrusion, there is concern that since 2001 this area has experienced ongoing groundwater level declines that is not being halted or improved upon by triennial pumping reductions. It is believed this is occurring due in part to the Natural Safe Yield of the subarea being too high and in part due to influences of groundwater pumping east of the Seaside Basin boundary (HydroMetrics WRI, 2016). Figure 31 shows in the eastern portion of the subarea that between 1999 and 2014, shallow groundwater levels declined at a rate of approximately 0.6 feet per year, and deep groundwater levels declined up to 4 feet per year. Although there was some stabilization in groundwater levels between Water Years 2014 and 2016, groundwater levels are continuing to decline at a rate of less than 0.6 feet per year. Figure 10 shows the location of wells with hydrographs on Figure 31 while Figure 32 shows the location of all wells, including production wells in the eastern Laguna Seca Subarea.

As pointed out from Laguna Seca subarea hydrographs on Figure 31, groundwater levels in the central and eastern Laguna Seca subarea have been declining approximately 0.6 feet per year since 2014. The pumping depression caused by the Laguna Seca Golf Ranch wells remains similar in size to recent years. Groundwater levels at the Ryan Ranch wells in the western portion of the Laguna Seca subarea have continued to experience recovery since they have not been pumped from February 2018. In Water Year 2019, 2nd quarter groundwater levels in this area have recovered approximately 11 feet for a total recovery of 26 feet over the past two years.

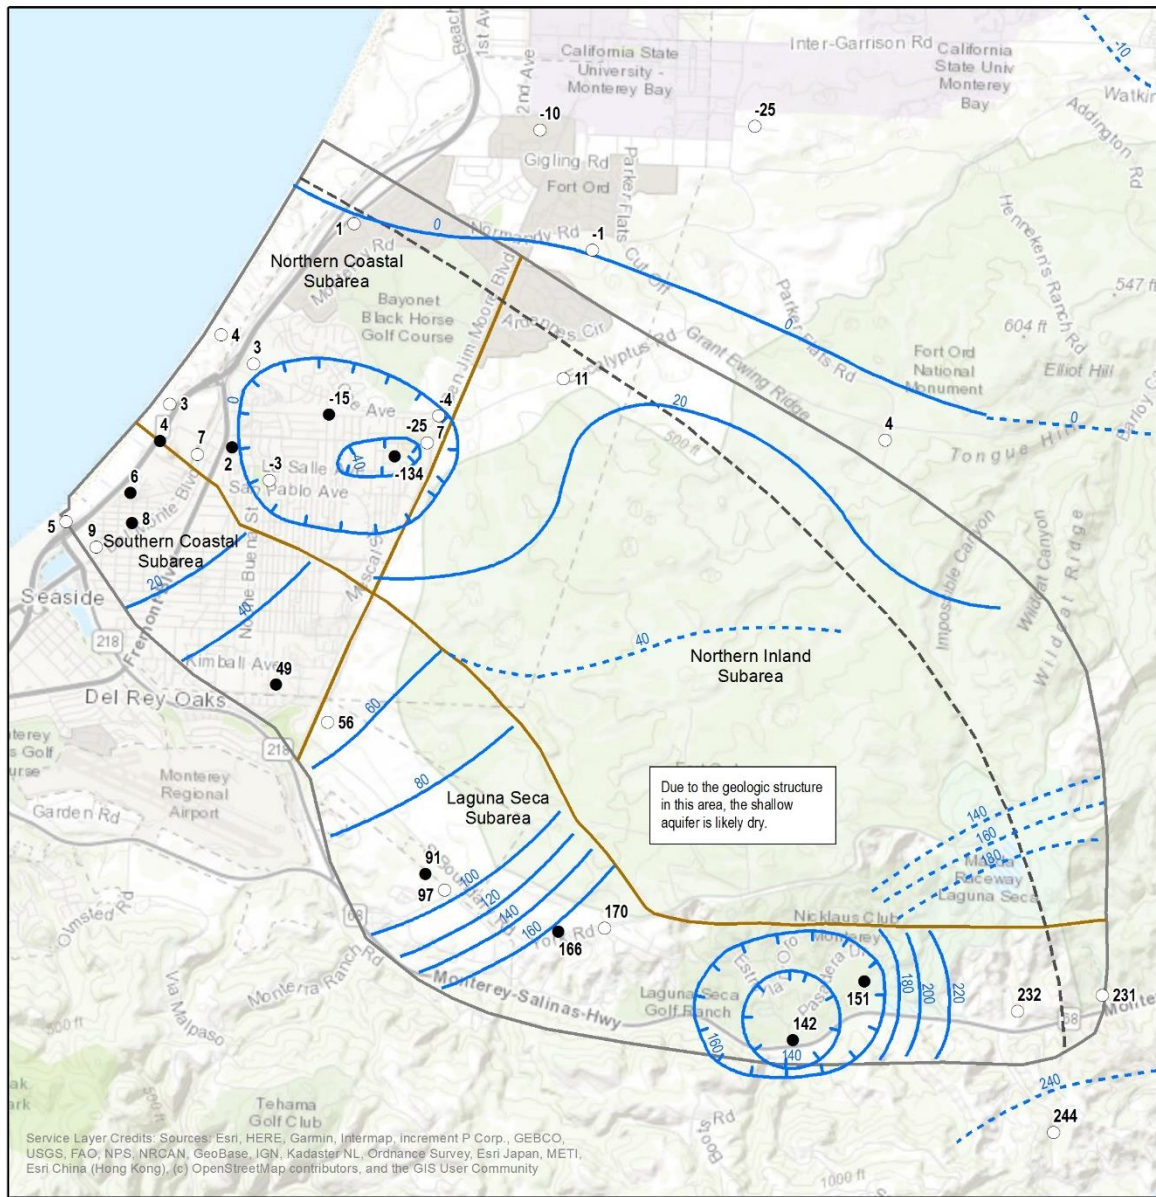
Figure 33. Shallow Zone Water Elevation Map – 2nd Quarter WY 2019 (January-March 2019)

Other than in areas of active groundwater pumping, the shallow aquifer does not show seasonal fluctuations to the same extent as the deep aquifer. Shallow groundwater levels near the coast have decreased by up to 2 feet over 2018 and 2019. Groundwater levels remain stable in the western portion of the Laguna Seca subarea, and the Laguna Seca subarea pumping depression remained similar in extent to last two water years. In the eastern portion of the Northern Inland subarea, an area of the shallow aquifer is indicated to be potentially dry due to geologic structural control (Figure 33). The shallow aquifer pumping depression in the Northern Coastal Subarea has expanded slightly since last year.

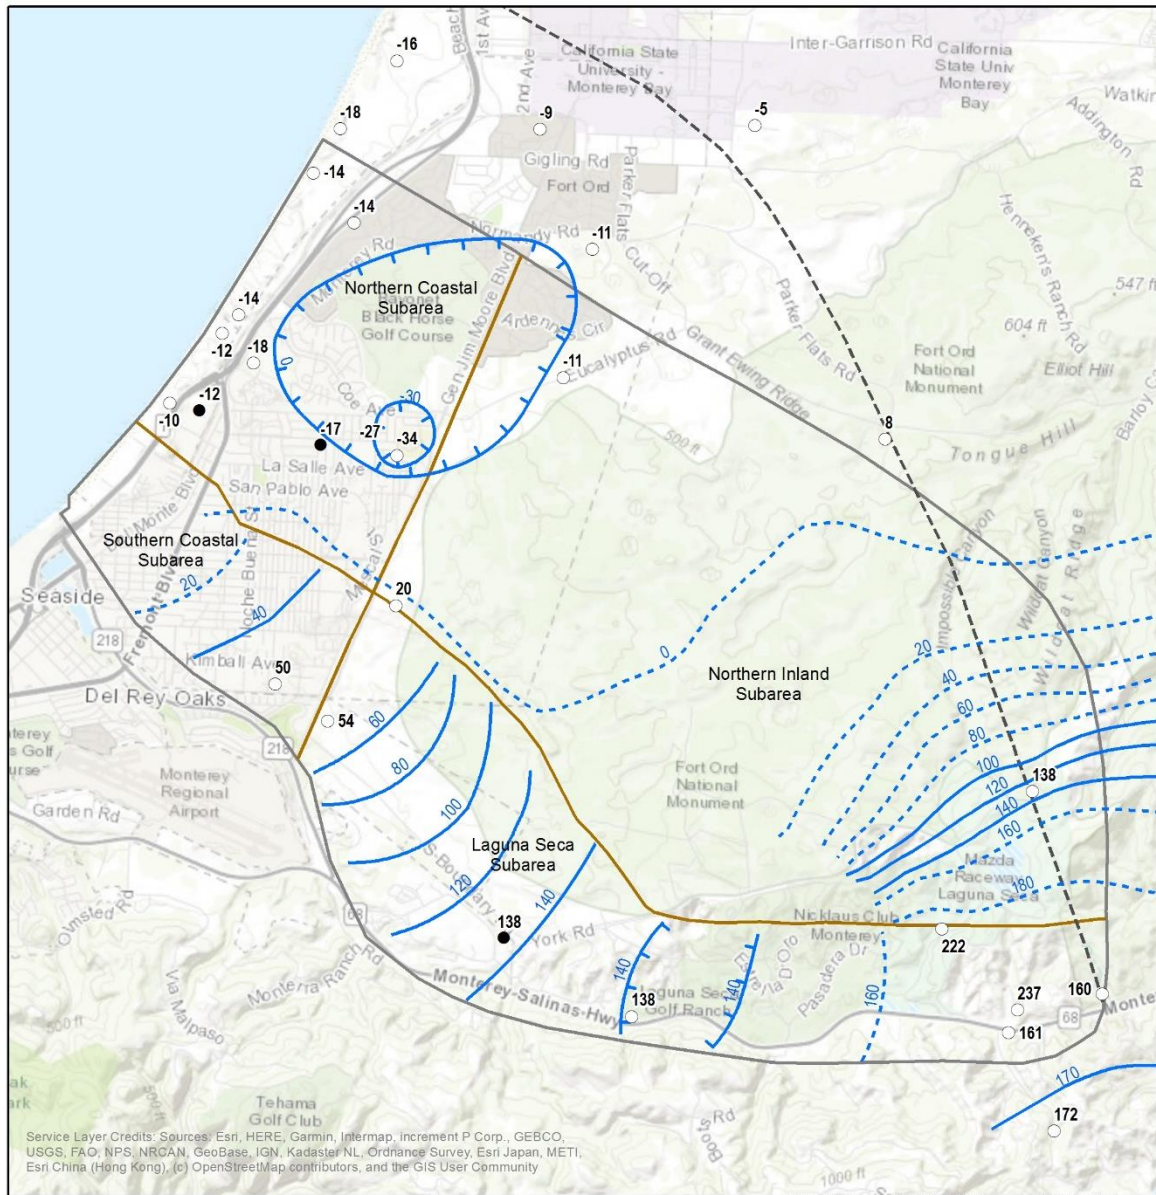
Figure 34. Deep Zone Water Elevation Map – 2nd Quarter WY 2019 (January-March 2019)

Second quarter groundwater levels in the deep aquifer, particularly along the coast, are usually higher than 4th quarter groundwater levels by up to 6 to 7 feet due to seasonal groundwater demand. Coastal deep aquifer groundwater elevations in Water Year 2019 have experienced some changes to those observed in Water Year 2018. Groundwater elevations in the Northern Coastal subarea increased by up to 5 feet in the south, and decreased by up to 7 feet in the north. The pumping depression in the Northern Coastal subarea in Water Year 2019 is slightly smaller in extent than in Water Year 2018 (Figure 34).

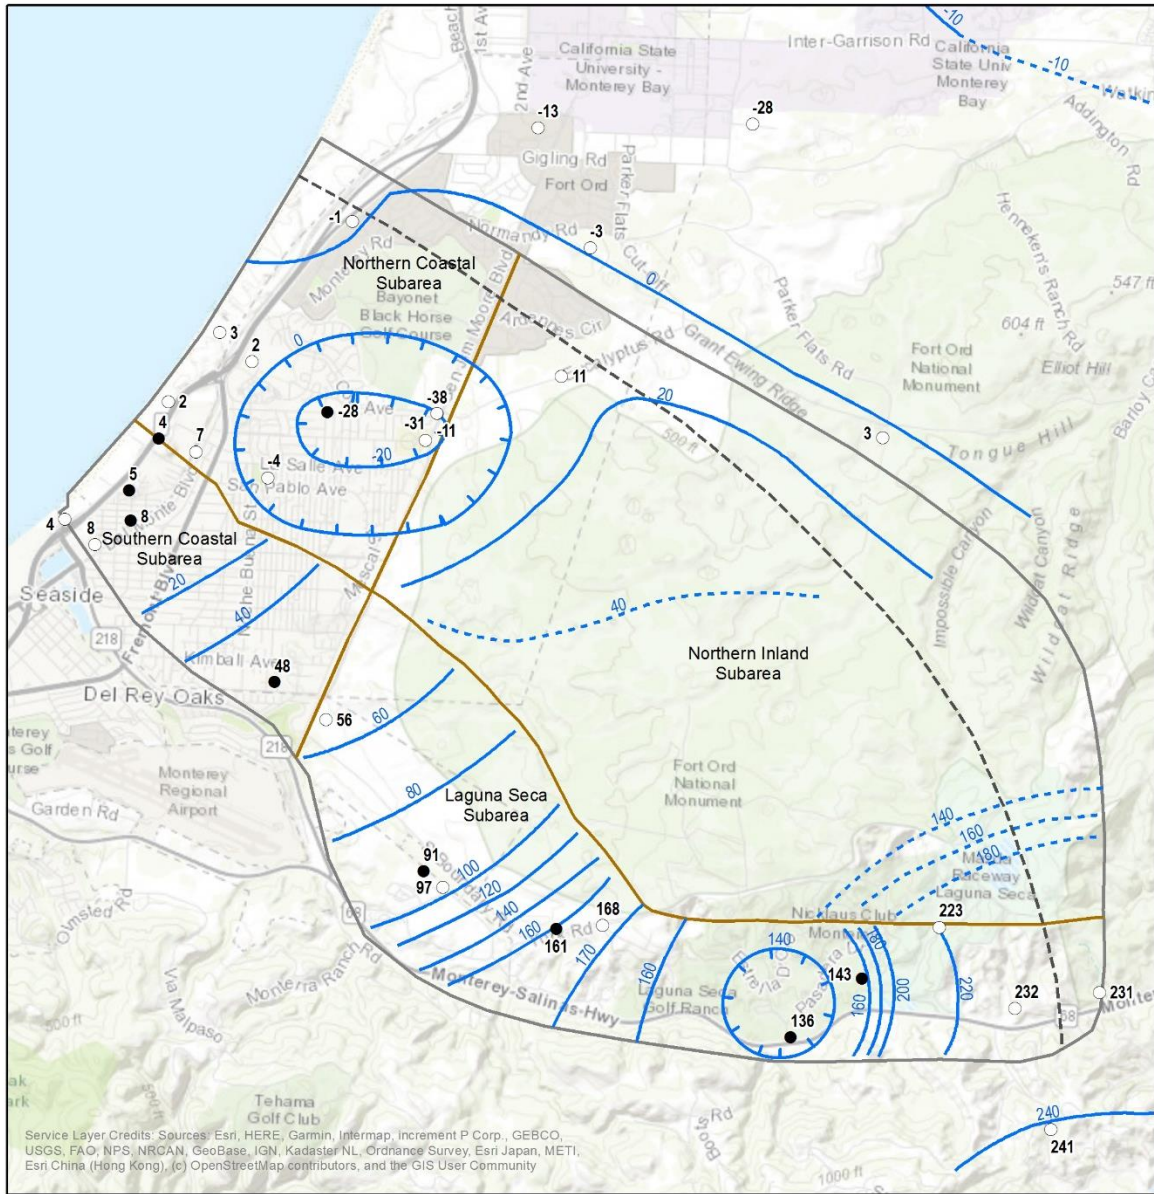
Figure 35. Shallow Zone Water Elevation Map – 4th Quarter WY 2019 (August/September 2019)

Groundwater elevation maps for the shallow and deep aquifer zones for the 4th quarter of Water Year 2019 are shown on Figure 35 and Figure 36, respectively. The contours for the shallow aquifer along the coast show that groundwater levels increased slightly in the Northern Coastal subarea from the 2nd quarter of Water Year 2018. The pumping depression in the Laguna Seca subarea has decreased slightly since last year. The pumping depression in the Northern Coastal subarea has remained of a similar extent to Water Year 2018 but its position has shifted slightly to the north. (Figure 35).

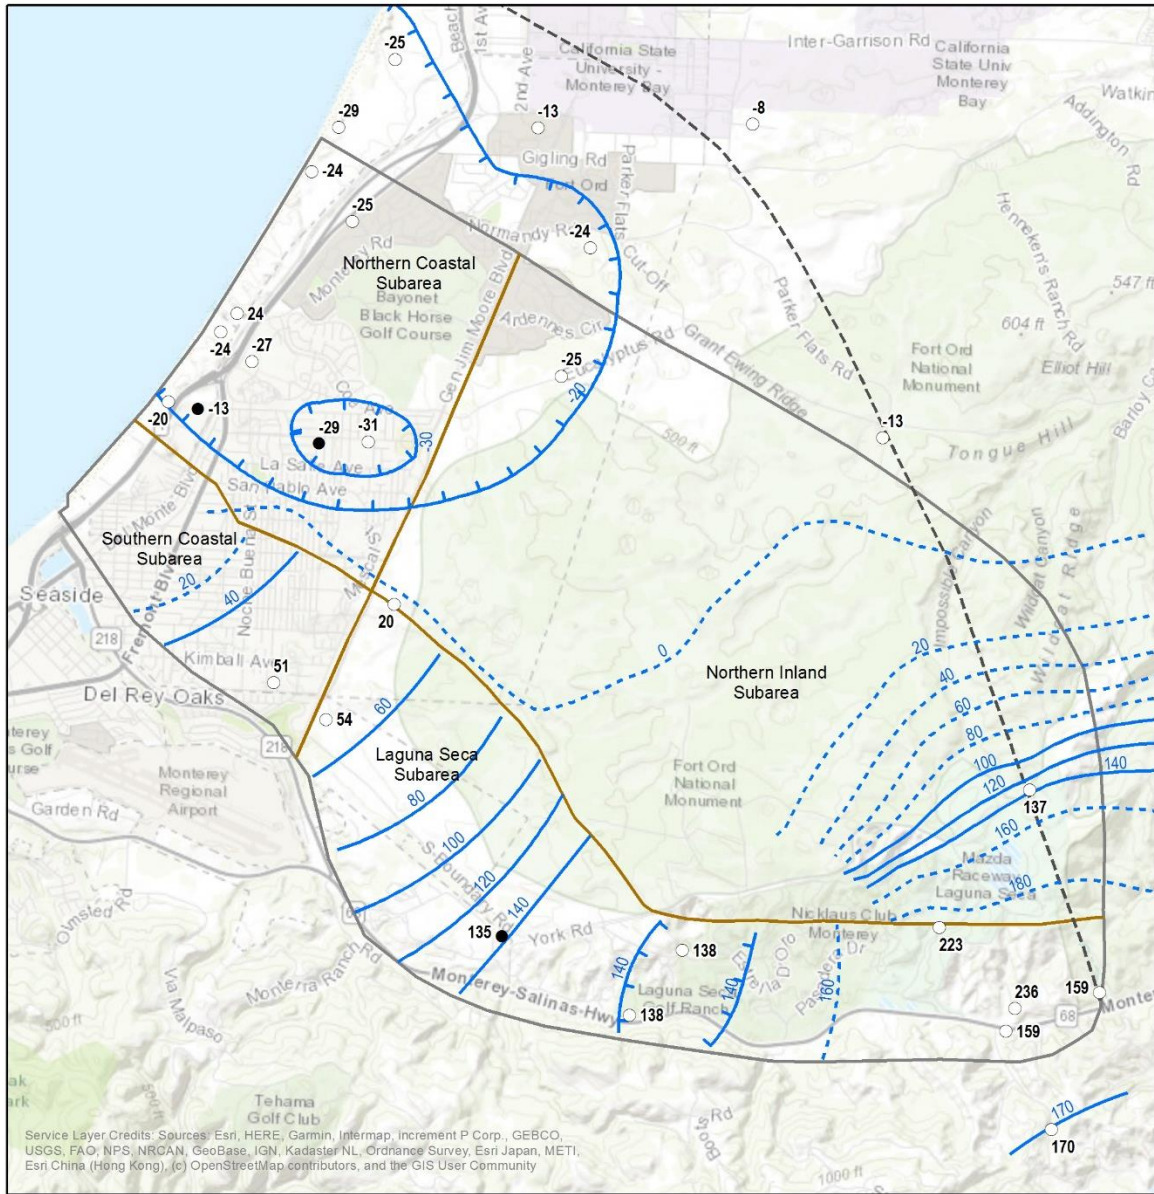
Figure 36. Deep Zone Water Elevation Map – 4th Quarter WY 2019 (August/September 2019)

The deep aquifer's -20 foot elevation pumping depression around the wells that pump the most in the Northern Coastal subarea was similar in extent to Water Year 2018 (Figure 36). At the coast, deep groundwater levels decreased by up to 3 feet. Groundwater elevations at Ryan Ranch in the central to western portion of Laguna Seca subarea increased by up to 6 feet since Water Year 2018. Fourth quarter groundwater level recovery at the Ryan Ranch wells was halted by Ryan Ranch #7 pumping 20 acre-feet over the summer but levels still remained similar to 4th quarter 2018 groundwater levels that had recovered 30 feet during that year. The Laguna Seca subarea pumping depression around the Laguna Seca Golf Ranch wells remained similar to last water year (Figure 36).

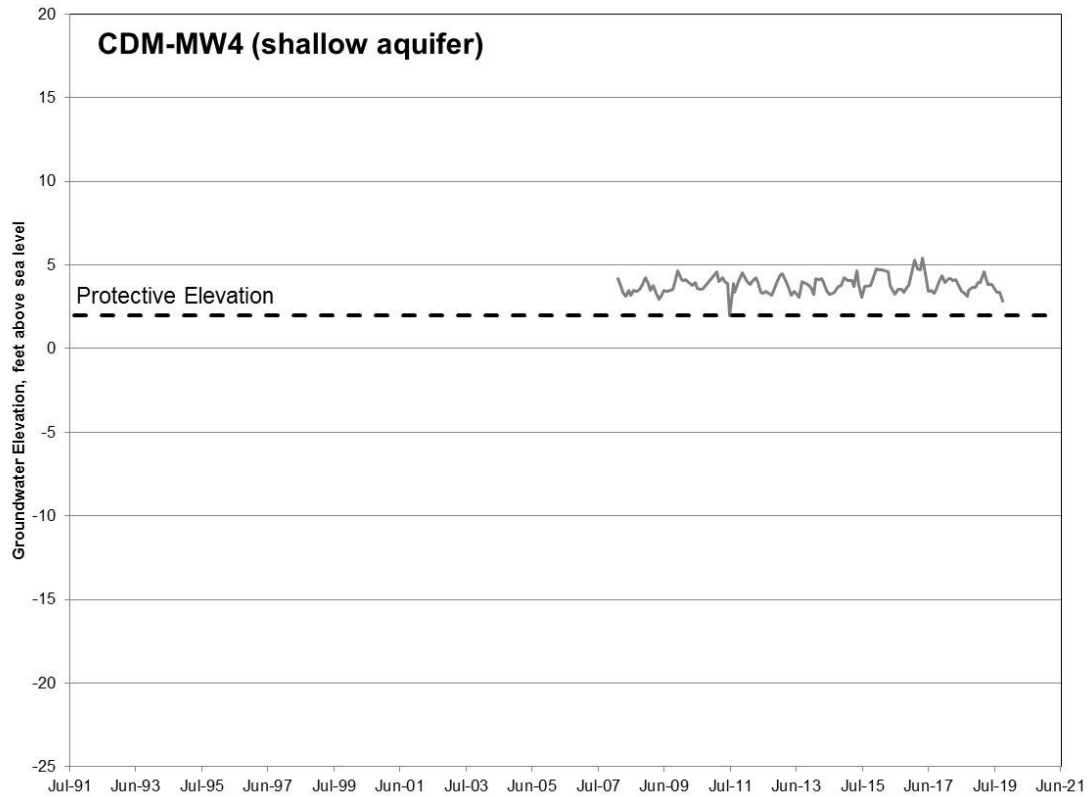
Figure 39. CDM-MW4 Groundwater and Protective Elevations

Figure 37 through Figure 40 show the historical groundwater elevations at each of the target protective elevation monitoring wells. Groundwater levels continue to be below protective elevations in all deep target monitoring wells (MSC deep, PCA-West deep, and Sentinel Well 3). Two of the three shallow wells' groundwater levels are again above protective elevations: the PCA-W shallow well and the CDM-MW4 well. In Water Year 2018, the PCA shallow well groundwater levels fell slightly below protective elevations. The greater seasonal fluctuations in this well are likely due to the recommencement of pumping from the shallow aquifer in 2015 at the Coe Ave well. Groundwater levels in the MSC shallow well continue to be below its protective elevation.
