**MONTGOMERY
& ASSOCIATES**

Seaside Groundwater Basin 2019 Seawater Intrusion Analysis Report

Seaside Groundwater Basin Watermaster
Monterey County, California

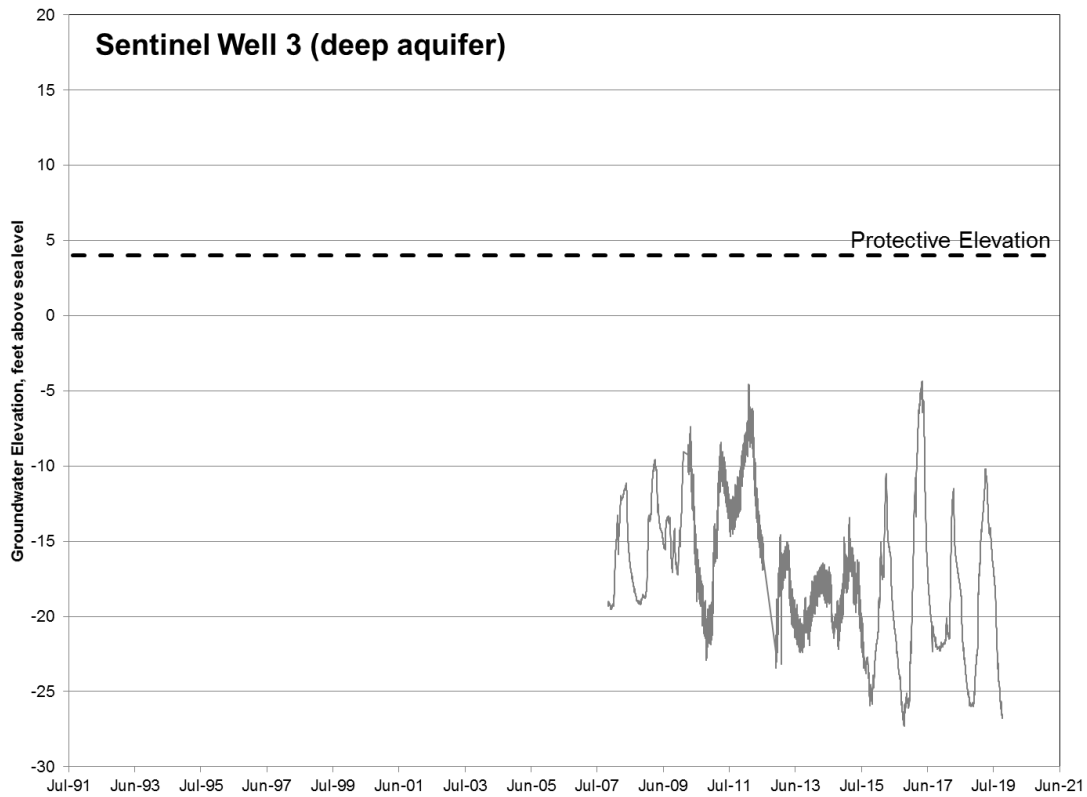
Figure 40. Sentinel Well 3 Groundwater and Protective Elevations

Figure 37 through Figure 40 show the historical groundwater elevations at each of the target protective elevation monitoring wells. Groundwater levels continue to be below protective elevations in all deep target monitoring wells (MSC deep, PCA-West deep, and Sentinel Well 3). Two of the three shallow wells' groundwater levels are again above protective elevations: the PCA-W shallow well and the CDM-MW4 well. In Water Year 2018, the PCA shallow well groundwater levels fell slightly below protective elevations. The greater seasonal fluctuations in this well are likely due to the recommencement of pumping from the shallow aquifer in 2015 at the Coe Ave well. Groundwater levels in the MSC shallow well continue to be below its protective elevation.

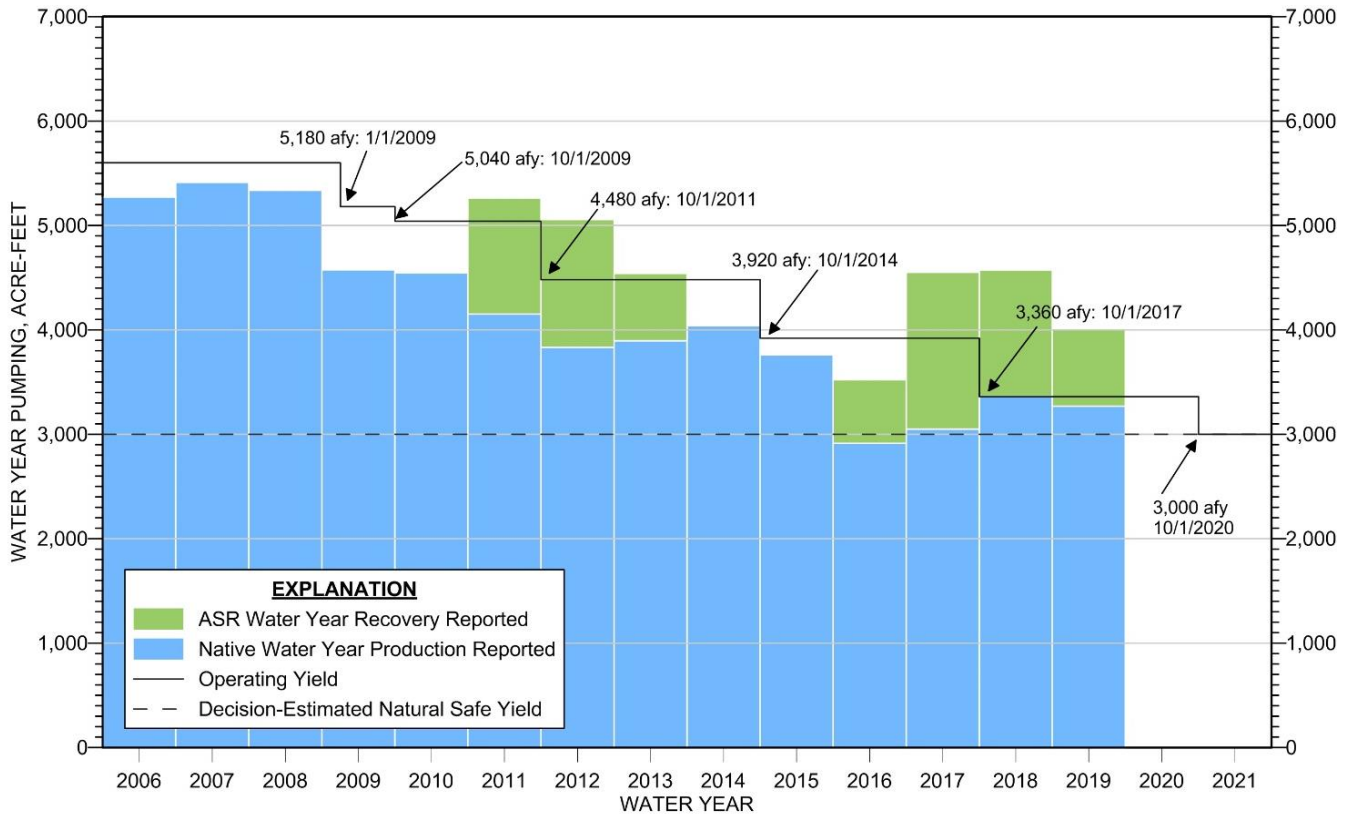
Figure 41. Annual Reported Groundwater Production and Operating Yield for Watermaster Producers

Gross pumping by Watermaster producers in Water Year 2019 was 4,013.6 acre-feet, which includes recovery of 744.4 acre-feet of aquifer storage and recovery (ASR) water (Figure 41). Net or native groundwater pumping is the amount pumped after ASR recovery is taken into account. This means that in years where there is water injected and recovered, more water may be pumped from CAW's wells to recover water injected the previous operational year. In Water Year 2019, 1,335.1 acre-feet of injection took place, and 744.4 acre-feet of injected water was recovered. The net or native groundwater production is therefore 3,269.2 acre-feet, which is 91 acre-feet below the Decision-ordered Operating Yield for Water Year 2019 of 3,360 acre-feet (Figure 41). The net or native groundwater produced from the Basin in Water Year 2019 was 94 acre-feet less than in Water Year 2018.

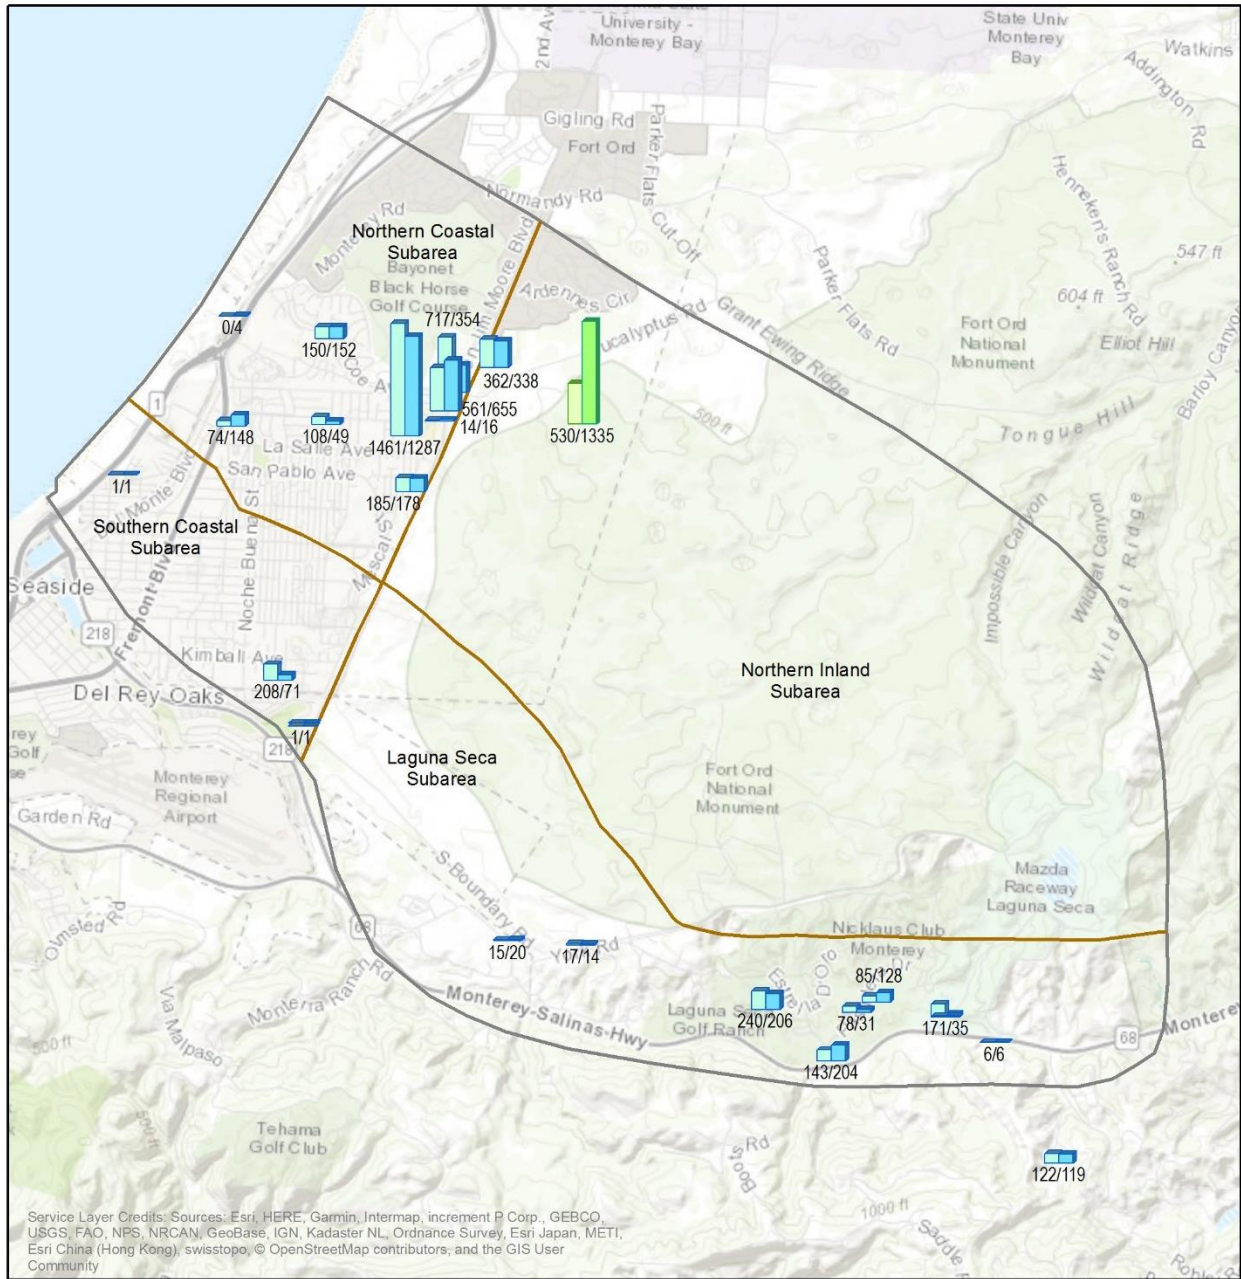
Figure 42. Watermaster Producers' Pumping Distribution for Water Years 2018 and 2019

The blue charts on Figure 42 reflect the actual or gross amounts pumped from each well, and the green chart reflects the amount of water injected at the ASR well. In Water Year 2019, the majority of pumping in the basin occurred at CAWC's Ord Grove No. 2 and Santa Margarita #1 production wells.
