**MONTGOMERY
& ASSOCIATES**

Seaside Groundwater Basin 2022 Seawater Intrusion Analysis Report

Seaside Groundwater Basin Watermaster
Monterey County, California

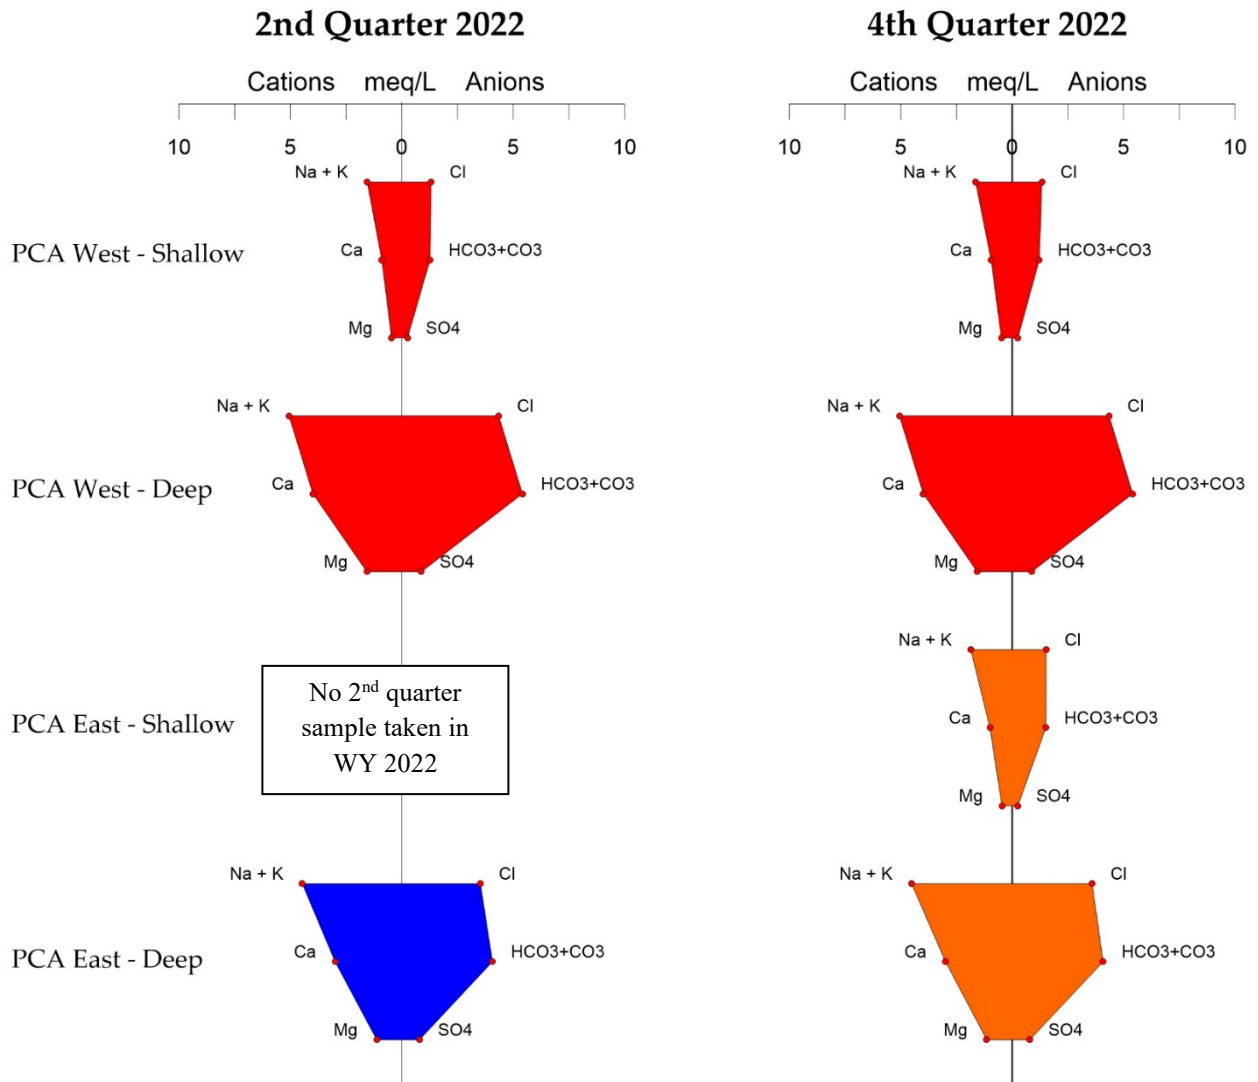
Figure 13. Stiff Diagrams for PCA West and PCA East Wells
(Data source: Watermaster)

Stiff diagrams for the monitoring wells sampled during the second quarter of WY 2022 are shown in the left column on Figure 12 through Figure 14. None of the Stiff diagrams, including monitoring well FO-10 Shallow and FO-10 Deep, show the high chloride spike shown on Figure 7 that indicates seawater intrusion. FO-10 Shallow and FO-10 Deep do show a slightly different shape than other shallow wells because of their increased chloride. As described above, the exact mechanism behind the evolving shape of these wells on the stiff diagrams is not currently known, and it is recommended that the well nest is destroyed and replaced.

Stiff diagrams for 11 monitoring wells sampled during the fourth quarter of WY 2022 are shown in the right column on Figure 12 through Figure 14. The shapes of the Stiff diagrams for the paired monitoring wells are similar to the shapes of the Stiff diagrams for most prior years, with the exception of FO-10 Shallow and FO-10 Deep which have greater chloride equivalent concentration than HCO_3 compared to other shallow coastal wells.

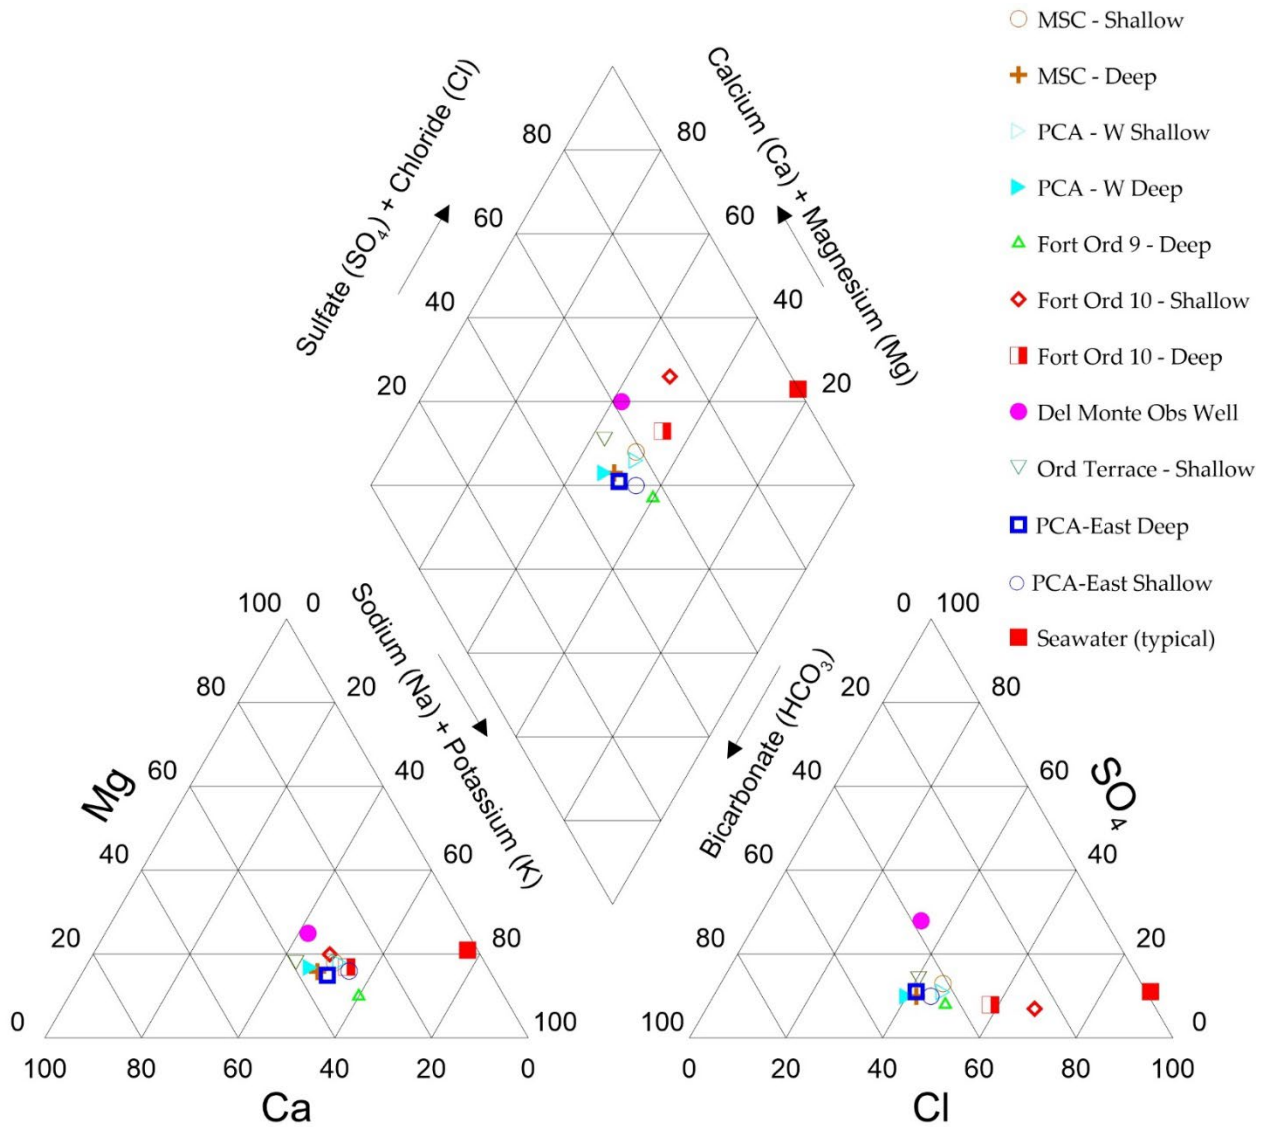
Figure 15. Piper Diagram for Seaside Groundwater Basin Monitoring Wells,
4th Quarter Water Year 2021 (July- September 2021)
(Data source: Watermaster)

The Piper diagram for monitoring wells (Figure 15) shows groundwater quality data clustering generally in a single area on the diagram. Groundwater is generally of a sodium-chloride/sodium-bicarbonate type and is not impacted by seawater. Monitoring well FO-10 Shallow and FO-10 Deep plot differently on both Piper (Figure 15) and Stiff (Figure 12) diagrams due to higher chloride than most other wells. As described above, current analysis is still inconclusive as to whether this is a result of seawater intrusion.

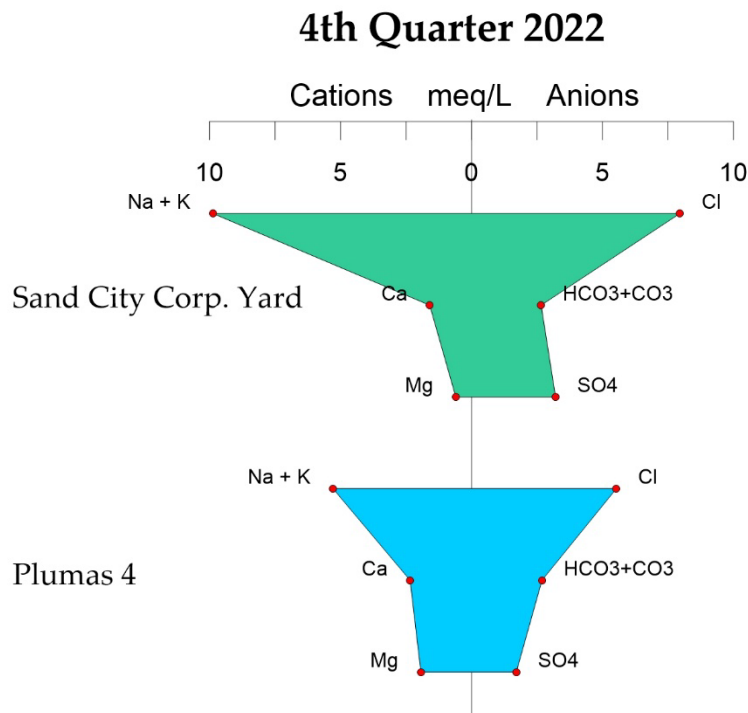
Figure 17. Stiff Diagrams for Southern Coastal Subarea Production Wells
 (Data source: Watermaster)

Stiff diagrams for 13 of the production wells sampled during the fourth quarter of WY 2022 are shown on Figure 17 through Figure 20. Production well Stiff diagrams show no significant changes from the shapes observed in previous years. Groundwater quality data for many of these wells was not available in WY 2022 at the time of this report. Ryan Ranch #7, #8, and #11 production wells were destroyed in 2021 and therefore groundwater quality data are no longer available for these wells. The Pasadera Paddock and LS Golf #12 production wells have a Stiff diagram shape that are slightly different from the other wells' chemistry. The cause of this could be localized mineralization. The Laguna Seca subarea is known to have higher salinity groundwater than the rest of the basin due to the underlying Monterey shale that was deposited in a marine environment. None of the Stiff diagrams for production wells near the coast show the high chloride spike shown on Figure 7 that indicates seawater intrusion.

The Sand City's Public Works Corp Yard production well in the Southern Coastal subarea and the York School production well in the Laguna Seca subarea typically have Stiff diagrams quite different from most other wells' groundwater quality. However, they do not have a large chloride spike associated with seawater intrusion as shown on Figure 7. None of the production wells sampled in WY 2022 and analyzed using Stiff and Piper diagrams show an indication of seawater intrusion.

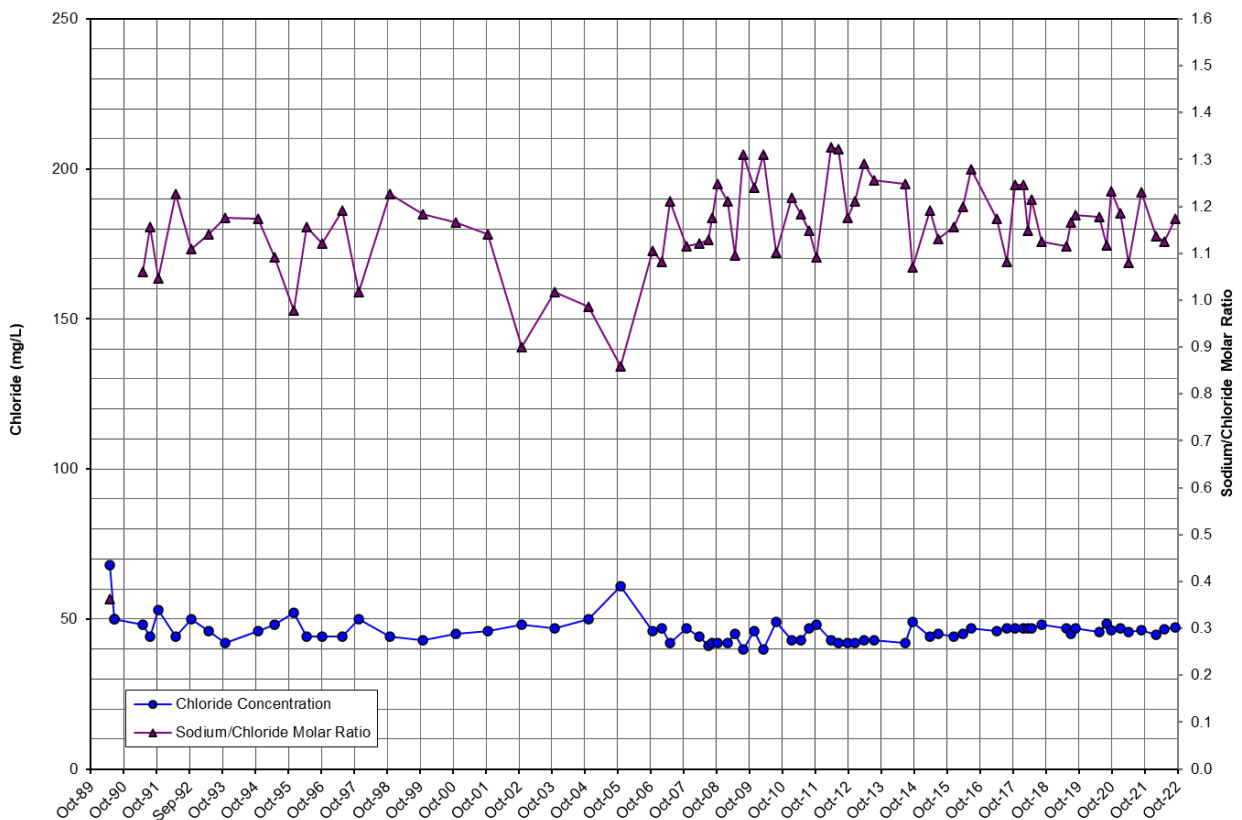
Figure 21. Historical Chloride and Sodium/Chloride Molar Ratios, PCA West Shallow

Chemographs showing chloride concentrations over time are plotted for each of the monitoring wells shown on the Piper and Stiff diagrams. An example plot displaying chloride concentrations for the shallow PCA-West Shallow monitoring well is shown on Figure 21. A complete set of chemographs is included in Appendix D. Chloride trends for most monitoring wells remain stable or fluctuate within a historical range.

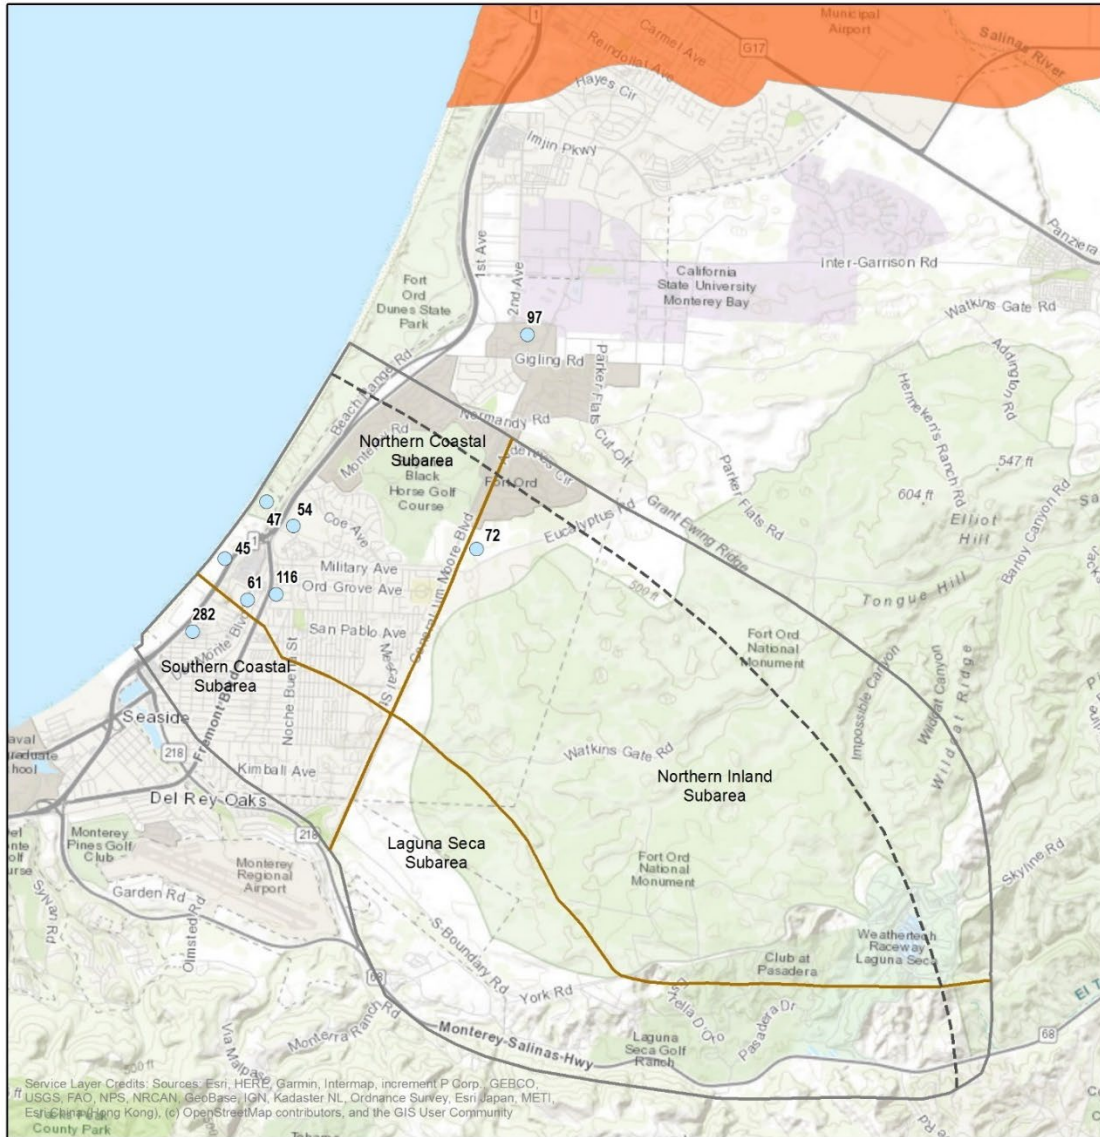
Figure 23. Paso Robles Aquifer (Shallow Zone) Chloride Concentration Map – 4th Quarter Water Year 2022

The Santa Margarita aquifer fourth quarter WY 2022 chloride concentration map is shown on Figure 23. Chloride data from Santa Margarita aquifer wells are posted on this map but do not show a spatial distribution that can be readily contoured because of differences in concentrations in wells near each other. Except for FO-10 Shallow, Santa Margarita aquifer chloride concentrations have not varied much from previous water years. FO-10 Shallow is located 0.7 miles north of the Basin, just over 1 mile inland of the coast. Chloride concentrations in the well increased 29.6 mg/L from February to September 2022. September's concentration of 96.6 mg/l reflects a continuous and sustained increase from previous years. As shown on Figure 22, chloride concentrations at this well jumped about 48 mg/L between September 2019 (42.2) and September 2020 (89.9), and continued increasing through August 2021 (92.8) and September 2022 (96.6).

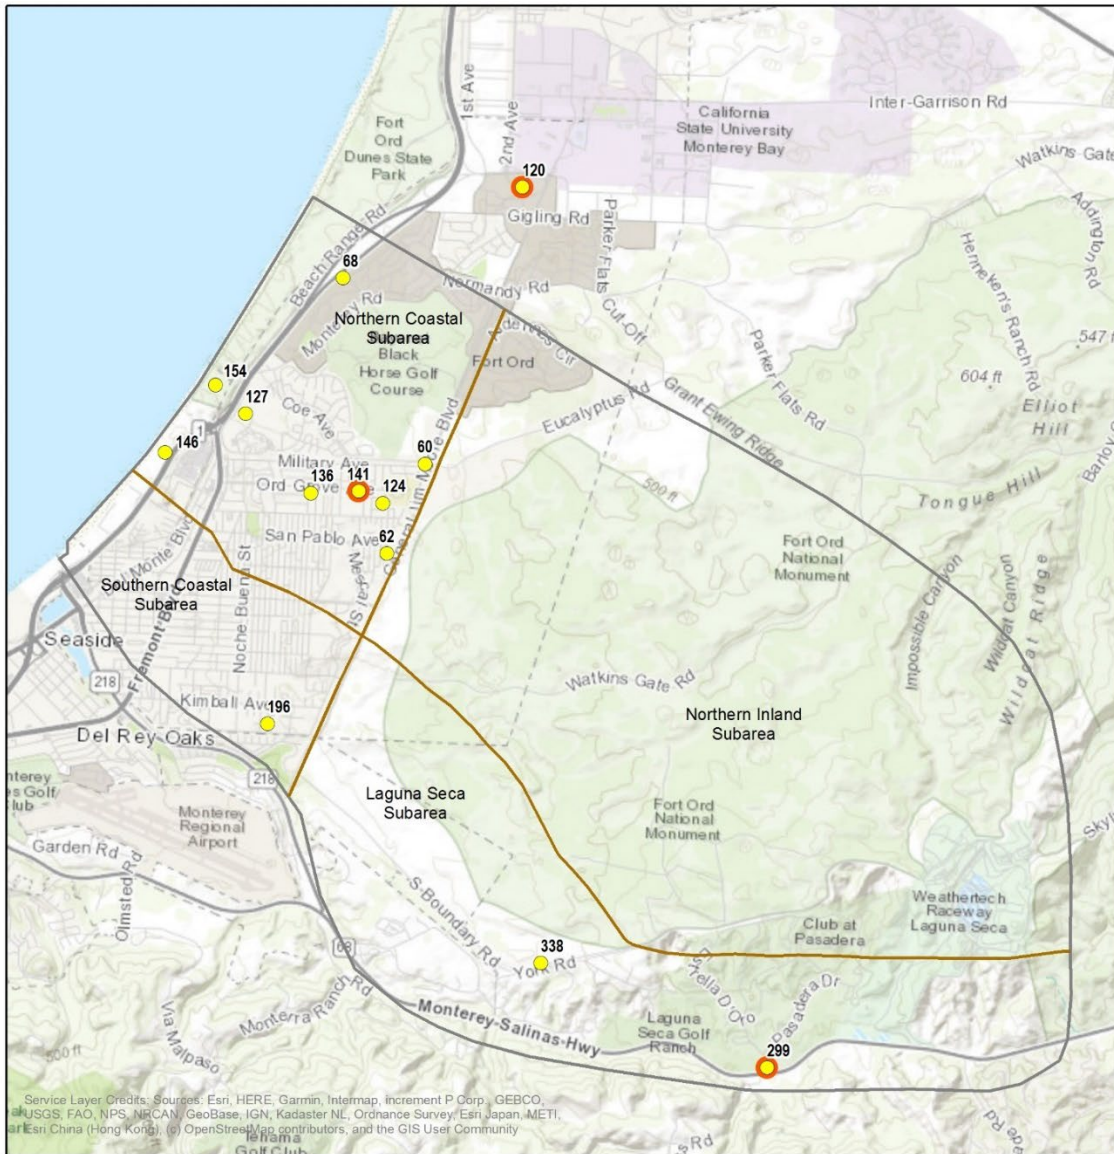
Figure 24. Santa Margarita Aquifer (Deep Zone) Chloride Concentration Map – 4th Quarter Water Year 2022

The Santa Margarita aquifer fourth quarter WY 2022 chloride concentration map is shown on Figure 24. Chloride concentrations for the Sentinel Wells are not shown on this map because it was found that groundwater samples collected from them are not representative of the aquifer. Santa Margarita aquifer chloride concentrations near the coast range roughly between 65 mg/L and 160 mg/L and are similar to last year. In WY 2021, the Ord Grove #2 production well experienced a 14 mg/L increase in chloride from last year to 134 mg/L, but that decreased in WY 2022 back down to 124 mg/L. These concentrations are generally within the 120-130 mg/L range of historical fluctuations. Since the chloride data show no discernible spatial distribution, with high concentrations close to low concentrations, the data cannot be readily contoured.

Chloride concentrations at both the Pasadera Golf- Paddock and the Ord Terrace Shallow wells increased over 20 mg/L from the previous measured year (Figure 24). The WY 2022 concentrations are the highest measured at Pasadera Golf – Paddock, and the second highest at Ord-Terrace Shallow. Due to its inland location, the increase at the Pasadera Golf-Paddock well is not related to seawater intrusion. Likewise, the Ord Terrace Shallow concentration of

141 mg/L remains within its historical range between 100 and 155 mg/L and is not likely to reflect seawater intrusion. Chloride concentrations at FO-10 Deep increased 56 mg/L from the previous year. As described earlier, the mechanism for this increase is not currently known.

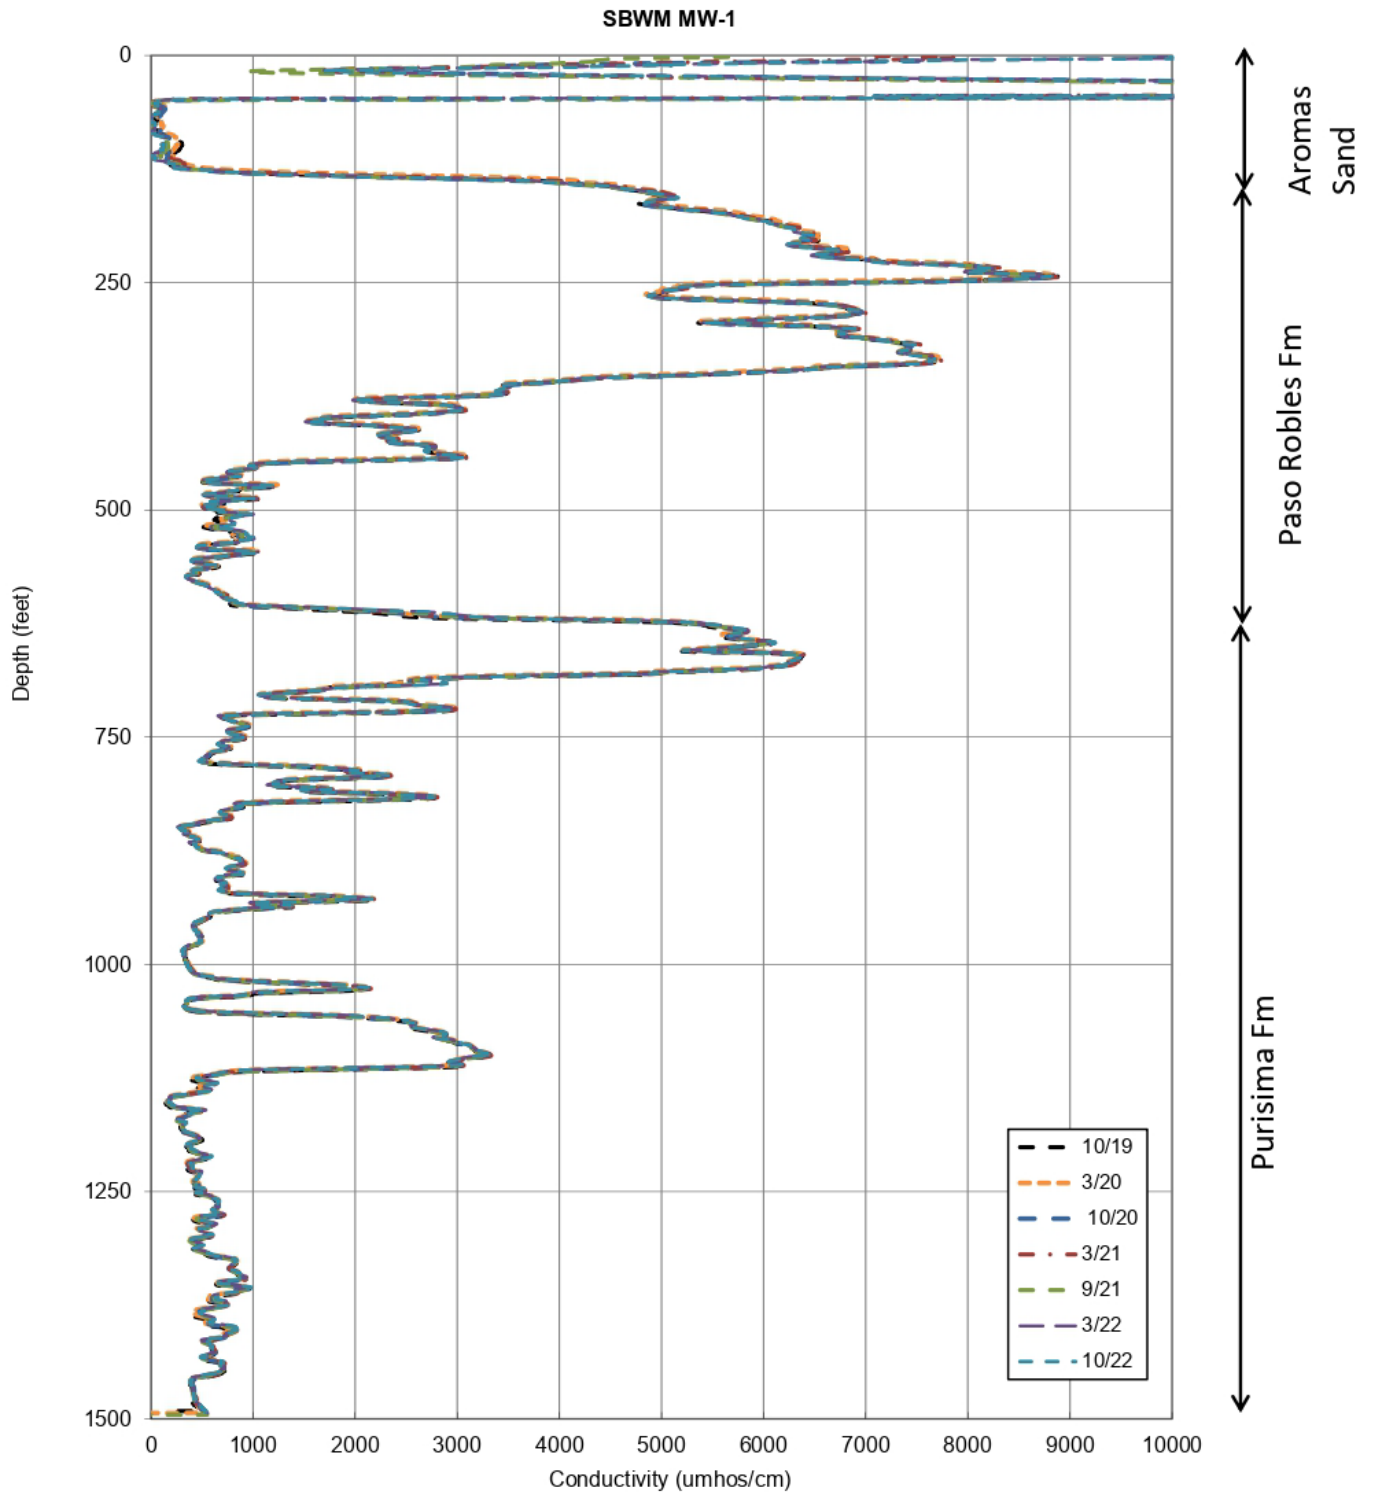
Figure 25. Sentinel Well SBWM MW-1 Induction Log

Salinity changes shown on Figure 25 through Figure 28 for Sentinel Wells 1 – 4, respectively, are only relative, and do not allow direct measurement of TDS or chloride concentrations in the aquifer. They do, however, provide a means to determine changes in salinity over time. Induction logging in previous years indicated salinity in the Dune Sands and Aromas Formation overlaying the main production aquifers fluctuates from season to season; becoming more saline in the fall months when stresses on the aquifer are greatest. The logging events that took place in WY 2022 plot similarly on the figures below, suggesting very little net change in salinity over the course of the year. As has been the case historically, none of the wells show detectable changes in conductivity to the deeper aquifers where the majority of production wells extract groundwater.
