TECHNICAL MEMORANDUM

To: Bob Jaques, Seaside Watermaster Program Manager
From: Georgina King and Derrik Williams
Date: February 21, 2017
Subject: Seaside Groundwater Basin Analysis of Wells Sampled in December 2016

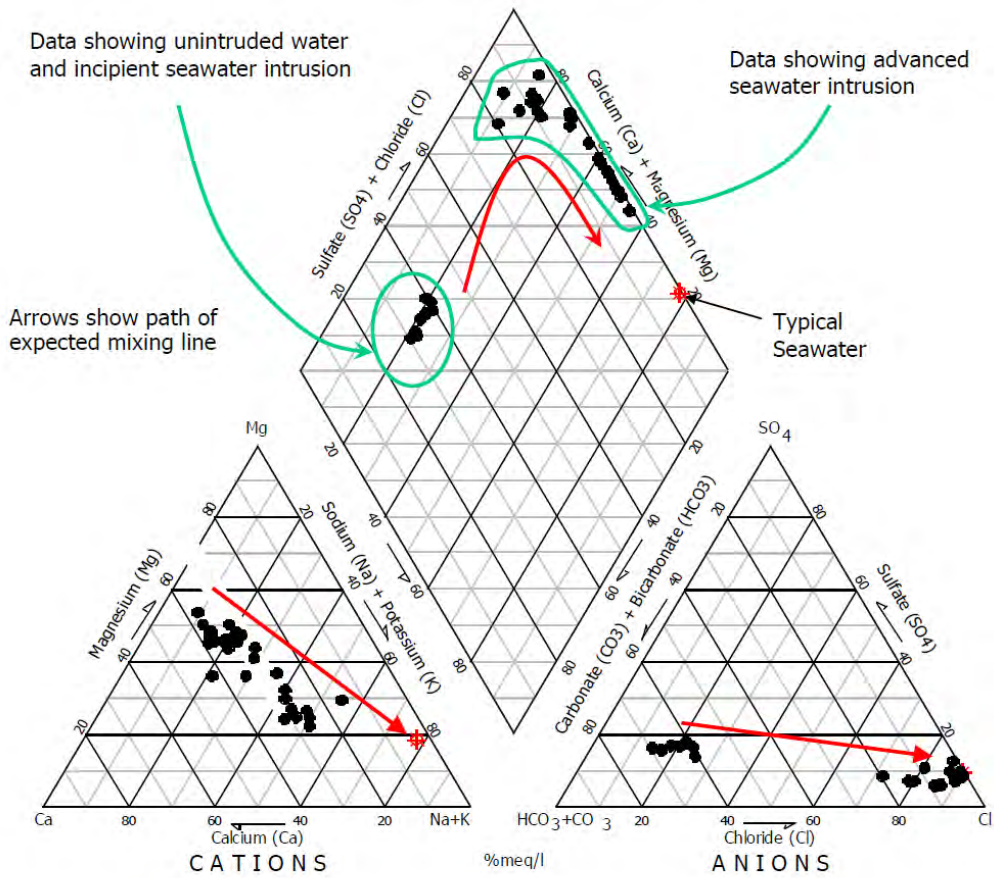
*Figure 9: Piper Diagram for Groundwater in Pajaro Valley
 (Data source: PVWMA)*

In the Pajaro Valley to the north, the evolution of groundwater quality from fresh to seawater intruded followed the paths indicated with red arrows on the piper diagram shown on Figure 9. In the Pajaro Valley, unintruded groundwater was of a calcium-bicarbonate type. During the initial phase of seawater intrusion in the Pajaro Valley, the dominant chemical change in groundwater was an increase in chloride concentrations, as evidenced by the plotted samples moving up towards the peak of the diamond in Figure 9. The expected increase in sodium concentrations only occurs later, as evidenced by the later samples moving down and to the right of the diamond in Figure 9. Groundwater samples from the Pajaro Valley did not exhibit an immediate sodium increase during the initial phase of seawater intrusion because of an ion exchange reaction in which sodium in the groundwater replaces the calcium on the clays; effectively taking sodium out of the groundwater and replacing it with calcium.

The groundwater quality evolution shown in Figure 9 is what we expect to see for any groundwater that is initially of a calcium-bicarbonate type. For wells starting off as a sodium-bicarbonate or sodium-chloride-bicarbonate water type, including wells SBWM-1, SBWM-2 and SBWM-4, it is unclear what the expected chemical evolution of groundwater will look like as seawater advances. To date, we have found no other examples of clearly documented seawater intrusion in these types of groundwater from which to examine whether calcium enrichment occurs or not in sodium-rich waters.

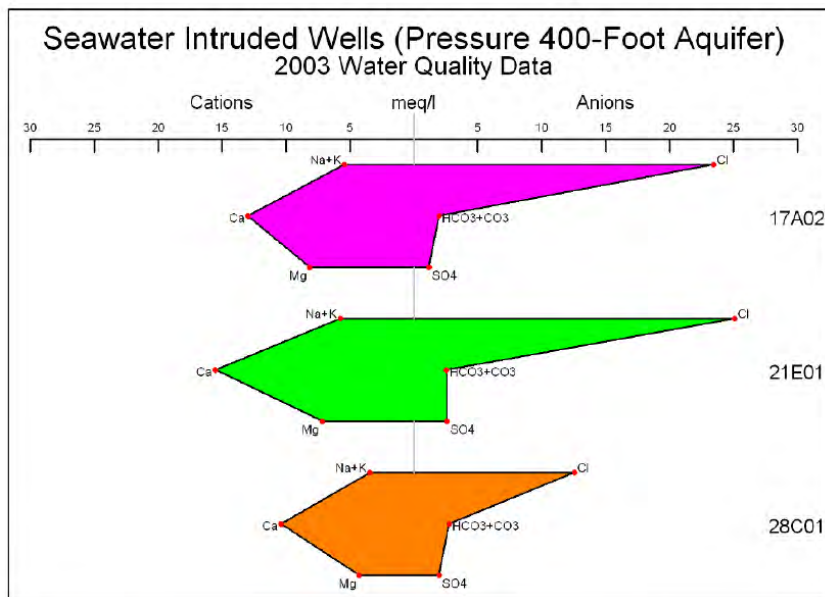
Figure 12: Stiff Diagrams from Salinas Valley Wells with Seawater Intrusion
 (Source: MWCRA)

The stiff diagrams demonstrating what a seawater intruded sample might look like are provided on Figure 12. Comparing the stiff diagrams on Figure 10 and Figure 11 with Figure 12 reveals that none of the December sample's stiff diagrams are indicative of seawater intrusion, which is characterized on the stiff diagram as having calcium enrichment and a chloride spike. The stiff diagrams in Figure 12 came from locations where the native, unintruded groundwater was a calcium-bicarbonate type. It is unclear what the stiff diagrams of incipient seawater intrusion look like for areas where the native groundwater is of sodium-chloride or sodium-chloride-bicarbonate types.

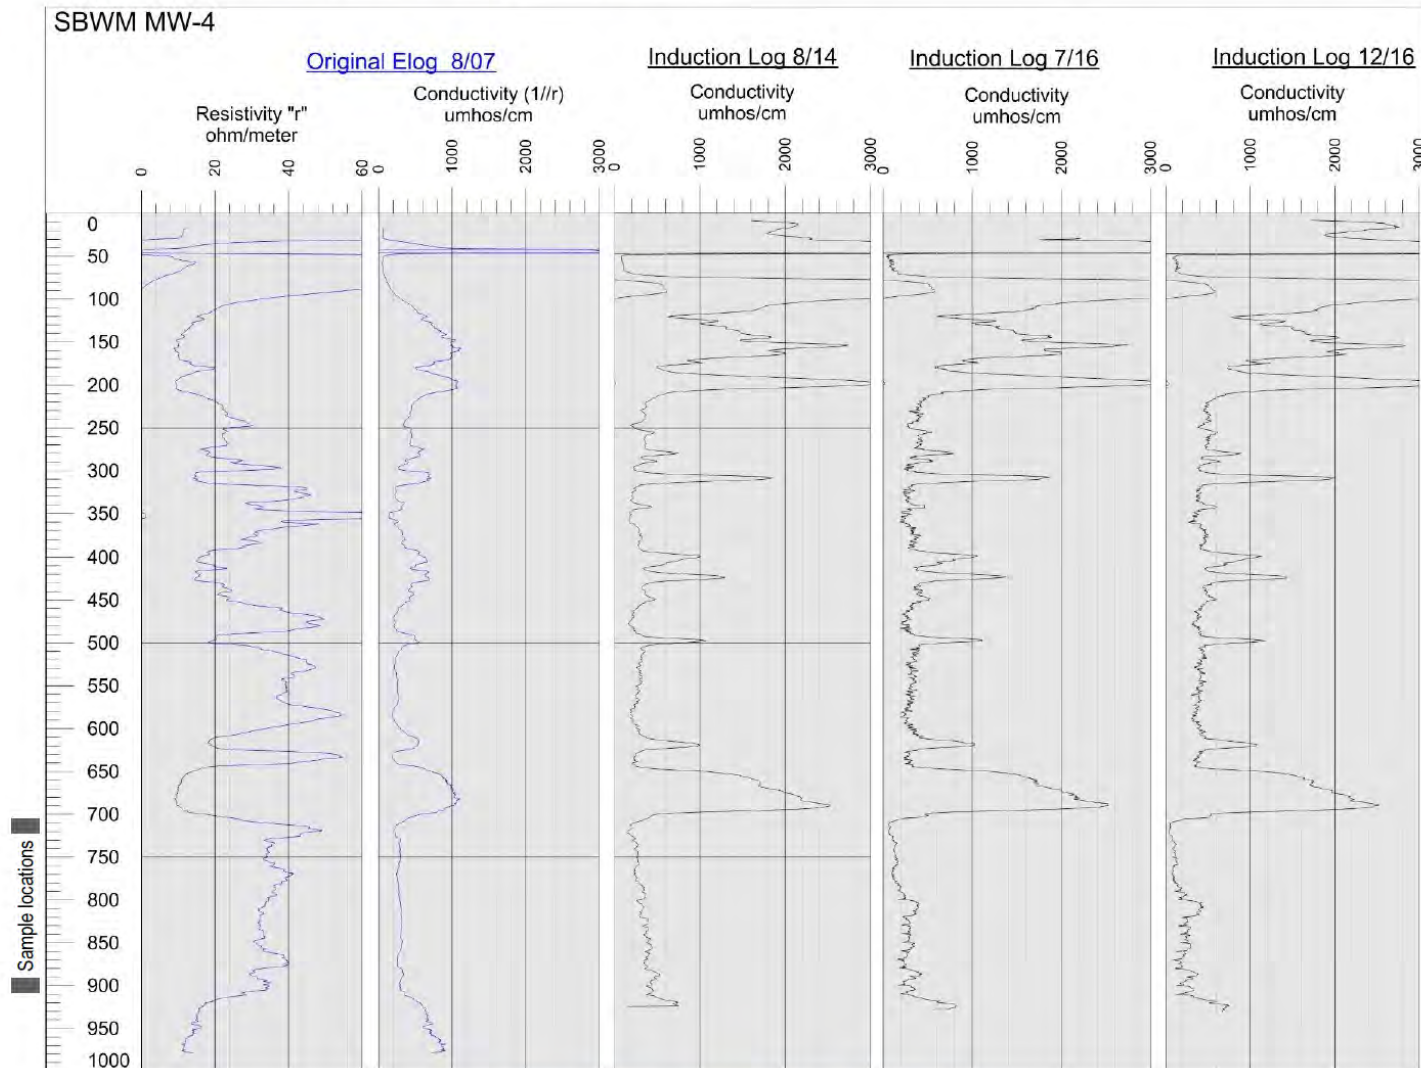
Figure 16: Sentinel Well 4 Induction Logs

Figure 14 through Figure 16 shows the initial induction logs for the entire length of wells SBWM-1, SBWM-2 and SBWM-4 when they were installed (blue), and for all induction logs run by Pacific Surveys since 2014. Welenco performed the logging between 2007 and 2013 but due to a different tool used by Pacific Survey, a new baseline was established in August 2014. To improve readability of the lower portion of the wells, Figure 17 and Figure 18 provide a zoomed in view with the logs overlain on one another.
